LICENSEE EVENT REPORT (LER)

Facility Name (1) Dresden Nuclear Power Station, Unit 2 Docket Number (2) 0 5 0 0 0 2 3 7 Page (3) 1 of 0 5

Title (4) Unanticipated LPCI Minimum Flow Valve M02-501-13B Closure Due to Spurious Master Trip Unit Spike During Calibration

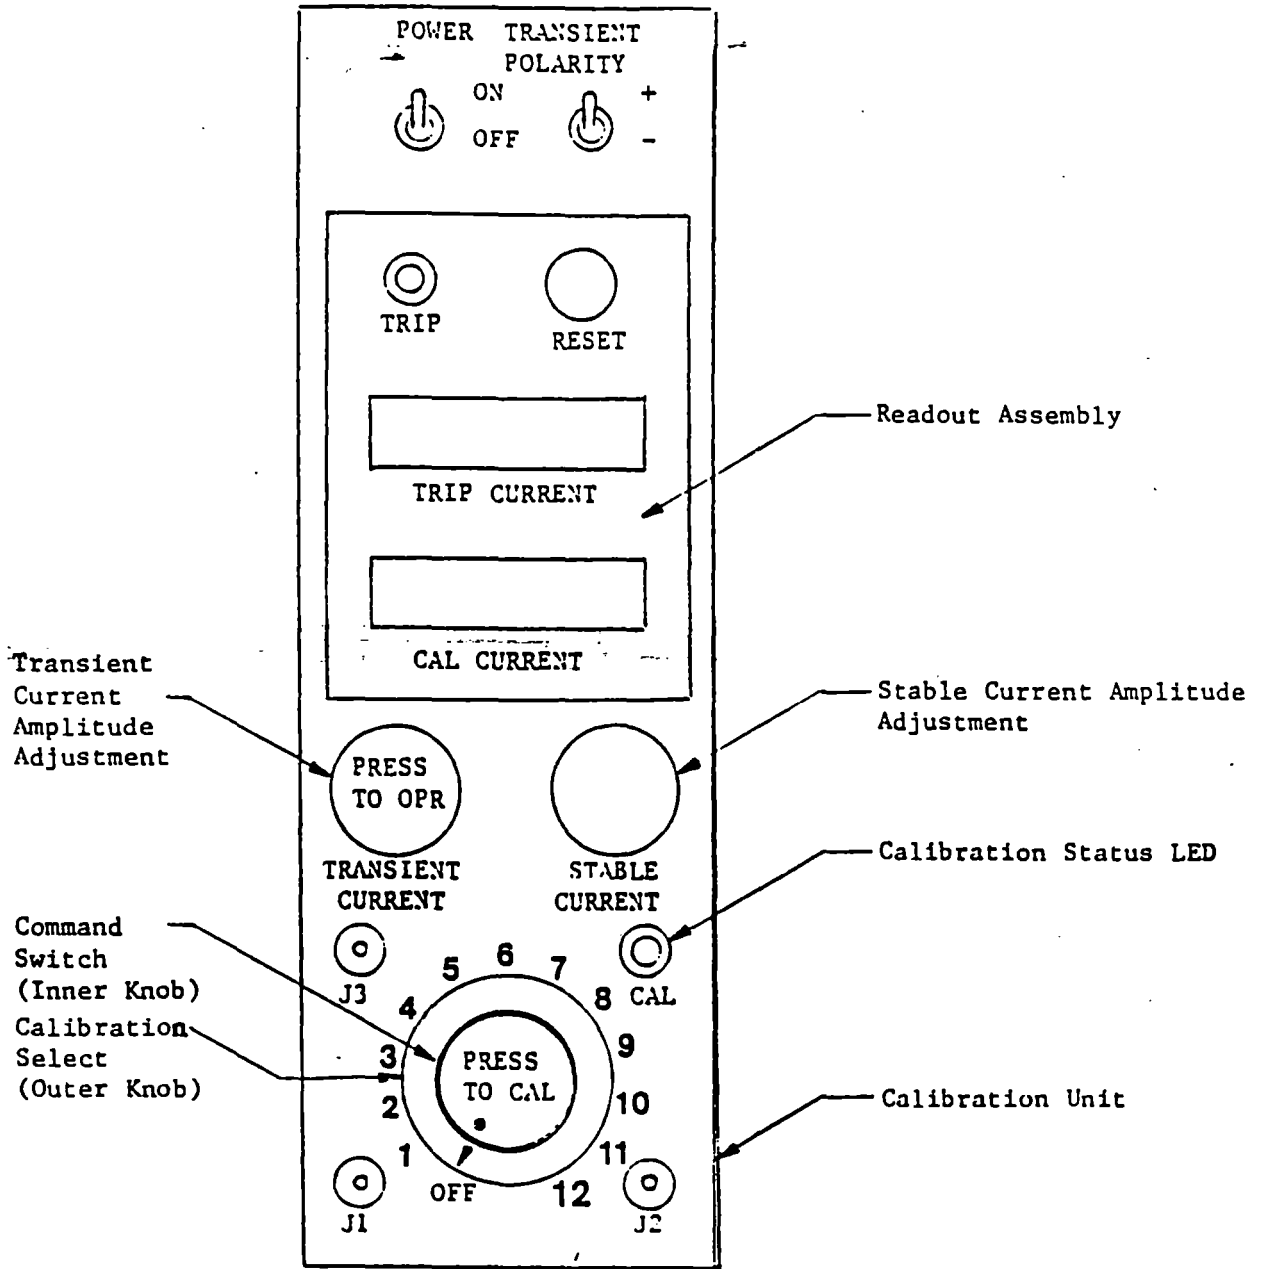
Figure 1. Calibration Unit and Readout Assembly Front Panel

To investigate the root cause of this event, the Master Calibration Unit was sent out to the Manufacturer (Rosemount) for technical evaluation. Upon completion of the evaluation, the apparent root cause of this event was attributed to the knob for the channel select being loose on the shaft. The shaft had a groove worn into it from the sliding motion of the set screw. Based on the manufacturer's evaluation, it appears that the IMD technician had selected the correct channel 11 as indicated, but it selected adjacent channel 12 due to a loose knob from the shaft. Consequently, when the inner knob was pressed to CALIBRATE, adjacent LPCI minimum flow MTU 2-1501-92B was spiked. Spurious MTU spikes during calibration have not been a previous adverse trend.

The immediate corrective action was to initiate WR 07621 to replace the existing MTU calibration unit for further inspection and failure analysis. On March 20, 1992, the MTU calibration unit was replaced by the IMD under WR 07621 and inspected by the System Engineer. For further failure mode analysis, the MTU calibration unit was shipped out to the vendor and evaluated. The IMD will continue to perform Analog Trip System (ATS) calibration on a monthly basis to verify proper function. A periodic inspection program of MTU calibration unit will be created by March 31, 1993 (237-180-92-04501S1).

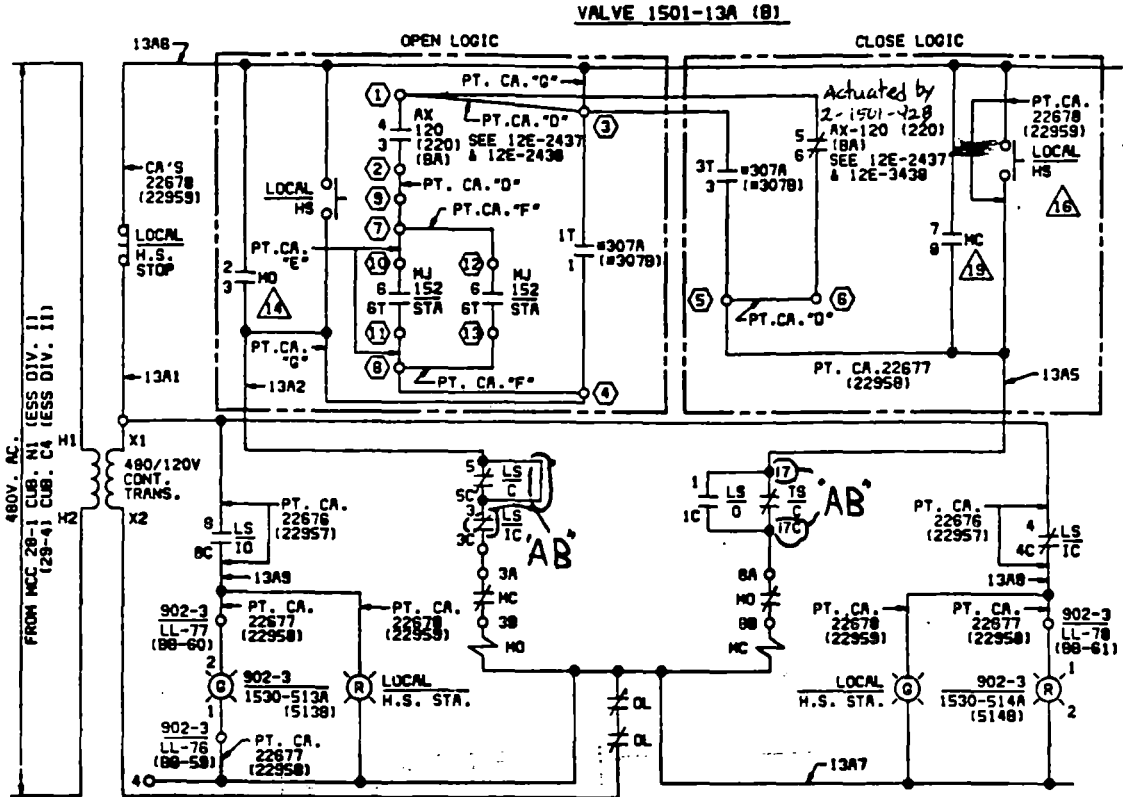
Figure 2. Schematic for MOV 2-1501-13B

The function of M02-1501-13B is to provide a minimum flow path for the system II LPCI pumps in order to prevent pump damage. The valve is normally open. The LPCI logic (see Figure 2 attached) provides for opening the minimum flow valve. Also, the system II LPCI pumps were not operating at the time and redundant low pressure emergency cooling systems were unaffected. The valve was repositioned back to the open position immediately. Momentary closing of the LPCI minimum flow valve presented minimal potential for damaging the pump as damage would occur only after prolonged operation with no minimum flow protection. Safety significance of this event is therefore considered minimal.
