Commonwealth Edison
Dresden Nuclear Power Station
R.R. #1
Morris, Illinois 60450
Telephone 815/942-2920

LICENSEE EVENT REPORT (LER)

Title (4) Manual Reactor Scram Due to Loss of Instrument Air Through Unit 3A IA Dryer Inlet Valve AO 3-4799-1194 and Failure of SA/IA Cross-Tie Valve AO 3-4701-500 to Open Timely

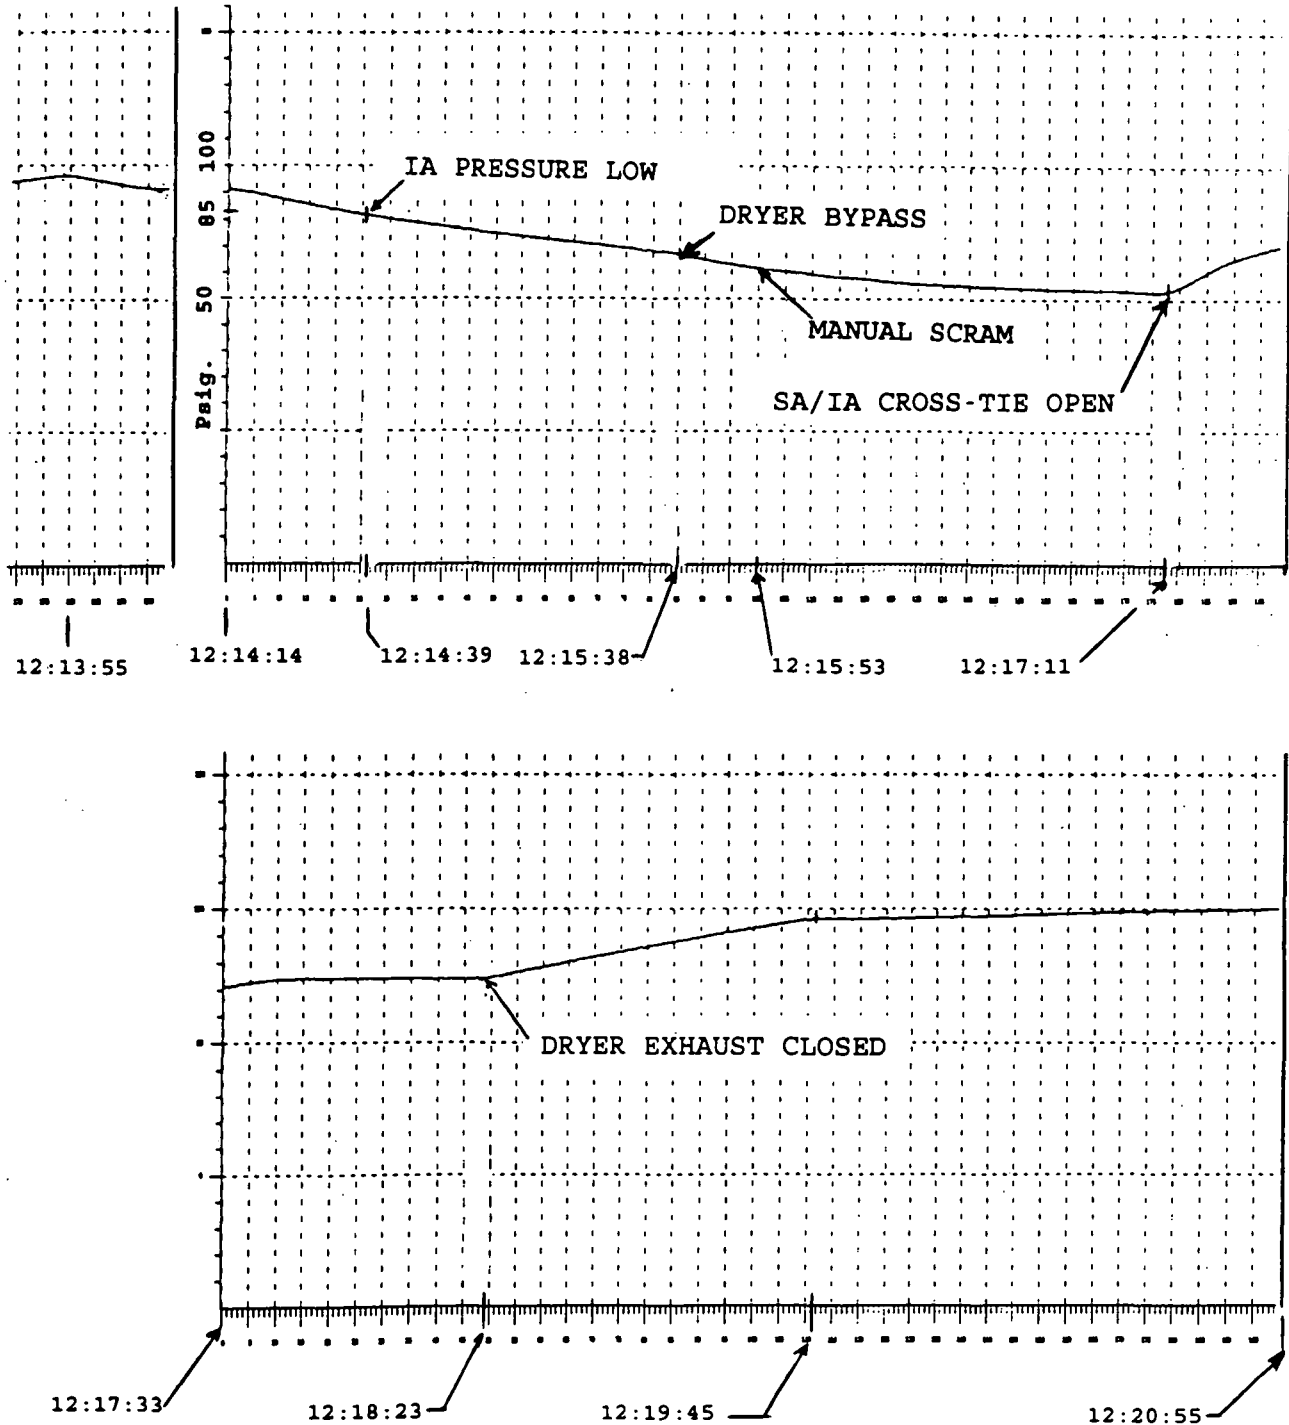
FIGURE 1

A review of the Instrument Air Transient Analysis Recorder Plot (TARP) was performed as part of the initial scram investigation. The Instrument Air header time decay trace was compared against the 3A Instrument Air Dryer operating cycle (Figure 2). The right chamber inlet valve closes at time zero. At 5 seconds, the right chamber blowdown (purge) cycle is initiated with the exhaust valve opening. The exhaust cycle continues for 245 seconds, after which the exhaust valve closes. Chamber repressurization commences approximately 3 seconds later and lasts for 33 seconds. At the end of the repressurization phase, the right chamber inlet valve opens for the drying cycle of 313 seconds. During the right chamber drying phase, the left chamber processes through the same blowdown and repressurization cycles. One complete dryer cycle lasts 6 minutes after which time the process repeats.

Review of the Instrument Air Transient Analysis Recorder Plot (Figure 1) indicated air header pressure continued to decay from time 0 to 178 seconds after which the header pressure began to recover. Recovery is believed to have resulted from the back-up Service Air to Instrument Air (SA/IA) cross-tie valve opening. Header pressure began to increase rapidly and stabilized at approximately 75 psig. At 250 seconds, the header pressure again started to increase to approximately 95 psig at 310 seconds. For the next 390 seconds air header pressure varied between 100 and 105 psig (operating on the Service Air system pressure).

Based on a review of the dryer operating cycle, review of the TARP time-line and conditions observed by operators on the Unit 3 instrument air system, it was determined that a dryer inlet valve failed in the open position for one drying cycle. With an inlet valve failing open, low air header pressure would be observed for 245 seconds during the purge cycle. The TARP time-line corroborates this condition. If the inlet valve remained in the failed open position, low air header pressure would have been observed 355 seconds later on the subsequent chamber purge cycle; this did not occur. If a dryer exhaust valve failed in the open position, air header pressure decay would have been observed for 313 seconds during the chamber drying cycle; this condition also did not occur.

**TRANSIENT ANALYSIS RECORDER PLOT
UNIT 3 INSTRUMENT AIR RECEIVER PRESSURE
(12:13:55 THROUGH 12:20:55 JANUARY 16, 1993)**

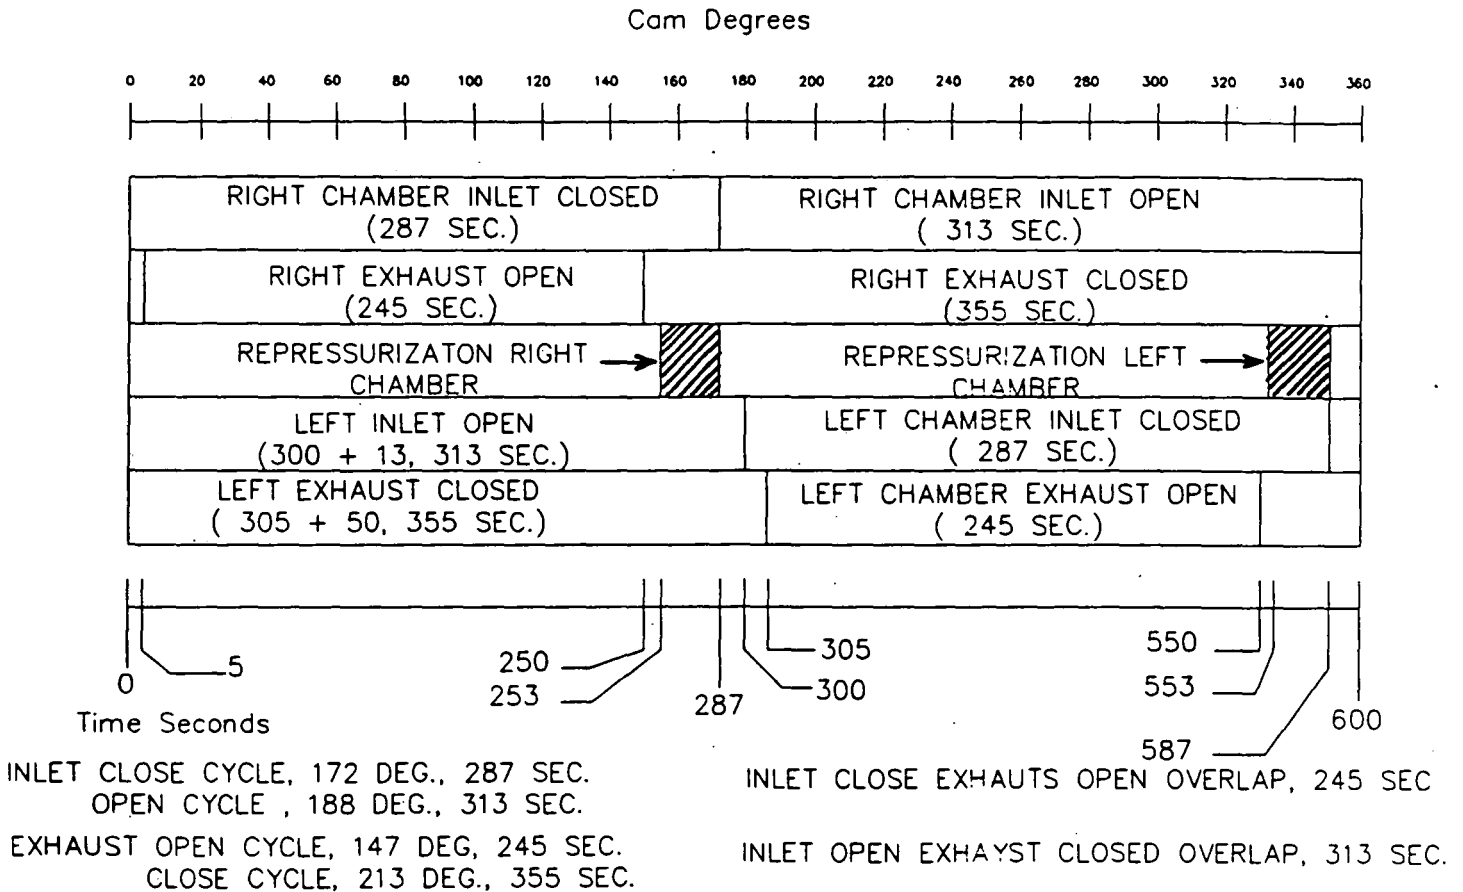
FIGURE 2

UNIT 3A INSTRUMENT AIR DRYER TIMING CIRCUIT

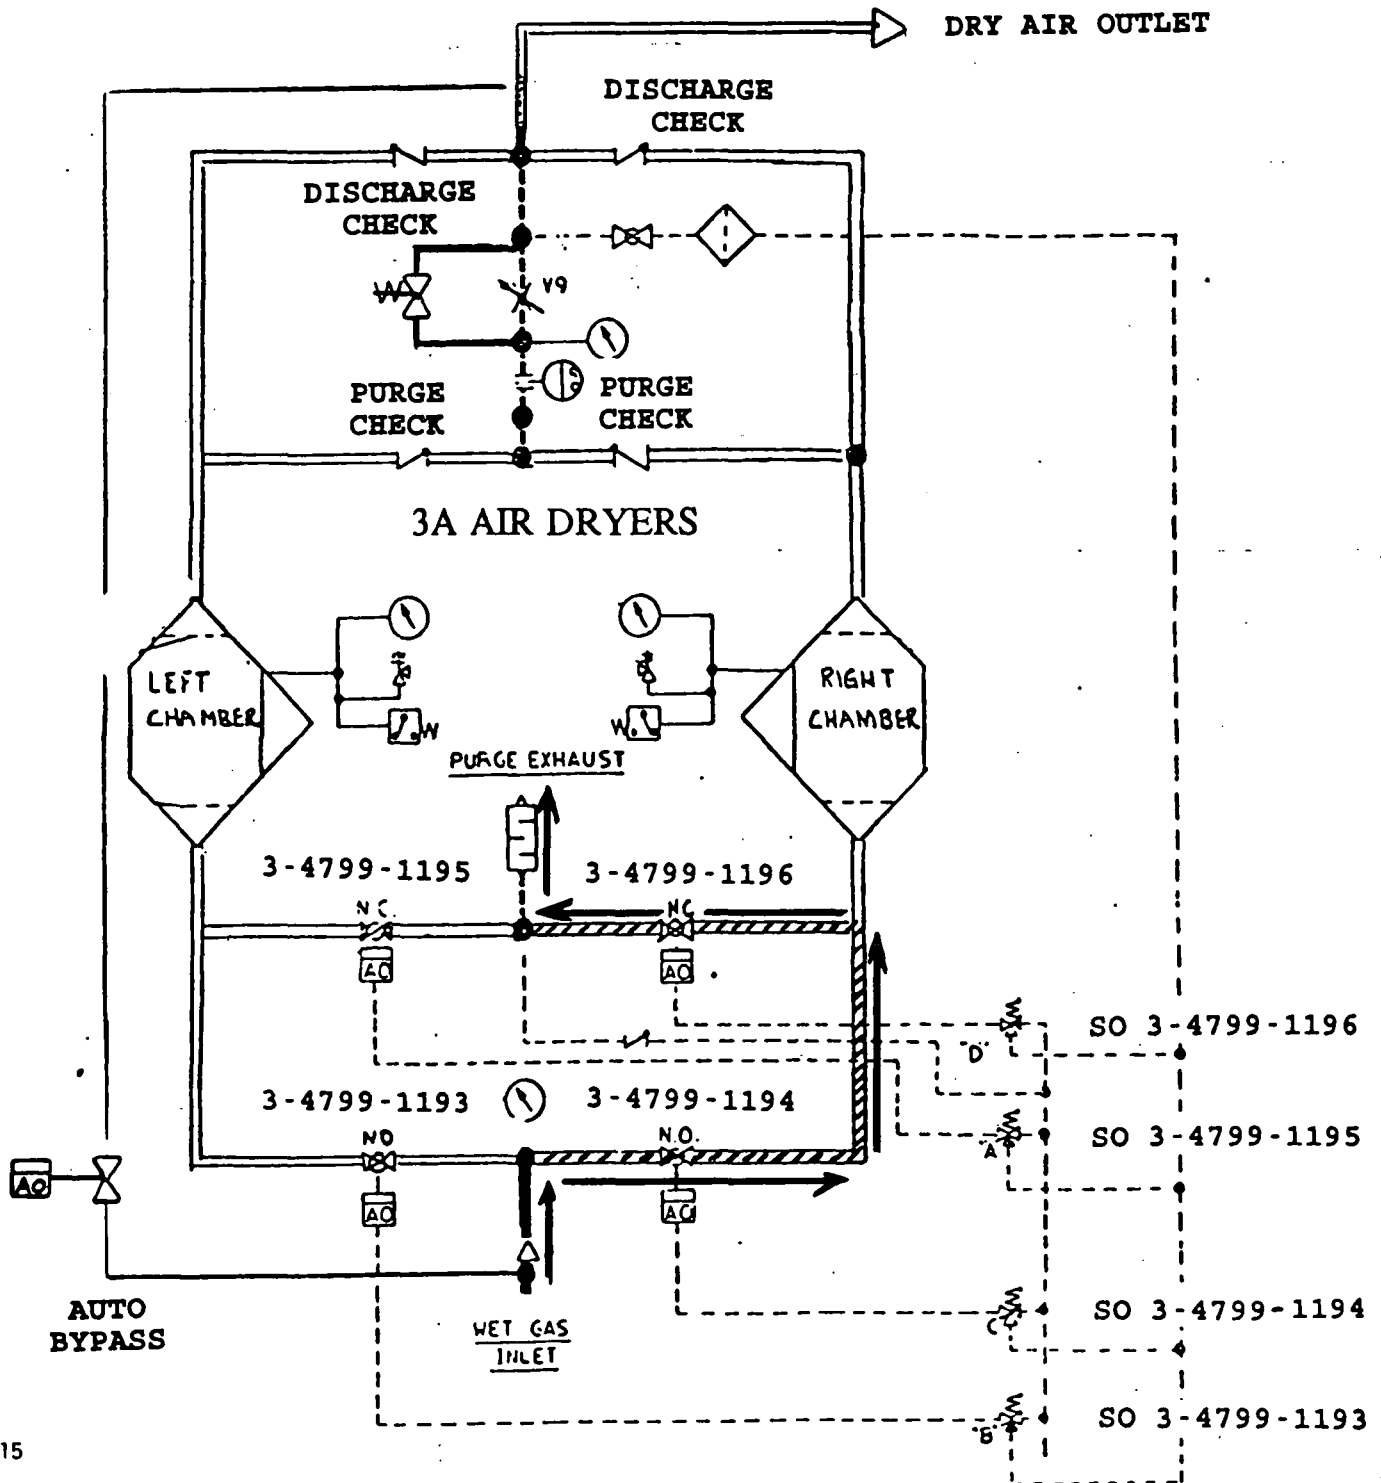
FIGURE 3

Focusing on the dryer inlet valve as the root cause for loss of instrument air, three failure modes were investigated as indicated on Figure 3. The failure path is identified for one dryer chamber; however, it equally applies to both chambers. The three failure modes investigated were:

- a. Dryer timing circuit malfunction.
- b. Inlet valve pilot solenoid failure to energize closing the dryer inlet air operated valve.
- c. Air operated inlet valve failure to stroke.

On January 16, the two port dryer inlet and exhaust valves were replaced with single port fail-safe valves. On February 1st, the replaced valves were bench tested to determine valve operability. Both exhaust valves operated freely in the open and close positions with air applied to their respective ports. One inlet valve was found to operate freely in the open and closed positions; however, the remaining inlet valve failed to move to its closed position. The valve was manually closed and air was reapplied. In each attempt the valve either remained open or stuck in a partially open position. Silicone spray was then applied to valve ball. The valve then moved to both the open and closed positions; however, movement had noticeable resistance. Successful valve actuation following lubrication demonstrated that valve actuator was operating properly. The failed valve had not been altered during the 15 day period that it was removed until testing on February 1, 1993.

Based on bench testing it was determined that inlet valve binding in the open position was the root cause for dryer blowdown.

UNIT 3A INSTRUMENT AIR DRYER FAILURE MODE, AIR RELEASE PATHS

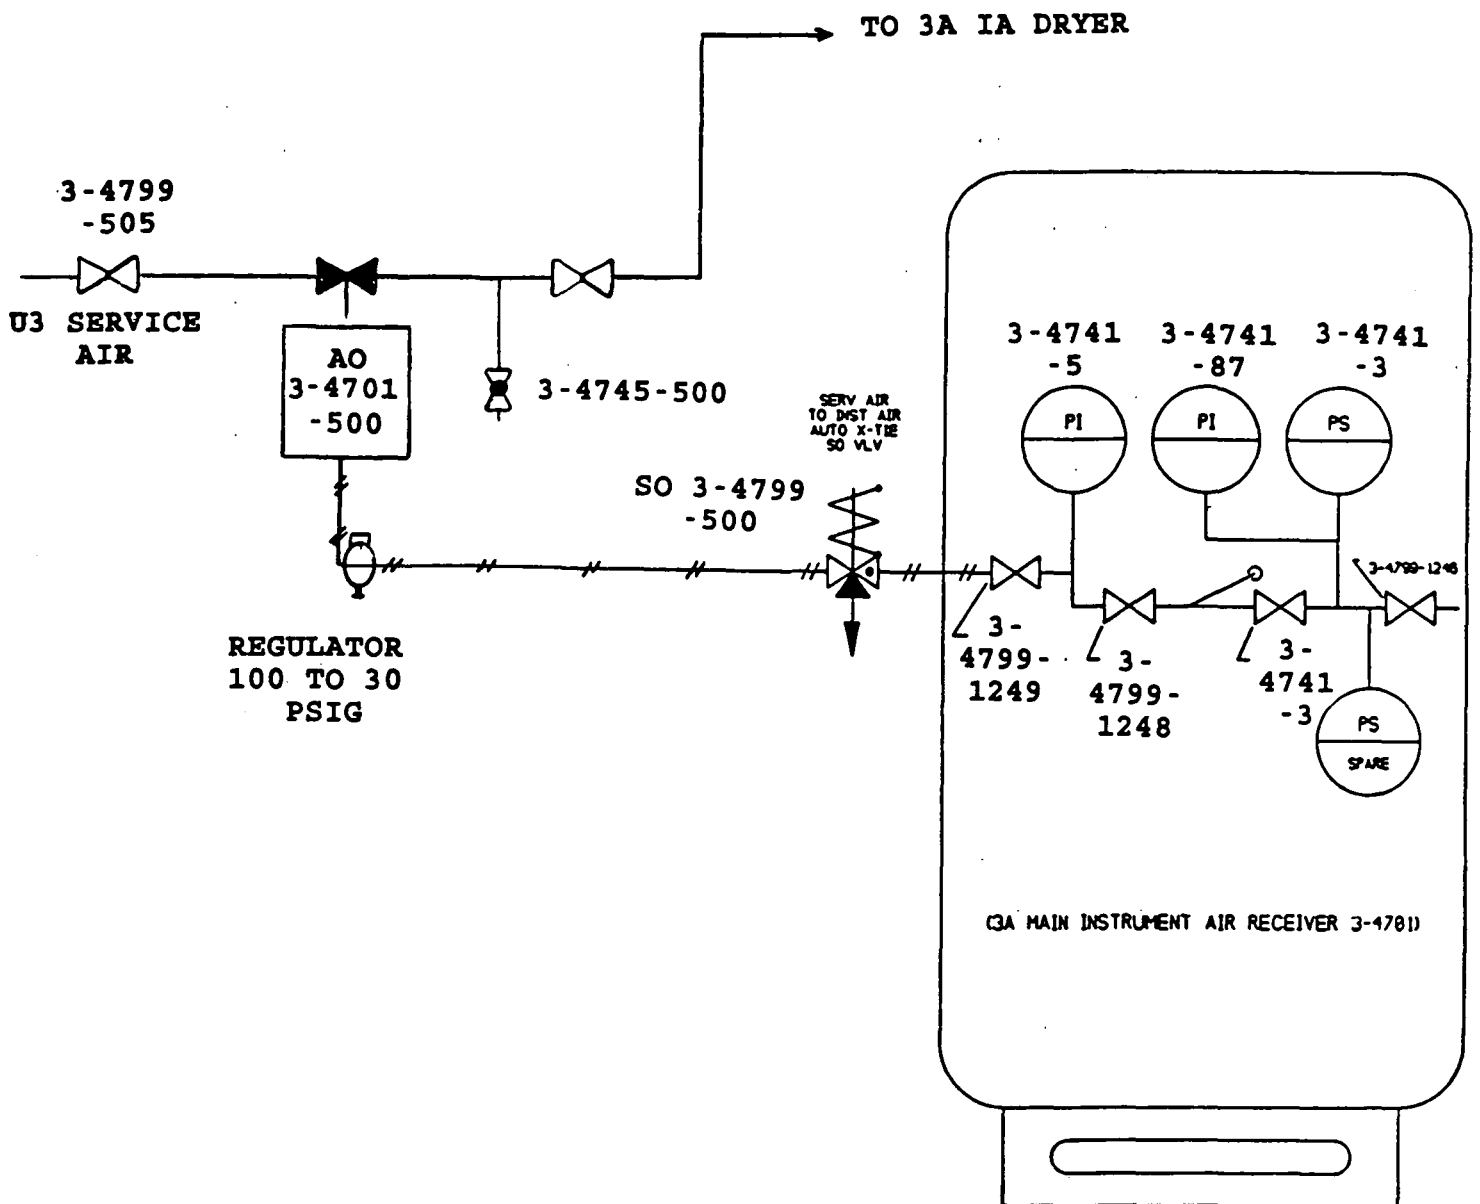
FIGURE 4

Review of the TARP time-line indicated the Service Air to Instrument Air cross-tie valve remained closed for approximately 150 seconds following the low instrument air header pressure alarm. Figure 4 provides a schematic diagram of the cross-tie air operated valve (AOV), valve air regulator, solenoid operated relief valve (SOV) and instrument air low pressure switch. The low pressure switch is set to energize the SOV at a header pressure of 85 psig. The SOV relieves pressure from the SA/IA cross-tie valve operator through the valve pressure regulator. The pressure regulator is set to maintain 30 psig on the cross-tie valve operator. Operating Surveillance DOS 4700-01, Quarterly Service Air to Instrument Air Auto Cross-Tie Test, was performed several times to establish the as-found cross-tie valve opening time and to trouble shoot possible failure modes. Four possible failure modes were evaluated for slow cross-tie valve response: a. Solenoid relief valve operation, b. pressure switch operation, c. Pressure regulator operation and, d. Cross-tie operation under simulated dryer inlet valve failure.

Having eliminated the Pressure Switch and AOV as probable failure modes, attention was placed on the cross-tie valve pressure regulator. The surveillance was performed several more times, each time tapping on the cross-tie valve pressure regulator. With each attempt, the cross-tie responded more rapidly with the final stroke time of approximately 25 seconds from the low pressure initiation signal. The pressure regulator was replaced and testing resumed on January 17, shift 3. Three stroke times were performed and the cross-tie valve achieved full-open in approximately 25 seconds for each test.

The root cause for cross-tie valve slow response time is attributed to air regulator operation.

During these tests it was observed that the cross-tie valve did not open sufficiently to pass service air until regulator pressure dropped to approximately 12 psig. Regulator pressure decay was constant while venting through the solenoid valve. It is believed that more rapid cross-tie response could be achieved by locating the solenoid relief valve upstream of the AOV pressure regulator.

UNIT 3 SERVICE AIR TO INSTRUMENT AIR CROSS-TIE VALVE CONTROL SCHEMATIC

- a. A Special Procedure will be written to evaluate SA/IA Cross-tie valve stroke time on rapid bleed of the valve air operator upstream of the valve air regulator. If this test demonstrates improved valve response time a work request will be processed to relocate the solenoid relief valve upstream of the Cross-tie valve air regulator. This will be completed by July 1, 1993. (2491809300401)

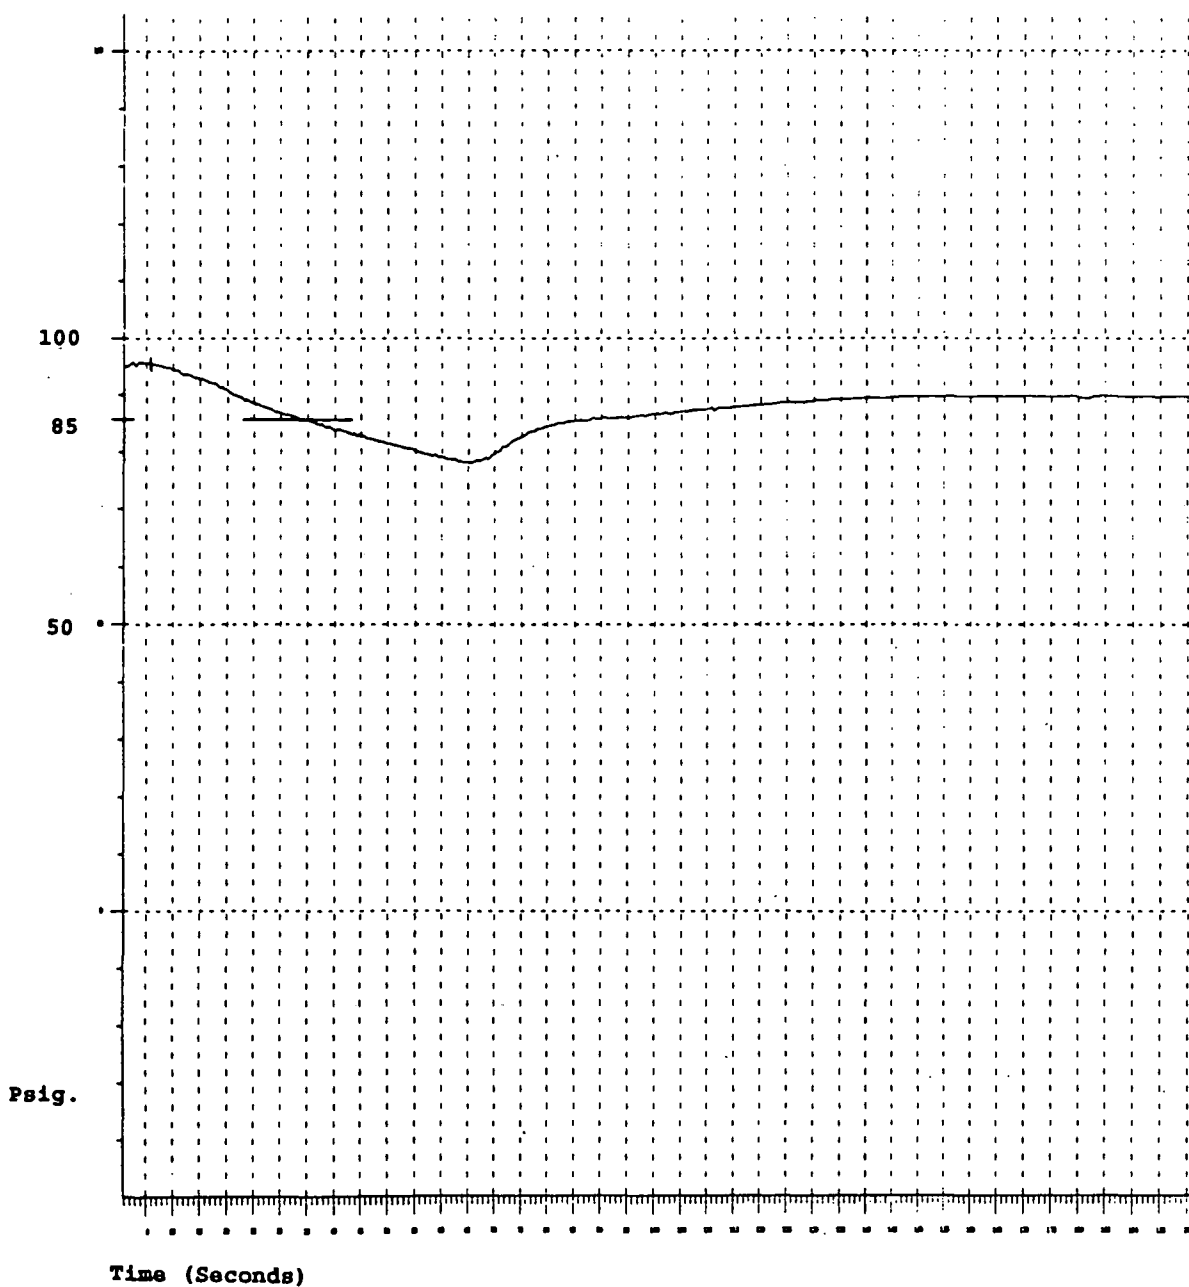
FIGURE 5

On January 18, at 1911 hours, a Special Procedure (SP 93-1-6) was performed as part of the Start-Up On-Site Review. The SP was performed to demonstrate the ability of the cross-tie valve to open and maintain instrument air header pressure with a failed open dryer inlet valve. This test would simulate the initiating failure which led to the January 16, loss of Instrument Air. Successful performance of this test would demonstrate adequate cross-tie valve operation for post scram reactor start-up.

During this test, the right dryer inlet valve was forced to fail in the open position during the right chamber purge cycle. A low air pressure signal was initiated by bleeding air from the air receiver mercury pressure switch. Air receiver pressure was recorded every 15 second during the transient. The mercury pressure switch was observed to actuate at approximately 85 psig. The cross-tie valve was observed to be fully open approximately 26 seconds following low pressure signal initiation. The Transient Analysis Recorder was used to plot the instrument air pressure profile. The TARP profile (Figure 5) indicates that pressure dropped to approximately 78 psig sixty seconds following blowdown initiation. Approximately 30 seconds elapsed from header pressure of 85 psig to the time where header pressure began to recover. Header pressure stabilized at approximately 90 psig until 260 seconds had elapsed, at which time the dryer exhaust valve closed and pressure returned to 95 psig. The test was terminated, the dryer was returned to normal operation and the cross-tie valve closed. Based on the favorable results, cross-tie valve operation was found acceptable for Unit 3 Start-Up.

**TRANSIENT ANALYSIS RECORDER PLOT, UNIT 3 INSTRUMENT
AIR RECEIVER DURING SIMULATED FAILED OPEN INLET
VALVE**
