CWS PMLTR 93-0137

Facility Name (1) Dresden Nuclear Power Station, Unit 2 (3)						Docket Number (2) 0 5 0 10 10 12 3 17			Page (3) 1 of 0 4		
Title (4) Postulated LPCI Swing Bus Loss Resulting From an Original Construction Design Deficiency

Postulated LPCI Swing Bus Loss Resulting From an Original Construction Design Deficiency.

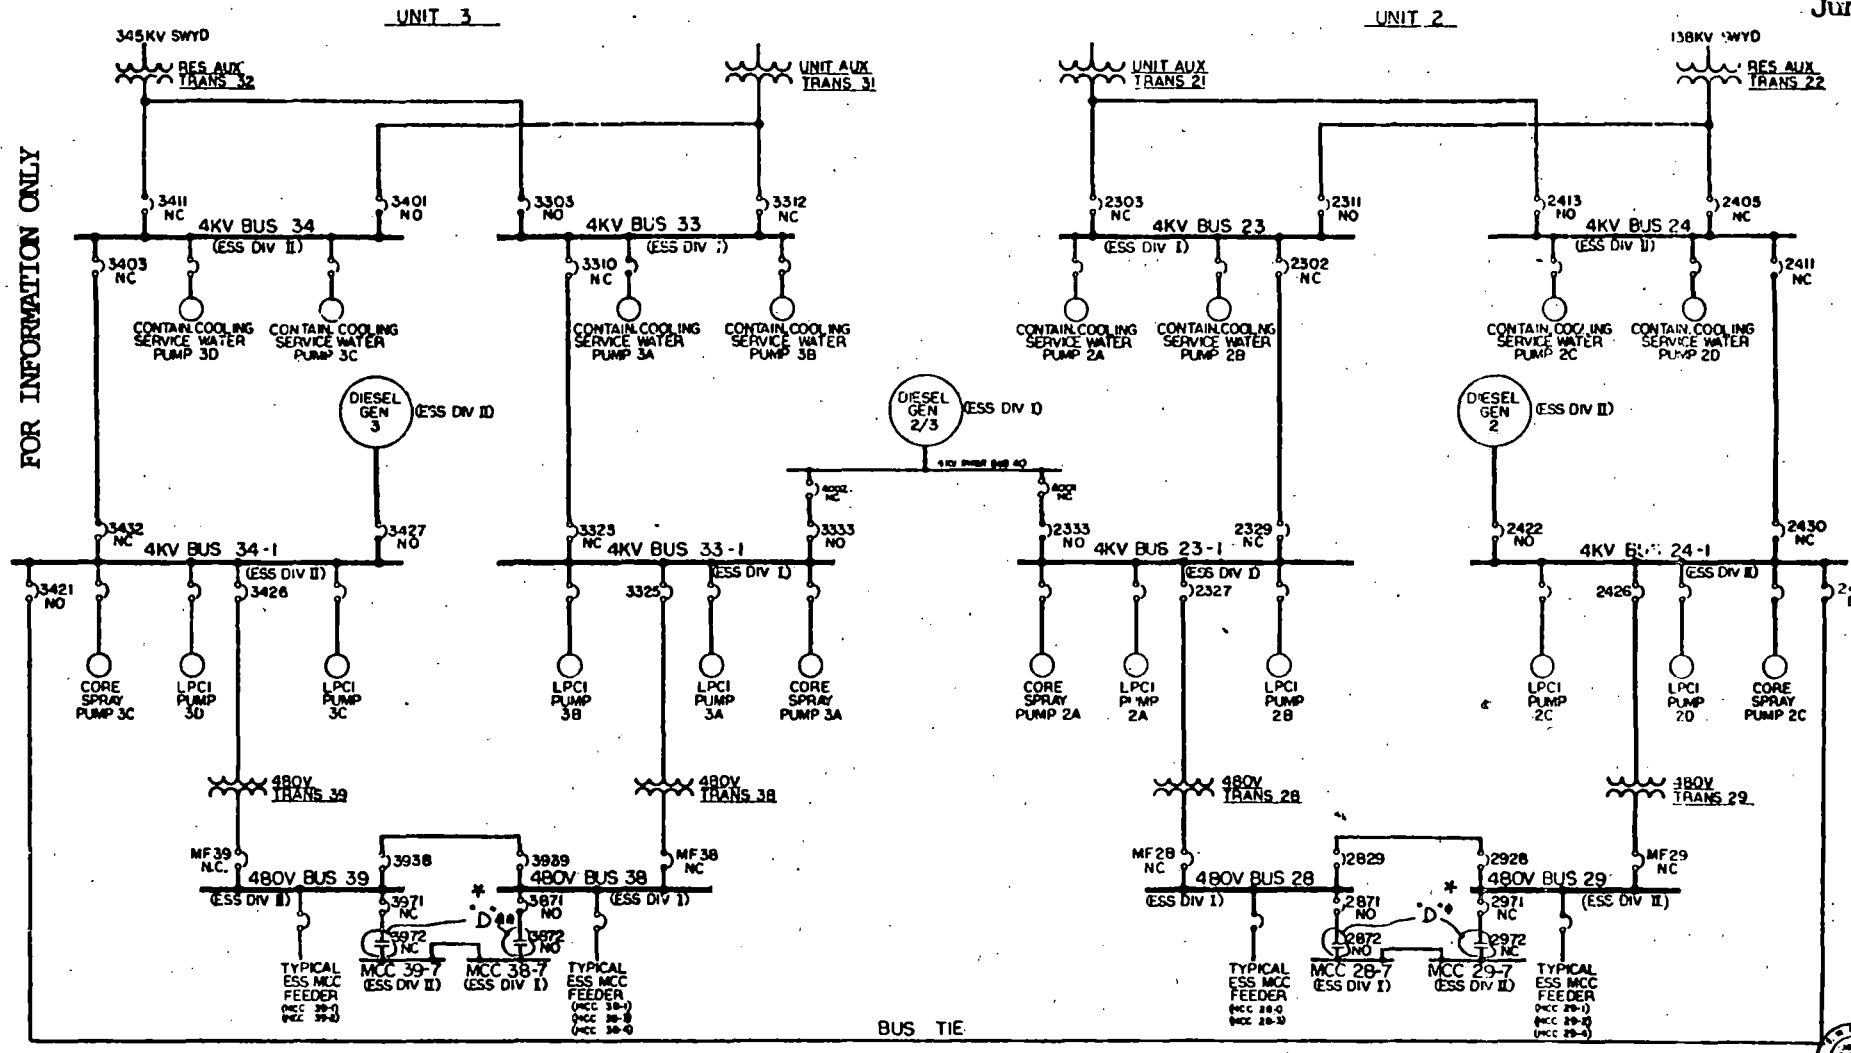
FIGURE # 1

On March 5, 1993 with Unit 2 in a Refuel outage and Unit 3 in a forced outage, it was determined that during a Loss Of Coolant Accident concurrent with a degraded voltage condition, that a single breaker failure, (the main feed breaker to the 4 KV Safety Bus, device 152-2411), could render the Low Pressure Coolant Injection (LPCI) System 480 volt swing bus Motor Control Center, (MCC 29-7/28-7(39-7/38-7) and the Division II Core Spray Systems incapable of performing their intended functions. Failure of both LPCI and Division II Core Spray Systems results in an Emergency Core Cooling response that is more limiting than the current licensing basis.

Under the current licensing basis, the LPCI Swing Bus is designed to operate as described below. The event assumes a LOCA concurrent with a LOOP on Unit 2. (Refer to Sketch 1, attached, for a simplified one line of Unit 2, showing the relevant buses and breakers.) At the LPCI Swing Bus (MCC 29-7/28-7), the normal feed contactor (Device 2972) drops out (opens) on a loss of power. However, this alone does not cause a transfer of the Swing Bus due to the presence of a time-delay-on-drop-out relay (TDOD). The undervoltage relays (IAV27B relays), sensing a loss of voltage time out and trip the Bus 24-1 feed breaker (2411). Bus 24-1 feed breaker (2430) is interlocked (slaved) with breaker (2411), therefore it trips and initiates an auto start signal to the Unit 2 diesel generator (which has already received an autostart signal from the LOCA signal). The output breaker of the Unit 2 diesel generator (2422) will close when the Bus 24-1 feed breaker (2411) is open and the Unit 2 diesel generator is producing adequate voltage at rated frequency. Closing the Unit 2 diesel generator output breaker will restore voltage to 480 V Bus 29, picking up (closing) the contactor (2972) and preventing a transfer. If the Unit 2 diesel generator fails to start, or one of the breakers fails to operate, the time delay relay associated with the contactor (2972) will initiate a transfer after a period of 20 seconds. This affords the Unit 2 diesel generator an opportunity to restore the normal feed to the Swing Bus.

The above scenario can now be reconsidered with the initiating event a LOCA with degraded voltage rather than a LOOP. The Unit 2 Diesel Generator would start (from the LOCA signal) and the output breaker (2422) would close after the second level undervoltage relay times out, identical to the actions initiated by the undervoltage relay as discussed above. However, a single failure of the normal feed breaker (2411), prevents the Unit 2 Diesel Generator output breaker from closing. Thus, the diesel generator could not close in, and would continue to run unloaded. The offsite source of power, still in a "degraded" voltage condition, would not assure adequate voltage to re-align the LPCI injection valves. However, if the voltage level remained above the 'drop out' voltage of the contactor (2972), the Swing Bus transfer mechanism would not execute its transfer sequence. Note that the new "power monitoring" scheme installed for detecting problems with the diesel generator voltage regulator under modification M12-2(3)-89-053 would detect the degraded condition, but would take no action as the trip logic requires that the Unit 2 Diesel Generator output breaker (2422) must be closed for a transfer to occur.

Further analysis of this event has shown that other single failure modes can be postulated that will result in the same outcome. Since the degraded voltage relay logic is two out of two, failure of either relay will also prevent the isolation of the Safety Bus. Failure of 125 volt DC at the Safety Bus, since the degraded voltage relays are energize to actuate, will also prevent the isolation of the Safety Bus. Finally, failure of the HFA relay, which actuates upon degraded voltage and provides the trip signal to the Safety Bus main feed breaker, will also prevent the Safety Bus from isolating.

The root cause of this event is an original construction design weakness. The event is considered to be outside the current licensing basis. This sequence of events was not considered when the existing degraded voltage relay protection package was installed.

No immediate actions were taken, as both units were in outages. Further analysis of the postulated scenario continues. No equipment was declared inoperable nor was there any actual component failure during this event. An engineering study continues to evaluate the design deficiency. Several different designs have been considered, however conceptual design work indicates that a change will require long lead time components (i.e. new Safety Bus potential transformers and voltage relays). Therefore, upon completion of the engineering study, a final decision will be made regarding the appropriate resolution of this issue. The engineering study will be completed and a supplemental report issued by 6/30/93 (NTS # 237-180-93-00501).

As an interim compensatory measure, procedural guidance will be provided to the Operators prior to Unit startup. This procedure will identify symptoms indicative of either the Safety Bus failing to isolate or MCCs 29-7/28-7 (39-7/38-7) failing to transfer on degraded voltage (NTS # 237-180-93-00502).
