CWS PMLTR 93-0137

Facility Name (1) Dresden Nuclear Power Station, Unit 2 (3)	Docket Number (2) 0 5 0 10 10 12 3 17	Page (3) 1 of 0 4
Title (4) Postulated LPCI Swing Bus Loss Resulting From an Original Construction Design Deficiency

Postulated LPCI Swing Bus Loss Resulting From an Original Construction Design Deficiency.

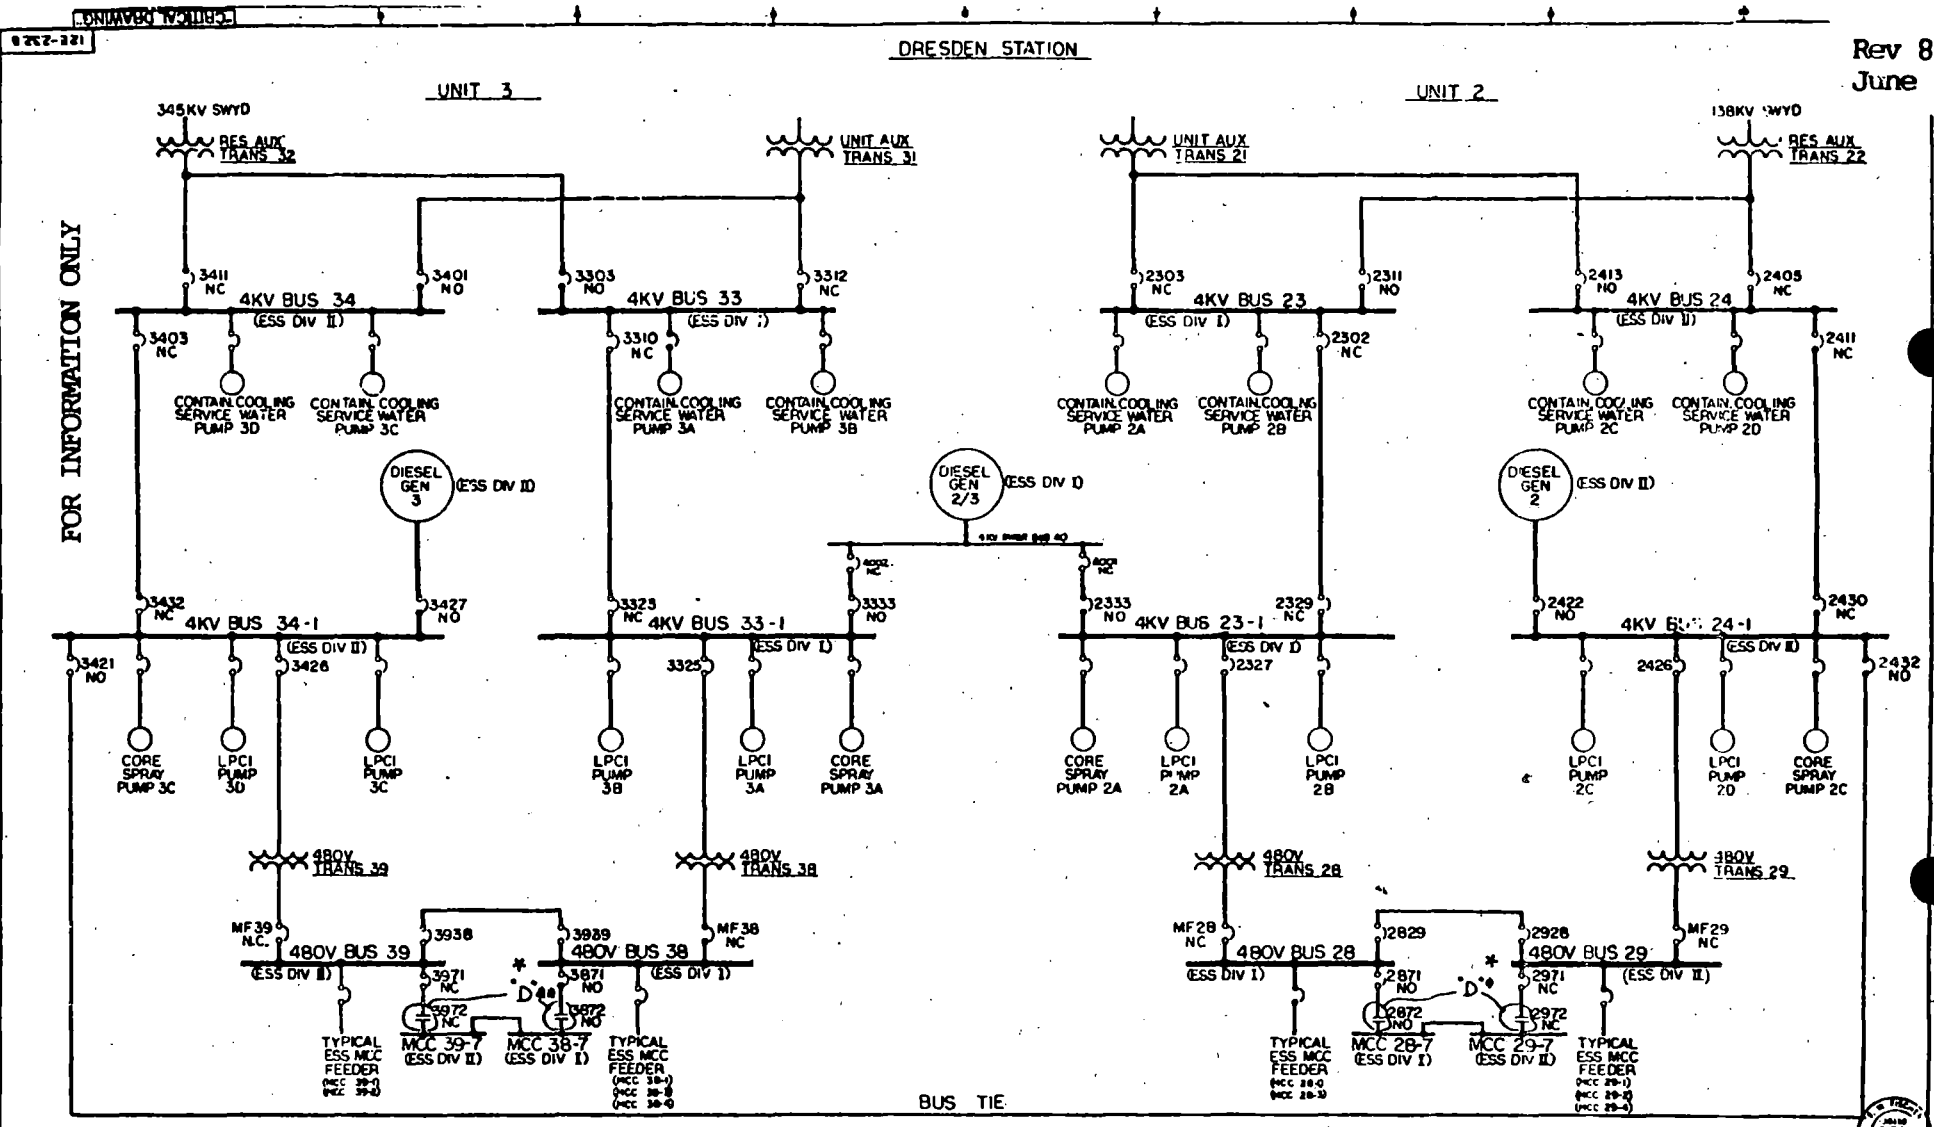
FIGURE # 1

Under the current licensing basis, the LPCI Swing Bus is designed to operate as described below. The event assumes a LOCA concurrent with a LOOP on Unit 2. (Refer to Sketch 1, attached, for a simplified one line of Unit 2, showing the relevant buses and breakers.) At the LPCI Swing Bus (MCC 29-7/28-7), the normal feed contactor (Device 2972) drops out (opens) on a loss of power. However, this alone does not cause a transfer of the Swing Bus due to the presence of a time-delay-on-drop-out relay (TDOD). The undervoltage relays (IAV27B relays), sensing a loss of voltage time out and trip the Bus 24-1 feed breaker (2411). Bus 24-1 feed breaker (2430) is interlocked (slaved) with breaker (2411), therefore it trips and initiates an auto start signal to the Unit 2 diesel generator (which has already received an autostart signal from the LOCA signal). The output breaker of the Unit 2 diesel generator (2422) will close when the Bus 24-1 feed breaker (2411) is open and the Unit 2 diesel generator is producing adequate voltage at rated frequency. Closing the Unit 2 diesel generator output breaker will restore voltage to 480 V Bus 29, picking up (closing) the contactor (2972) and preventing a transfer. If the Unit 2 diesel generator fails to start, or one of the breakers fails to operate, the time delay relay associated with the contactor (2972) will initiate a transfer after a period of 20 seconds. This affords the Unit 2 diesel generator an opportunity to restore the normal feed to the Swing Bus.

The above scenario can now be reconsidered with the initiating event a LOCA with degraded voltage rather than a LOOP. The Unit 2 Diesel Generator would start (from the LOCA signal) and the output breaker (2422) would close after the second level undervoltage relay times out, identical to the actions initiated by the undervoltage relay as discussed above. However, a single failure of the normal feed breaker (2411), prevents the Unit 2 Diesel Generator output breaker from closing. Thus, the diesel generator could not close in, and would continue to run unloaded. The offsite source of power, still in a "degraded" voltage condition, would not assure adequate voltage to re-align the LPCI injection valves. However, if the voltage level remained above the 'drop out' voltage of the contactor (2972), the Swing Bus transfer mechanism would not execute its transfer sequence. Note that the new "power monitoring" scheme installed for detecting problems with the diesel generator voltage regulator under modification M12-2(3)-89-053 would detect the degraded condition, but would take no action as the trip logic requires that the Unit 2 Diesel Generator output breaker (2422) must be closed for a transfer to occur.

Further analysis of this event has shown that other single failure modes can be postulated that will result in the same outcome. Since the degraded voltage relay logic is two out of two, failure of either relay will also prevent the isolation of the Safety Bus. Failure of 125 volt DC at the Safety Bus, since the degraded voltage relays are energize to actuate, will also prevent the isolation of the Safety Bus. Finally, failure of the HFA relay, which actuates upon degraded voltage and provides the trip signal to the Safety Bus main feed breaker, will also prevent the Safety Bus from isolating.

The root cause of this event is an original construction design weakness. The event is considered to be outside the current licensing basis. This sequence of events was not considered when the existing degraded voltage relay protection package was installed.

No immediate actions were taken, as both units were in outages. Further analysis of the postulated scenario continues. No equipment was declared inoperable nor was there any actual component failure during this event. An engineering study continues to evaluate the design deficiency. Several different designs have been considered, however conceptual design work indicates that a change will require long lead time components (i.e. new Safety Bus potential transformers and voltage relays). Therefore, upon completion of the engineering study, a final decision will be made regarding the appropriate resolution of this issue. The engineering study will be completed and a supplemental report issued by 6/30/93 (NTS # 237-180-93-00501).

As an interim compensatory measure, procedural guidance will be provided to the Operators prior to Unit startup. This procedure will identify symptoms indicative of either the Safety Bus failing to isolate or MCCs 29-7/28-7 (39-7/38-7) failing to transfer on degraded voltage (NTS # 237-180-93-00502).
