Commonwealth Edison
Dresden Nuclear Power Station
6500 North Dresden Road
Morris, Illinois 60450
Telephone 815/942-2920

DAP FORM 02-08C
 SUPPLEMENTAL REPORT TO LER

Facility Name (1)				Docket Number (2)				Page (3)			
Dresden Nuclear Power Station, Unit 3				0 5 0 0 0 2 4 9				1	of	0	5

Title (4)
Group II and Group III Primary Containment Isolations Due to a Procedure Deficiency

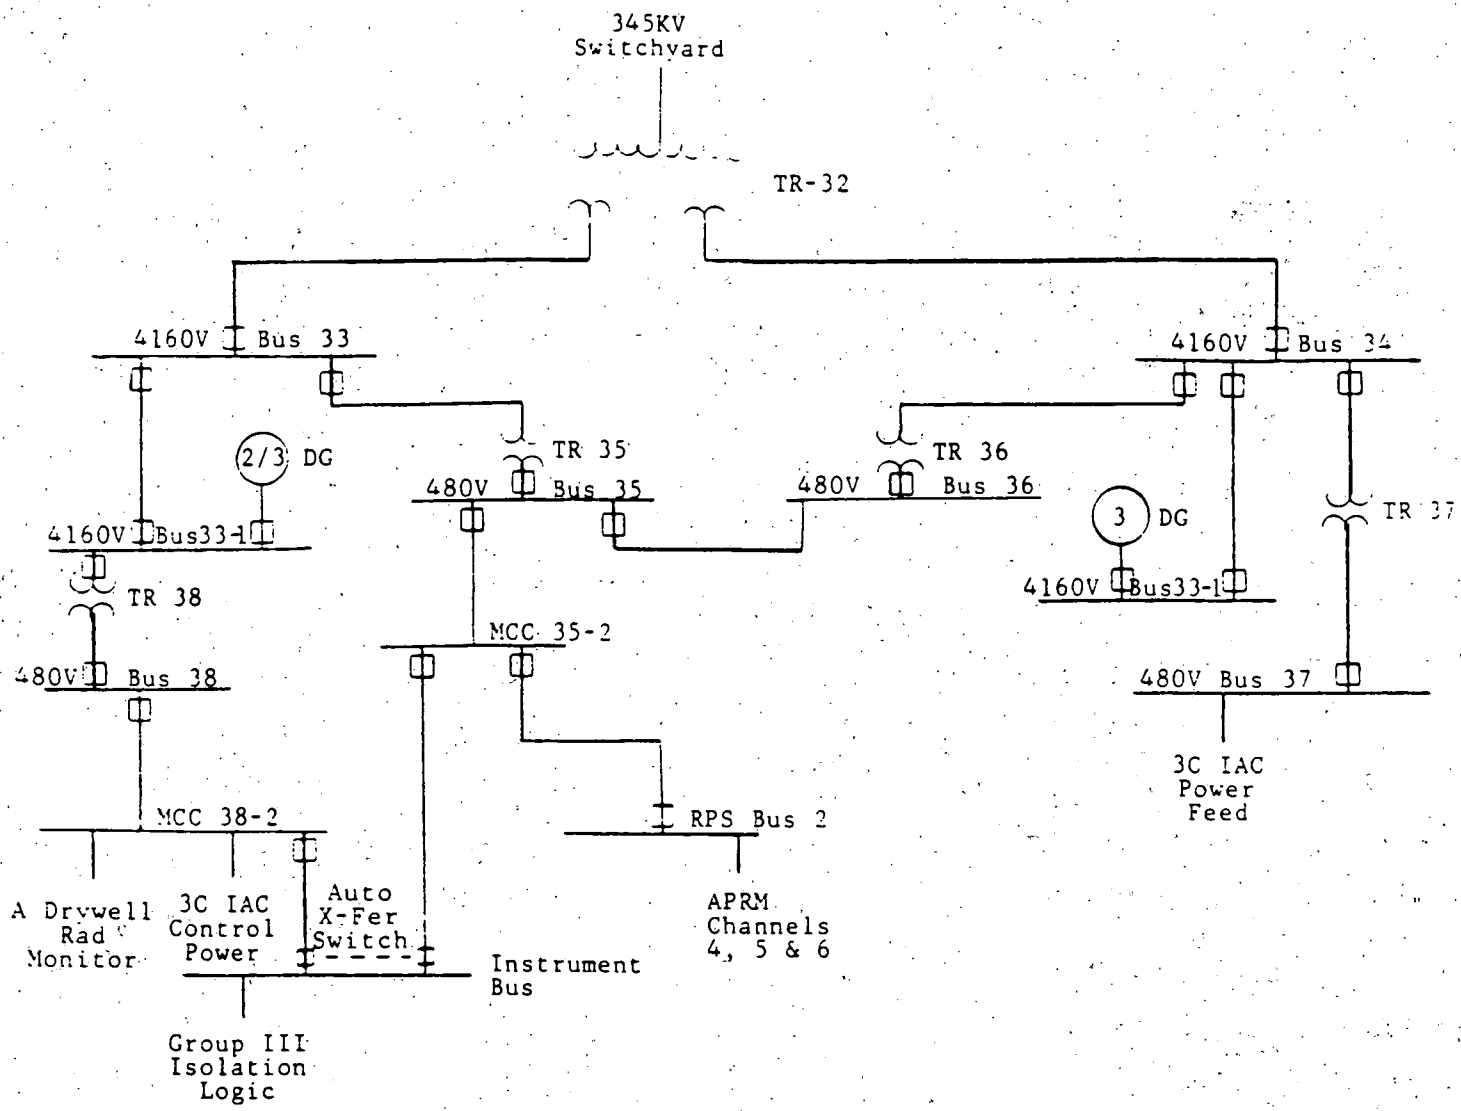
Figure 1

This report is being submitted to comply with 10CFR50.73(a)(2)(iv) which requires the reporting of any unplanned Engineered Safety Feature (ESF) actuation. The 3C Instrument Air Compressor trip was caused by the loss of control power when MCC 38-2 de-energized. The compressor power feed is from Bus 37, which remained energized during the event. When compressor control power was lost, a relay dropped out activating an electrical interlock which tripped the compressor's feed breaker at

Bus 37. The Bus 36 to Bus 35 tie breaker failed to close due to dirty contacts on the control switch. When the switch was exercised the contacts were sufficiently cleaned enabling the breaker to automatically close through the undervoltage logic. The failure of the Bus 33 to Bus 33-1 breakers is believed to have been caused by the Nuclear Station Operator (NSO) not holding the control switch in the close position for a sufficient length of time. Two breakers are required to close and the undervoltage relays have to reset prior to allowing the control switch to spring return to normal or the breakers will trip again. The Group II isolation was caused by the A Drywell Radiation Monitor. The monitor's power supply is MCC 38-2 which was de-energized. when the monitor was de-energized its trip contacts opened resulting in a group II isolation on Channel A which coupled with the expected Group II or Channel B resulted in the full isolation. The Group III Isolation was caused by the de-energization of the Instrument Bus which lost both its normal supply, MCC 38-2, and its reserve supply, MCC 35-2. This resulted in the de-energization of relays in the Group III logic, thereby resulting in the closure of all Group III valves. The APRM channels failed upscale high high when they lost their power supply, RPS Bus B which was being fed from MC 35-2. The root cause of the unplanned Group II and III Isolations has been determined to be a procedure deficiency as the Group II and Group III Isolations were not identified as occurring during the surveillance. The root cause of the failure of the Bus 36 to Bus 35 tie breaker to close was attributed to dirty control switch contacts.

Unit 3 Electrical Distribution Diagram

The control switch for the Bus 35 to Bus 36 breaker was cleaned and the contacts burnished. DOS 6600-3 was revised by a temporary procedure change to state that full Group II and Group III Isolations would be received during the course of the surveillance, and has since been implemented in a permanent procedure change. The surveillance was satisfactorily performed on June 9, 1988.
