**Commonwealth Edison**  
Dresden Nuclear Power Station  
6500 North Dresden Road  
Morris, Illinois 60450  
Telephone 815/942-2920

GFSLTR 94-0176

FACILITY NAME (1) Dresden Nuclear Power Station, Units 2 and 3 DOCKET NUMBER (2) 05000237 PAGE (3) 1 OF 4

TITLE (4) Auto-start of 2/3 Emergency Diesel Generator Due to Operator Error.

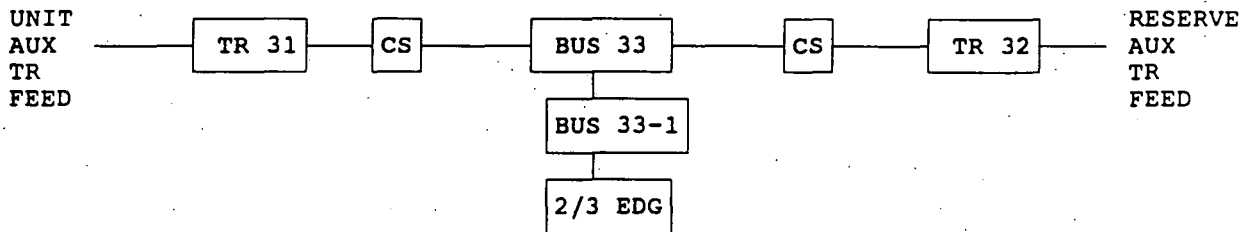
At 0908 on May 04, 1994, while performing 4Kv breaker checks on Bus 33 per a Special Procedure, Bus 33 and Bus 33-1 were inadvertently de-energized and the Unit 2/3 EDG auto-started and closed onto Bus 33-1. Bus 33 and Bus 33-1 were being fed from TR 31 feed breaker. The procedure steps being performed were meant to parallel feeds from TR 31 and TR 32 feed breakers across Bus 33 and then open the TR 31 feed breaker. (See sketch below)

The Operator had his hands on both TR 31 and TR 32 feed breaker control switches (CS) and was observing the Bus 33 amp meter. The Operator went to close on the breaker control switch for TR 32 and did not see any load picked up from the breaker closure. The Operator then realized that he should not see any load picked up because he had just verified all normal loads on the Bus were de-energized as part of the procedure he was performing. The Trip Free condition of TR 32 feed breaker to Bus 33 was not noticed by the Operator. The Shift Control Room Engineer (SCRE) observing the evolution noticed the Trip Free condition of TR 32 feed breaker but the Operator had operated the TR 31 feed breaker control switch before he could be warned.

Operators are taught not to rely on single indication but observing meter indication is stressed over breaker indication as this is the most accurate means of verifying breaker closure. The reason for opening the TR 31 feed breaker control switch in a timely manner is to reduce the possibility of the breaker tripping on an overcurrent condition due to circulating currents generated by phase mismatch of parallel power sources. An Annunciator alarm "Bus 33 Main and Res Bkr In Parallel" was expected to occur during the time both TR 31 and TR 32 feed breakers were closed. The Operator observing the Bus 33 Amp meters heard an alarm, "4Kv Main Feed Bkr Trip", signifying the breaker going to the Trip Free condition, he did not verify this was his expected alarm, "Bus 33 Main and Res Bkr In Parallel", and opened TR 31 feed breaker. The

opening of TR 31 feed breaker de-energized of Bus 33 and Bus 33-1. The Unit 2/3 EDG auto-started and energized Bus 33-1. The Unit 2/3 EDG functioned properly and was loaded and ran for approximately 20 minutes, Bus 33 power was then transferred to TR 31 and the Unit 2/3 EDG was secured.

The reason for TR 32 feed breaker to Bus 33 Trip Free condition was discovered to be a deficiency in a procedure that had been performed previously. This procedure did not include a step to reset the TR 32 UV devices. An Annunciator alarm from the UV devices "Res Aux TR 32 Undervoltage" was locked in but it did not cause the Operators to realize the TR 32 UV relays had not been reset. The opening of TR 31 feed to Bus 33 while TR 32 feed to Bus 33 was in a Trip Free condition is attributable to Operator error.

A Shift Engineers Review Board (SERB) was convened and the event and possible consequences was discussed with the individual involved.

The event was tailgated to all operation crews and training was notified of the event to stress self-check and attention to detail when performing Special Procedures. The author of the Special Procedure was also notified.

A letter detailing the event has been placed on the operation crews bulletin board written by the individual involved concerning a self assessment of his actions during the event.
