Commonwealth Edison
Dresden Nuclear Power Station
6500 North Dresden Road
Morris, Illinois 60450
Telephone 815/942-2920

LICENSEE EVENT REPORT (LER)

FACILITY NAME (1)
Dresden Nuclear Power Station, Units 2 and 3

TITLE (4)
Auto-start of 2/3 Emergency Diesel Generator Due to Operator Error.

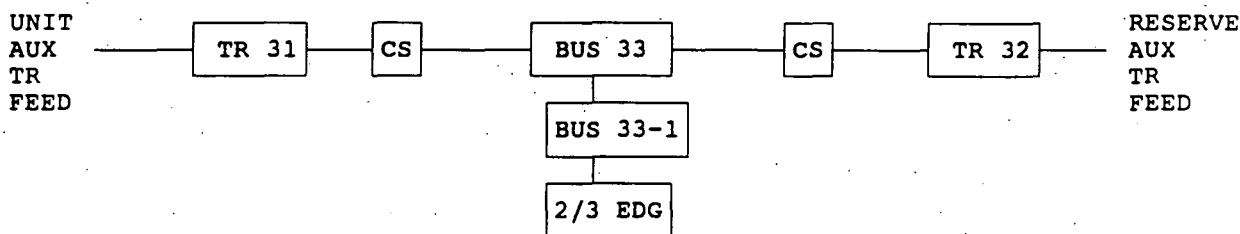
At 0908 on May 04, 1994, while performing 4Kv breaker checks on Bus 33 per a Special Procedure, Bus 33 and Bus 33-1 were inadvertently de-energized and the Unit 2/3 EDG auto-started and closed onto Bus 33-1. Bus 33 and Bus 33-1 were being fed from TR 31 feed breaker. The procedure steps being performed were meant to parallel feeds from TR 31 and TR 32 feed breakers across Bus 33 and then open the TR 31 feed breaker. (See sketch below)

The Operator had his hands on both TR 31 and TR 32 feed breaker control switches (CS) and was observing the Bus 33 amp meter. The Operator went to close on the breaker control switch for TR 32 and did not see any load picked up from the breaker closure. The Operator then realized that he should not see any load picked up because he had just verified all normal loads on the Bus were de-energized as part of the procedure he was performing. The Trip Free condition of TR 32 feed breaker to Bus 33 was not noticed by the Operator. The Shift Control Room Engineer (SCRE) observing the evolution noticed the Trip Free condition of TR 32 feed breaker but the Operator had operated the TR 31 feed breaker control switch before he could be warned.

The reason for TR 32 feed breaker to Bus 33 Trip Free condition was discovered to be a deficiency in a procedure that had been performed previously. This procedure did not include a step to reset the TR 32 UV devices. An Annunciator alarm from the UV devices "Res Aux TR 32 Undervoltage" was locked in but it did not cause the Operators to realize the TR 32 UV relays had not been reset. The opening of TR 31 feed to Bus 33 while TR 32 feed to Bus 33 was in a Trip Free condition is attributable to Operator error.

A Shift Engineers Review Board (SERB) was convened and the event and possible consequences was discussed with the individual involved.

The event was tailgated to all operation crews and training was notified of the event to stress self-check and attention to detail when performing Special Procedures. The author of the Special Procedure was also notified.
