Subject: Dresden Nuclear Power Station Units 2 and 3
Quad Cities Nuclear Power Station Units 1 and 2
Response to Request for Additional Information (RAI)
NRC Docket Nos. 50-237/249 and 50-254/265

RESPONSE TO REQUEST FOR ADDITIONAL INFORMATION
CONCERNING CORE SHROUD CRACKING

**RESPONSE TO NRC REQUEST FOR ADDITIONAL INFORMATION
CONCERNING CORE SHROUD CRACKING AT
DRESDEN, UNITS 2 AND 3, AND QUAD CITIES, UNITS 1 AND 2**

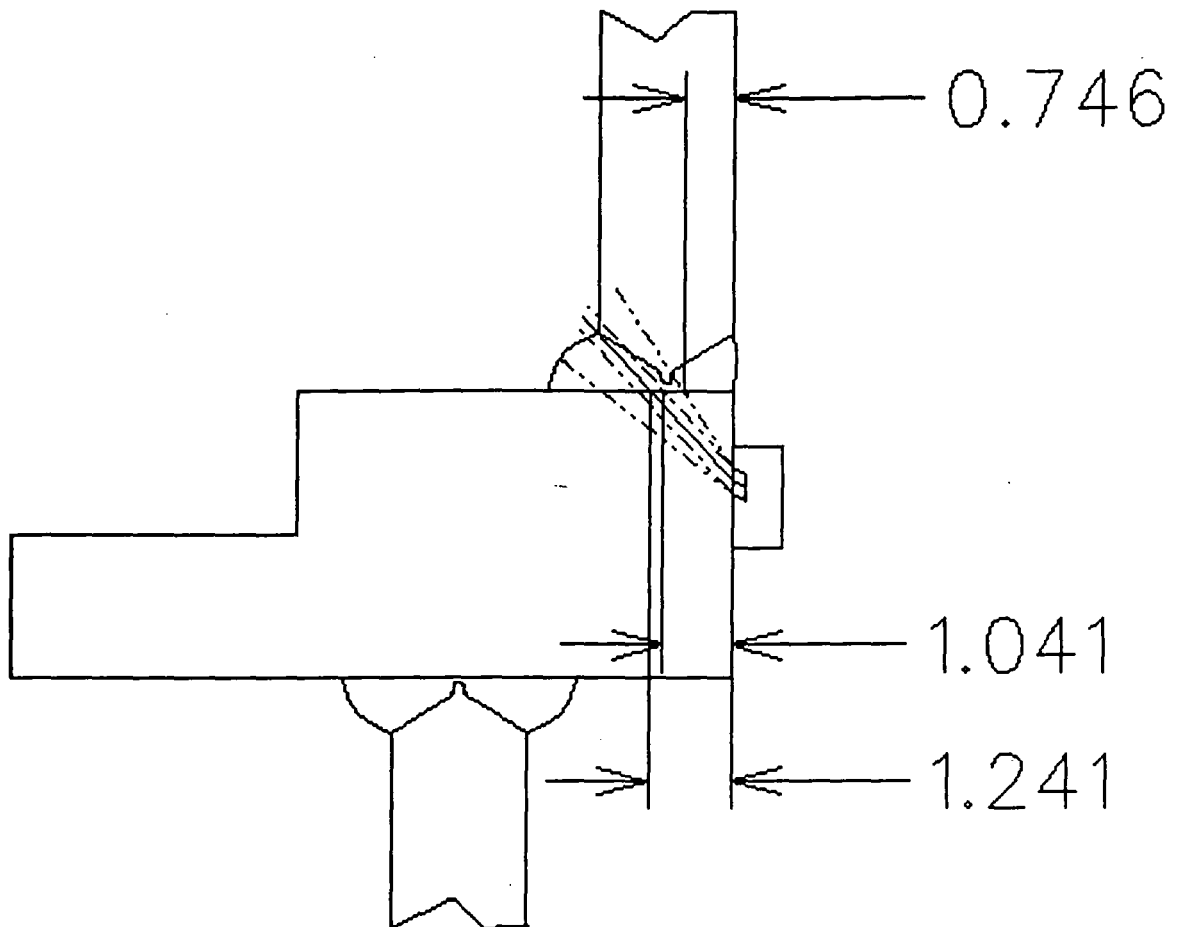
FIGURE 1

However, due to the design of the H5 weld at Dresden and Quad Cities stations, the UT examination results can be used to demonstrate that the flaw can not be any greater than 1.24" in depth. The H5 weld contains a 1.0" reinforcing fillet on the ID of the weld. A signal from the toe of this reinforcing fillet at the shroud cylinder was observed with the 4th transducer throughout the entire H5 examination. As can be seen from Figure 1, a flaw that started at the sound beam entry surface and intersected the sound beam at its central axis would be 1.24" in depth. A flaw any deeper than this would prevent the sound beam from reaching the toe of the reinforcing fillet and the signal from this reflector would be lost. Based on the above, the bounding depth of the H5 cracking at both Dresden Unit 3 and Quad Cities Unit 1 is 1.24".

H5 BOUNDING FLAW DETERMINATION
