SAFETY EVALUATION FOR  
DRESDEN UNIT 3  
CORE SPRAY SPARGER RISER REPAIR

May, 1994

Approved by: W. Sanders  
W. Sanders, Project Manager  
Dresden 3 Core Spray Sparger Riser Repair Project

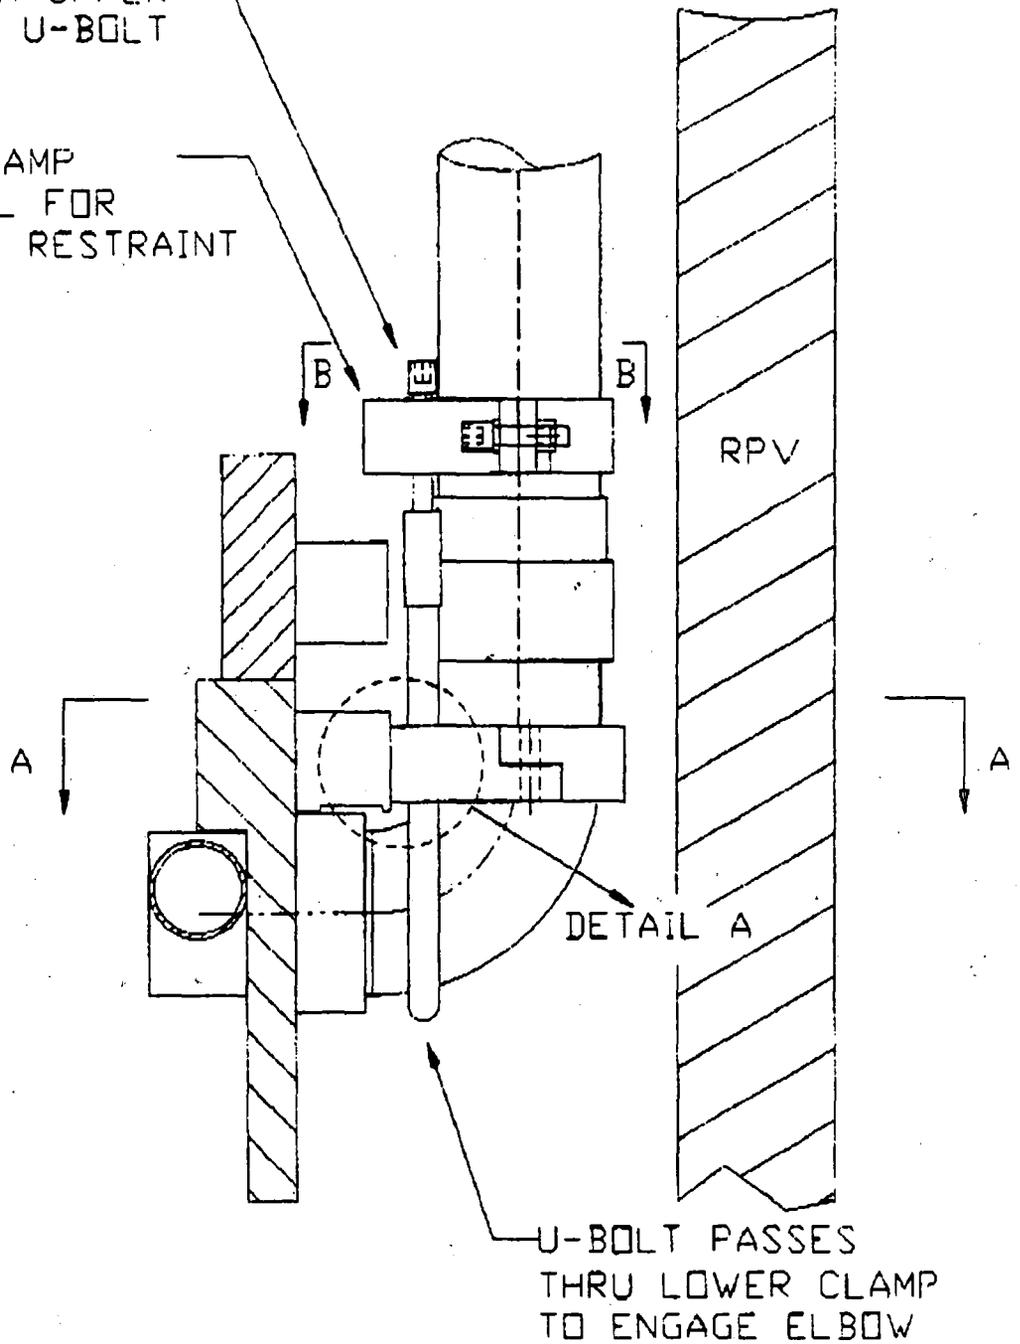
FIGURE 3-2 CSS RISER REPAIR CONCEPT

BOLT FROM UPPER  
CLAMP TO U-BOLT

UPPER CLAMP  
GRIPS CSL FOR  
VERTICAL RESTRAINT

The function of the modification is to assure the structural integrity of the CSS riser even if the reported defects were to grow to the full circumference of the weld. The proposed change adds two clamps to the area where the CSS and CSL join. The repair is shown conceptually in figure 3-2. The upper clamp mechanically grips the CSL, and

bears on the top of the collar that attaches the core spray line to the core spray sparger riser pipe. A rod supports and locates the lower clamp from the upper clamp. The lower clamp is centered over the riser pipe-to-riser elbow weld joint, where the crack is located. A U-bolt that attaches to the upper clamp provides axial restraint between the CSL collar and the riser elbow, spanning the crack location. The lower clamp provides lateral restraint to keep the riser pipe aligned with the riser elbow, in the event the present defect were to grow to a full 360°.

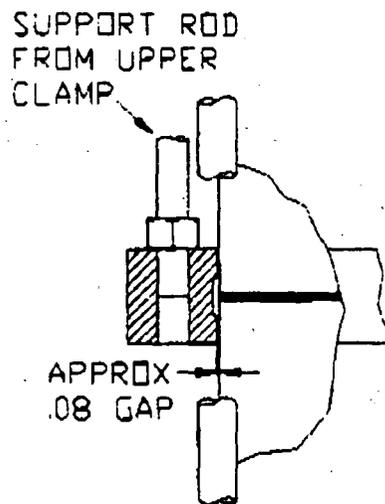
FIGURE 3-2 CSS RISER REPAIR CONCEPT (CONT)

DETAIL A LOWER CLAMP  
CENTERED OVER RISER  
ELBOW TO PIPE WELD
