Commonwealth Edison
Dresden Nuclear Power Station
6500 North Dresden Road
Morris, Illinois 60450
Telephone 815/942-2920

Licensee Event Report 94-013, Docket 50-237 is being submitted as required by Technical Specification 6.6, NUREG 1022 and 10CFR50.73(a)(2)(iv).

Auto Initiation of Diesel Generator 2/3 During Modification Due to Design Error

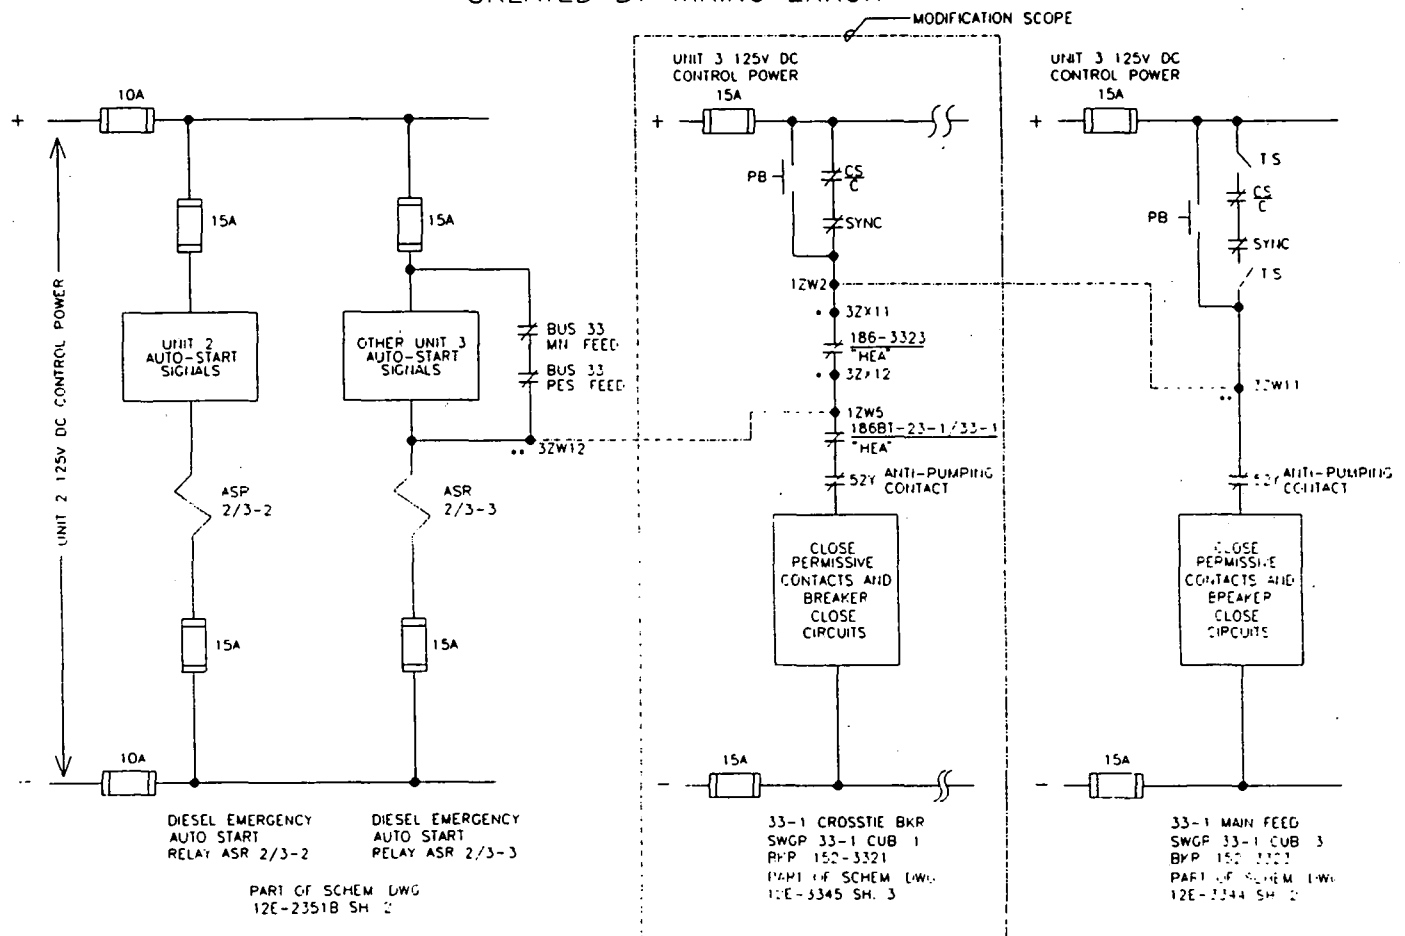
Attachment A

The cause of the event was a wiring error during the installation of the Bus 33-1 and Bus 23-1 Tie modification due to a design error in the installation drawings (see Attachment A). The control circuitry for the Bus 33-1 breaker for the Bus 33-1 and Bus 23-1 Tie, the Bus 33-1 Main Feed breaker, and the Unit 3 automatic start of the Unit 2/3 Diesel Generator were superimposed, resulting in the automatic start signal to the generator when the Bus 33-1 to Bus 23-1 tie breaker was closed.

A review of the circuit with the wiring discrepancy installed identified that several different inadvertent actuations could have occurred dependent on the initial conditions. The close circuit for the Bus 33-1 crosstie breaker, the Unit 3 automatic start circuit for the Unit 2/3 Diesel Generator, and the Bus 33-1 Main Feed Breaker close circuit were inadvertently tied together. The actuation of any one of these components could have resulted in the actuation of all three components under specific conditions. When the Bus 33-1 crosstie breaker was closed, Unit 3 125 volt DC system positive voltage was applied to a portion of the Unit 2/3 Diesel Generator auto start circuit with Unit 2 125 volt system negative potential for the duration that the control switch was in the close position. The potential difference in this case was large enough to result in the momentary actuation of the automatic start relay, but not large enough to generate enough current to open the protective fuses for the circuit.

**SIMPLIFIED SCHEMATIC SHOWING SNEAK CIRCUIT
CREATED BY WIRING ERROR**

Immediate corrective actions included diagnosis of the wiring discrepancy, development of an approved work package to correct the discrepancy, and development of an approved testing package to verify the correction of the discrepancy.

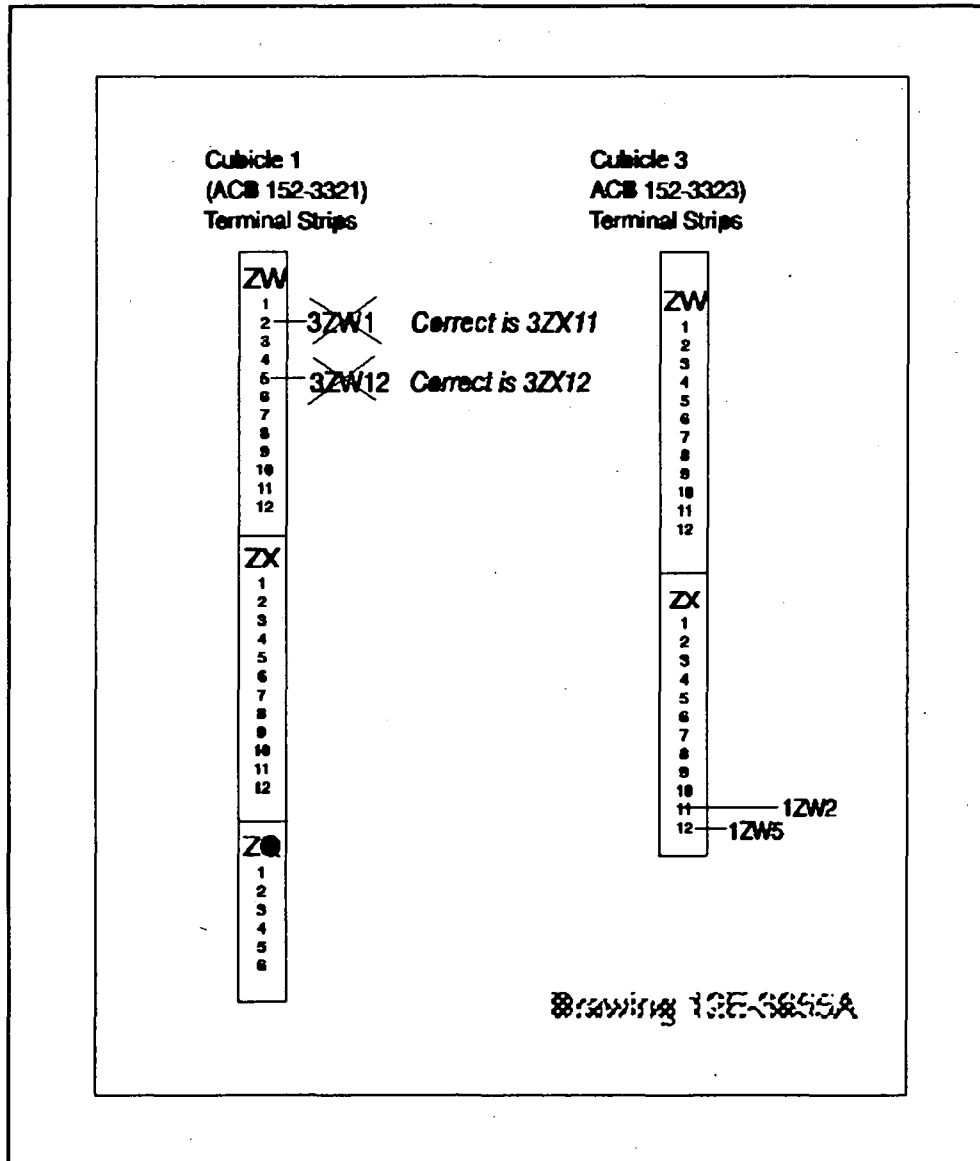
Attachment B

Other contributing factors were identified which led to the discrepancy and its failure to be detected throughout the process of design, installation, and testing of the modification. First, the organization performing the design of this modification did not identify the discrepancy during the initial design or through their internal checking process. Termination / determination checklists or "wiring lists" were prepared from a combination of the wiring diagrams and the cubicle wiring lists provided by the switchgear vendor. These lists were prepared as recommended by design procedure for complex modifications due to a lack of true existing wiring diagrams for the internal wiring of the switchgear cubicle. The arrangement of the external wiring diagram which depicted the "ZW" and "ZX" terminal blocks with a faint separation between blocks contributed to the initial error of listing the incorrect destination points on the wiring diagrams at the other end of the affected wires and on the wiring lists (see Attachment B). The design package, including the drawings, were subsequently issued to the station for comments.

Identification of the Design Error Included in
Electrical Drawing 12E-3655A
