Commonwealth Edison
Dresden Nuclear Power Station
6500 North Dresden Road
Morris, Illinois 60450
Telephone 815/942-2920

Licensee Event Report 94-013, Docket 50-237 is being submitted as required by Technical Specification 6.6, NUREG 1022 and 10CFR50.73(a)(2)(iv).

NRC FORM 366 (5-92)				U.S. NUCLEAR REGULATORY COMMISSION				APPROVED BY OMB NO. 3150-0104 EXPIRES 5/31/95			
LICENSEE EVENT REPORT (LER)											
FACILITY NAME (1) Dresden Nuclear Power Station, Unit 2								DOCKET NUMBER (2) 05000237		PAGE (3) 1 OF 8	
TITLE (4) Auto Initiation of Diesel Generator 2/3 During Modification Due to Design Error											
EVENT DATE (5)			LER NUMBER (6)			REPORT DATE (7)			OTHER FACILITIES INVOLVED (8)		
MONTH	DAY	YEAR	YEAR	SEQUENTIAL NUMBER	REVISION NUMBER	MONTH	DAY	YEAR	FACILITY NAME None		DOCKET NUMBER
05	23	94	94	-- 013 --	00	06	22	94	FACILITY NAME		DOCKET NUMBER
OPERATING MODE (9)		N	THIS REPORT IS SUBMITTED PURSUANT TO THE REQUIREMENTS OF 10 CFR §: (Check one or more) (11)								
POWER LEVEL (10)		089	20.2201(b)			20.2203(a)(3)(i)			50.73(a)(2)(iii)		73.71(b)

Auto Initiation of Diesel Generator 2/3 During Modification Due to Design Error

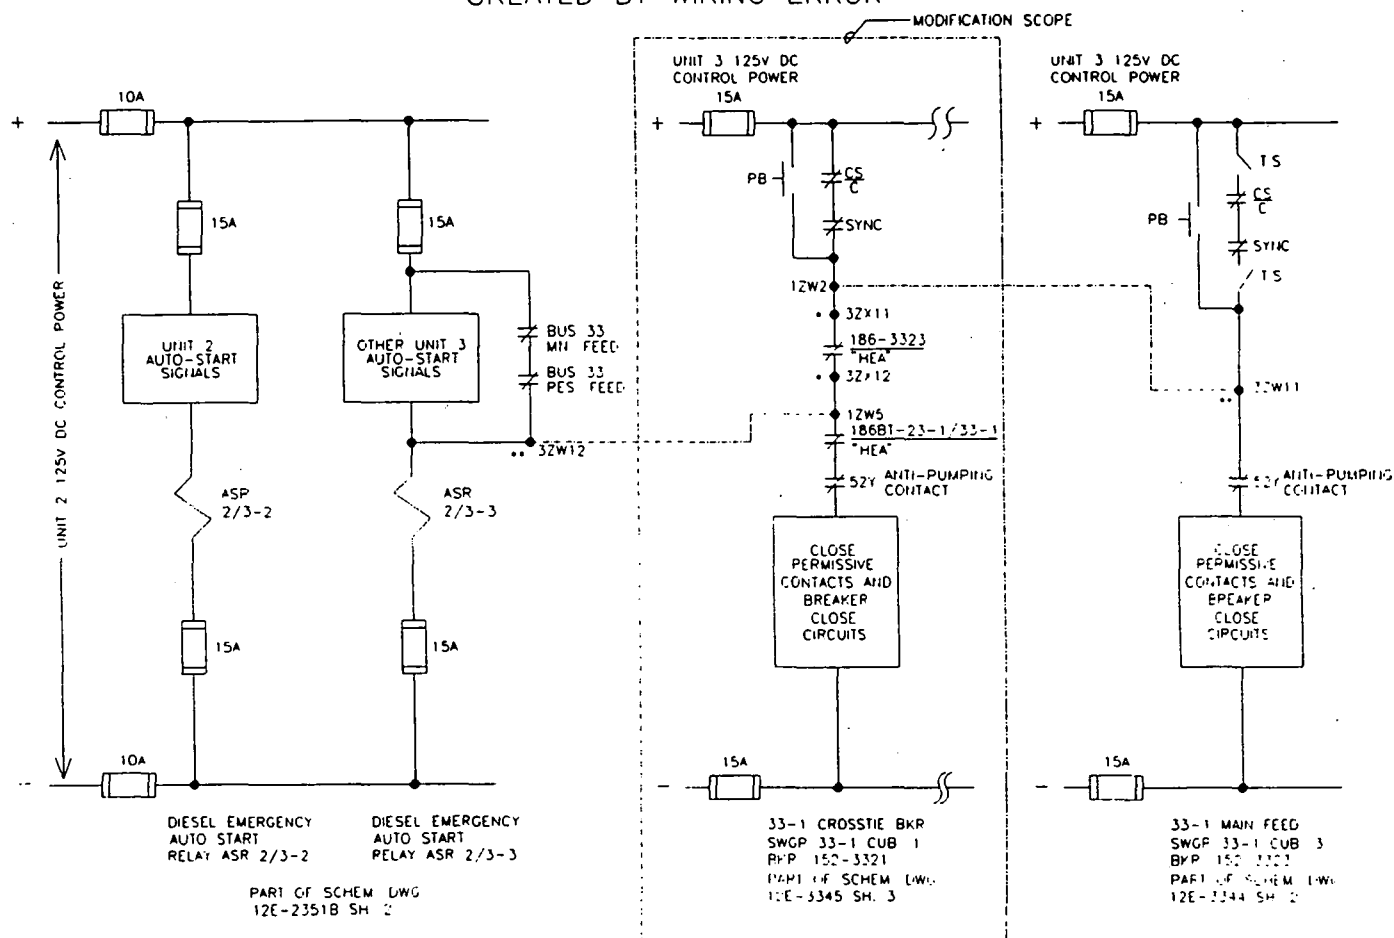
Attachment A

The cause of the event was a wiring error during the installation of the Bus 33-1 and Bus 23-1 Tie modification due to a design error in the installation drawings (see Attachment A). The control circuitry for the Bus 33-1 breaker for the Bus 33-1 and Bus 23-1 Tie, the Bus 33-1 Main Feed breaker, and the Unit 3 automatic start of the Unit 2/3 Diesel Generator were superimposed, resulting in the automatic start signal to the generator when the Bus 33-1 to Bus 23-1 tie breaker was closed.

A review of the circuit with the wiring discrepancy installed identified that several different inadvertent actuations could have occurred dependent on the initial conditions. The close circuit for the Bus 33-1 crosstie breaker, the Unit 3 automatic start circuit for the Unit 2/3 Diesel Generator, and the Bus 33-1 Main Feed Breaker close circuit were inadvertently tied together. The actuation of any one of these components could have resulted in the actuation of all three components under specific conditions. When the Bus 33-1 crosstie breaker was closed, Unit 3 125 volt DC system positive voltage was applied to a portion of the Unit 2/3 Diesel Generator auto start circuit with Unit 2 125 volt system negative potential for the duration that the control switch was in the close position. The potential difference in this case was large enough to result in the momentary actuation of the automatic start relay, but not large enough to generate enough current to open the protective fuses for the circuit.

**SIMPLIFIED SCHEMATIC SHOWING SNEAK CIRCUIT
CREATED BY WIRING ERROR**

Immediate corrective actions included diagnosis of the wiring discrepancy, development of an approved work package to correct the discrepancy, and development of an approved testing package to verify the correction of the discrepancy.

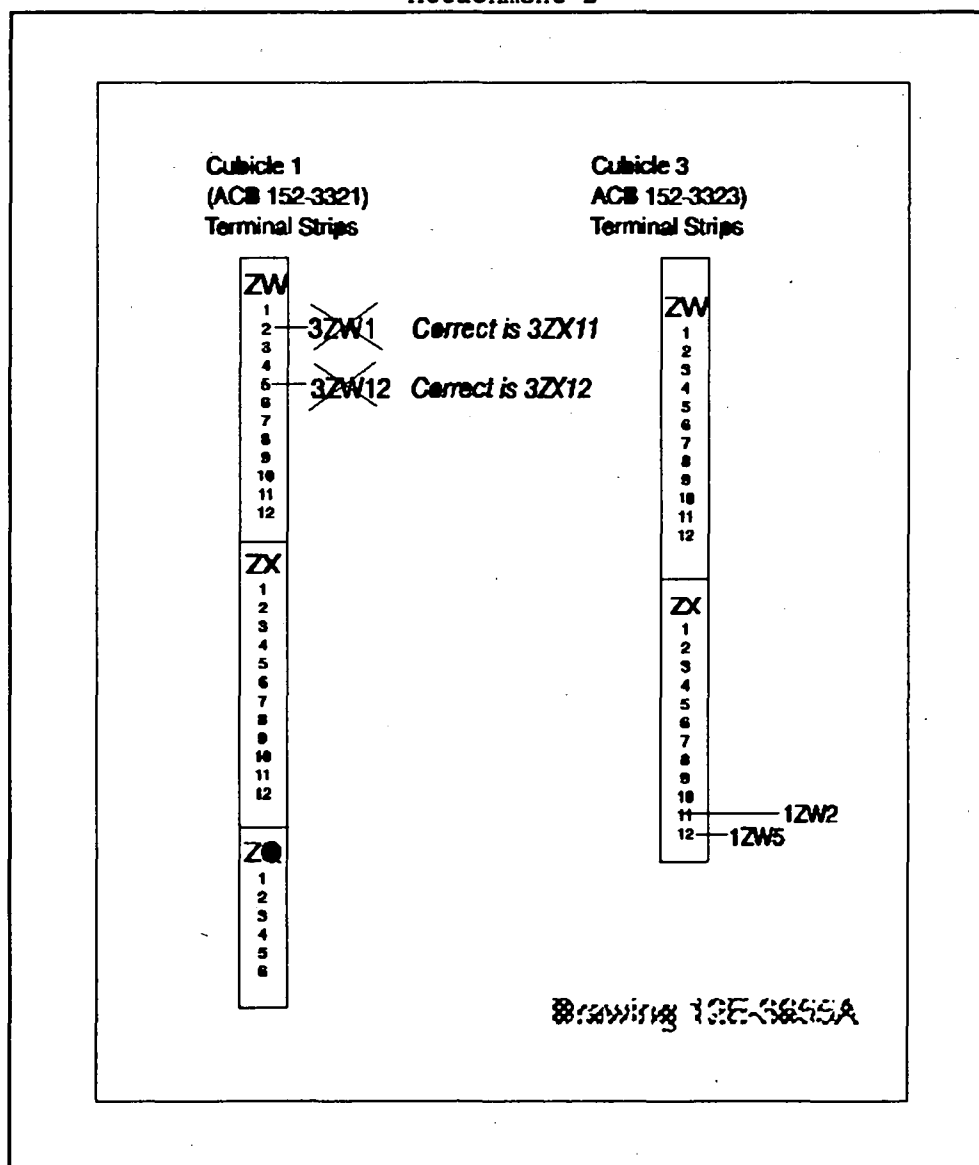
Attachment B

Other contributing factors were identified which led to the discrepancy and its failure to be detected throughout the process of design, installation, and testing of the modification. First, the organization performing the design of this modification did not identify the discrepancy during the initial design or through their internal checking process. Termination / determination checklists or "wiring lists" were prepared from a combination of the wiring diagrams and the cubicle wiring lists provided by the switchgear vendor. These lists were prepared as recommended by design procedure for complex modifications due to a lack of true existing wiring diagrams for the internal wiring of the switchgear cubicle. The arrangement of the external wiring diagram which depicted the "ZW" and "ZX" terminal blocks with a faint separation between blocks contributed to the initial error of listing the incorrect destination points on the wiring diagrams at the other end of the affected wires and on the wiring lists (see Attachment B). The design package, including the drawings, were subsequently issued to the station for comments.
