Subject: Dresden Nuclear Power Station Unit 3  
 Quad Cities Nuclear Power Station Unit 1  
 Clarification of Ultrasonic Examination Methods Used at  
 Dresden Unit 3 and Quad Cities Unit 1 to Address Core  
 Shroud Cracking at the H5 Weld  
NRC Docket No. 50-249 and 50-254

# ULTRASONIC EXAMINATION METHODS

## *As used at Dresden 3 and Quad Cities 1*

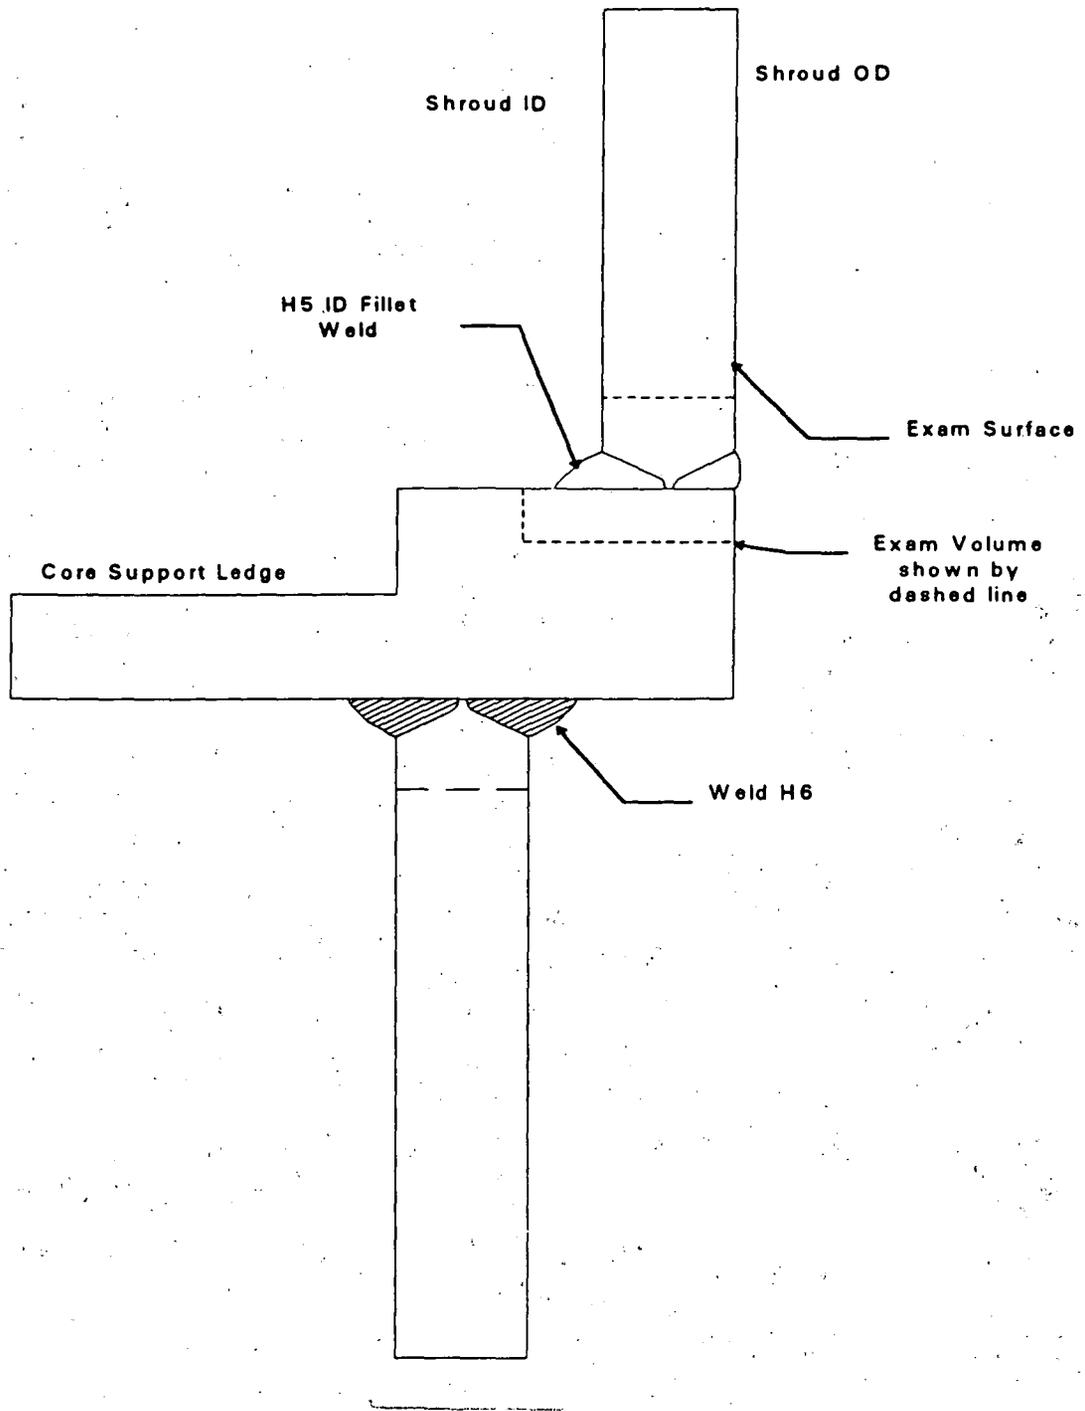
**Figure 1 - H5 Weld Geometry**

The examination recorded fillet weld geometry with both the 45° shear (as well as 60° RL) transducer, because of the shroud geometry at the H5 weld (see Figure 1). The geometry signals were from the fillet weld on the ID surface. This weld geometry gave an excellent benchmark indication on the system C-scan using both 45° shear and 60° RL search units. It is the 45° shear that is used as the primary exclusion zone transducer.

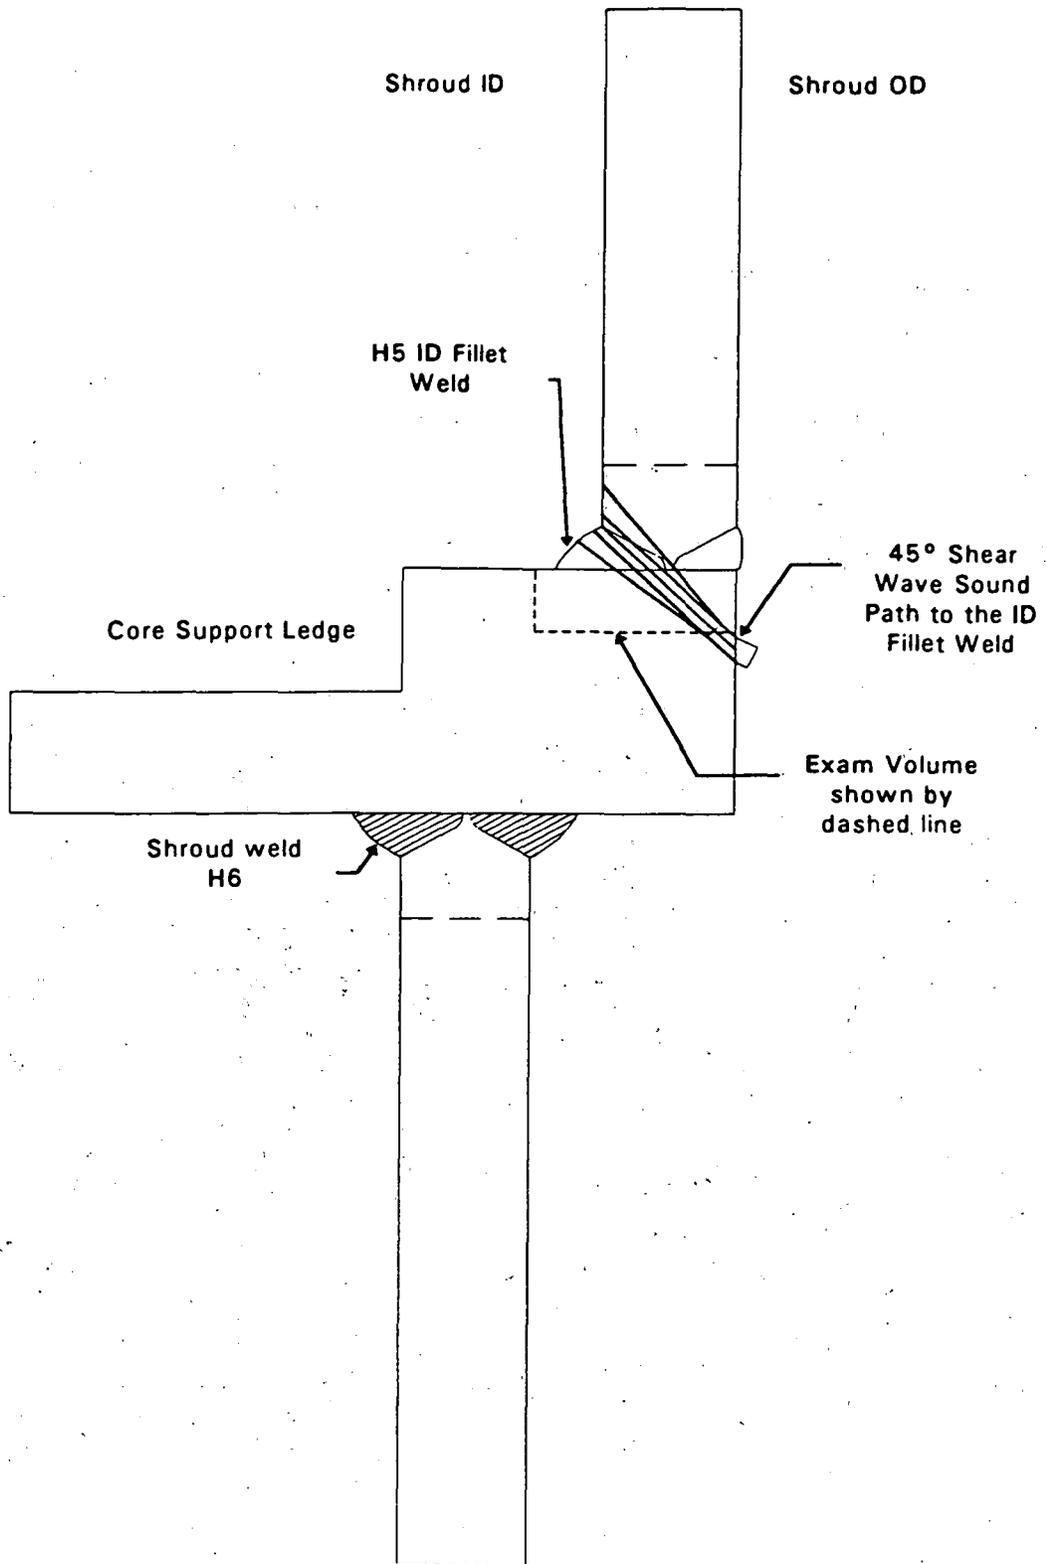
**Figure 2 - 45° Shear Wave No Flaw**

Figure 2 shows the 45° sound pattern including beam spread and how it can insonify the entire ID fillet weld region. The technical basis for establishing an exclusion zone is the fact that during normal examination of the weld, geometric signals were consistently recorded from the fillet weld. If a flaw were to penetrate the sound path of the 45° transducer while the transducer was insonifying the ID fillet weld region, 2 responses would be recorded on the acquisition system:

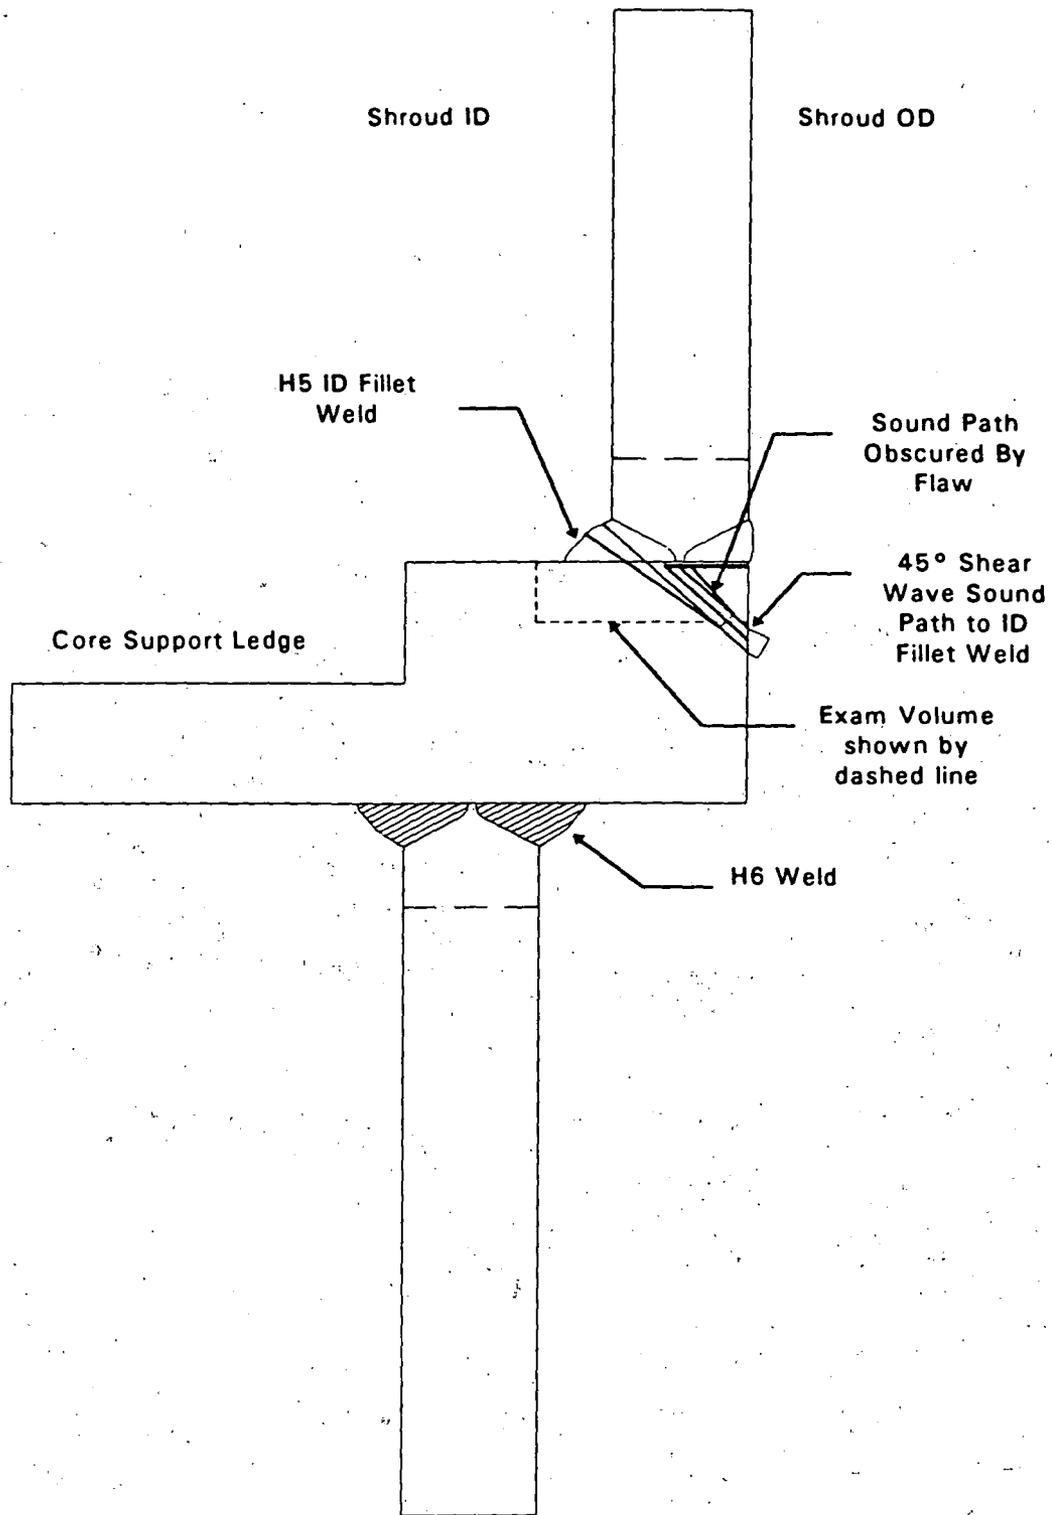
**Figure 3 - 45° Shear Wave with Flaw**

1. The response amplitude from the ID fillet weld region would be noticeably reduced by the flaw.
2. An indication response of the shorter metal path to the flaw, than to the ID fillet weld, would be observed.

This detection method is directly analogous to techniques taught at the EPRI NDE center for IGSCC detection. For example, when an operator finds a signal that obscures the response from the weld root geometry, he can be confident that the signal is a crack. Conversely, if no signal obscures the response from the weld root geometry, it is concluded that no crack is present between the 45° shear wave transducer and the weld root. This premise is fundamental to IGSCC crack detection using a 45° shear wave. Figure 3 below displays this concept for the H5 weld configuration. In this case a flaw intersects the 45° sound beam at its mid point, obscuring ~ 50% of the sound energy, which would both reduce the amplitude response from the ID fillet weld, and produce a response from the flaw at a shorter metal path.

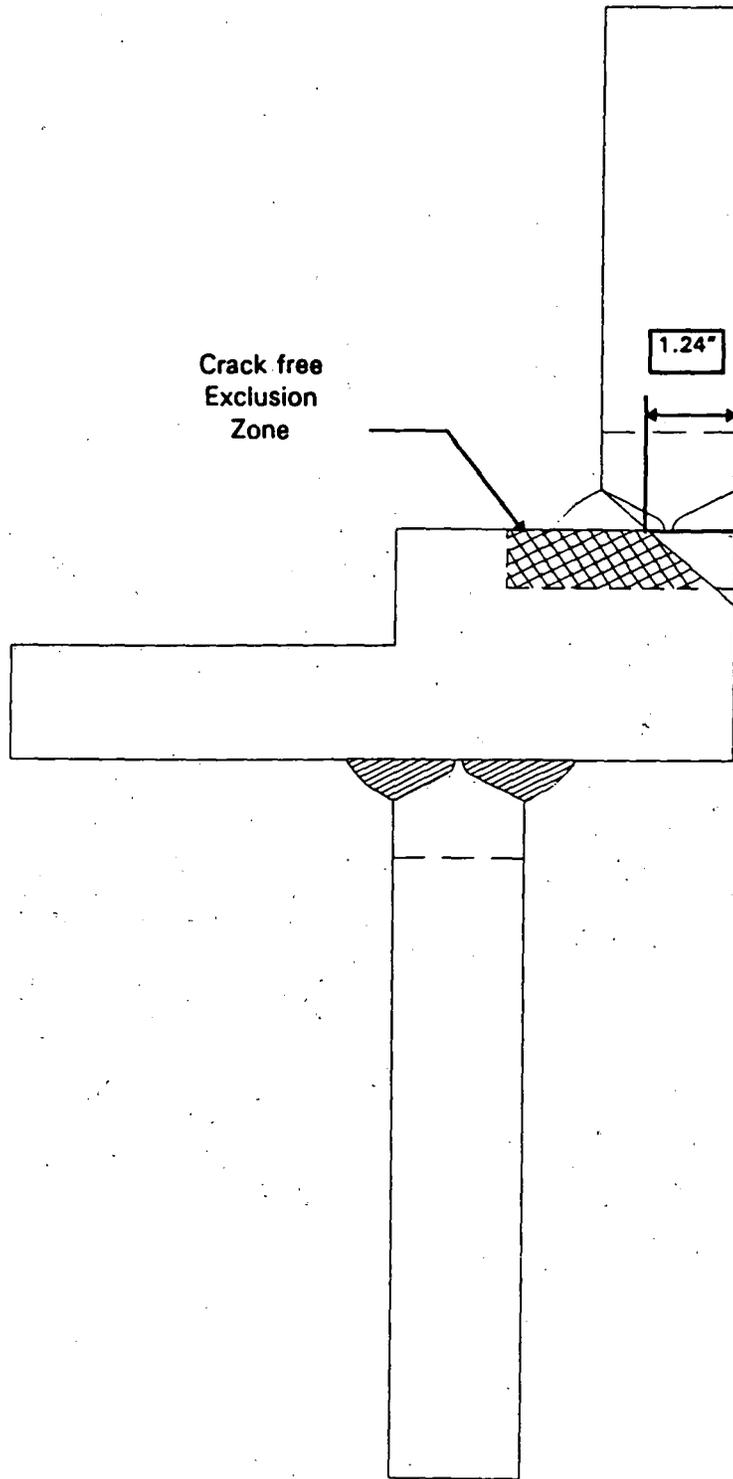
**Figure 4 - Definition of "Crack Free" Exclusion Zone  
Based on 45° Shear Wave Examination**

Empirical data supporting the 45° shear wave crack detection is available in shroud exams performed to date with the OD Tracker system. Shallow crack indications (determined to be IGSCC by evaluation of boat samples at Dresden 3 and Quad Cities 1) were detected with the 45° shear wave transducer, with the response from the ID fillet weld also present. Since the ID fillet weld was observed in each of the more than 2000 stepped transducer scans, it is unlikely that any crack-like defect intersecting the central beam path would not have been seen. Therefore, the 1.24 inch bounding limit on crack size is assured.

- The 1.24" flaw exclusion is based conservatively on the center of the beam. The previous figures show that approximately 50% of the sound energy, including beam spread, would be blocked from the fillet weld for a 1.24" flaw. This dimension represents the largest flaw that could possibly exist and still see the fillet intersection with the vertical cylinder.
- Sound transmission through a crack (if it occurred) would be further attenuated in this application because of the two-way transmission through the crack to the fillet weld and back to the transducer.
- Flaws shadowing the root is an established flaw detection method.

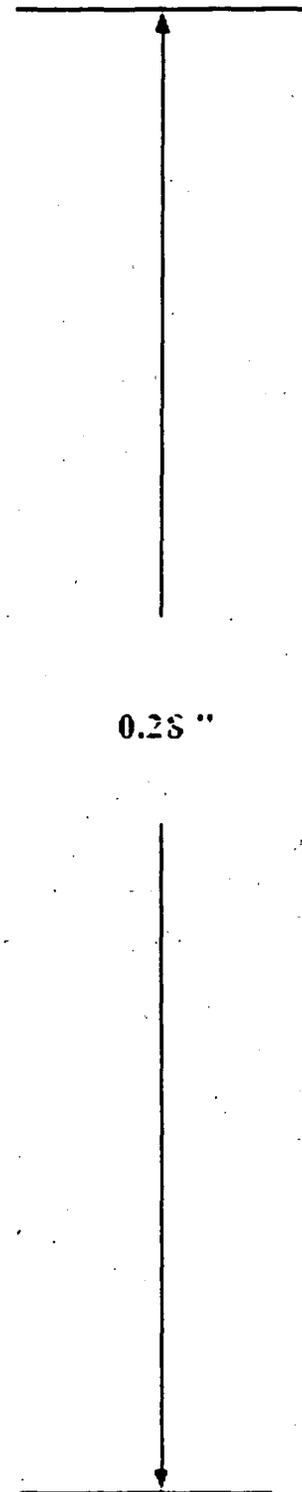
**Figure 5 - Quad Cities Unit 1, 154 Degree Azimuth Showing Intergranular Cracking, Branching and Grain Encirclement**

A note of concern for the exclusion zone approach has been raised based on the notion that the crack would be transparent to the sound beam near the crack tip. It was noted that this phenomenon may have occurred during the qualification of Time of Flight Diffraction (TOFD) techniques for the Brunswick shroud UT. Through conversations with the team members involved with this TOFD qualification, including EPRI NDE Center personnel, it was determined that the sound transmission through cracks referred to was observed with the lateral wave produced using the TOFD technique. This lateral wave is a longitudinal wave, whereas the 45° search unit discussed for this application is a shear wave. Shear waves reflect sound energy from multifaceted flaws more strongly than longitudinal waves. Additionally, the crack morphology, as evidenced in the Dresden and Quad Cities boat samples, show these cracks to be open, with some grain encirclement from corrosion, enhancing sound reflection. Figures 5 through 8 show example cracks from each of the 4 boat samples taken at Dresden 3 and Quad Cities 1.

- The 45° shear wave search unit consistently recorded the ID fillet weld during the examination.
- The 60° RL also recorded this fillet weld geometry.
- The metallography results show that these cracks are relatively open and exhibit grain encirclement. The flaw branches extensively in several instances.
- The 45° shear wave is very sensitive to grain boundaries. Crack morphology as seen in figures 5 through 8 show grain encirclement, and multifaceted flaws. The

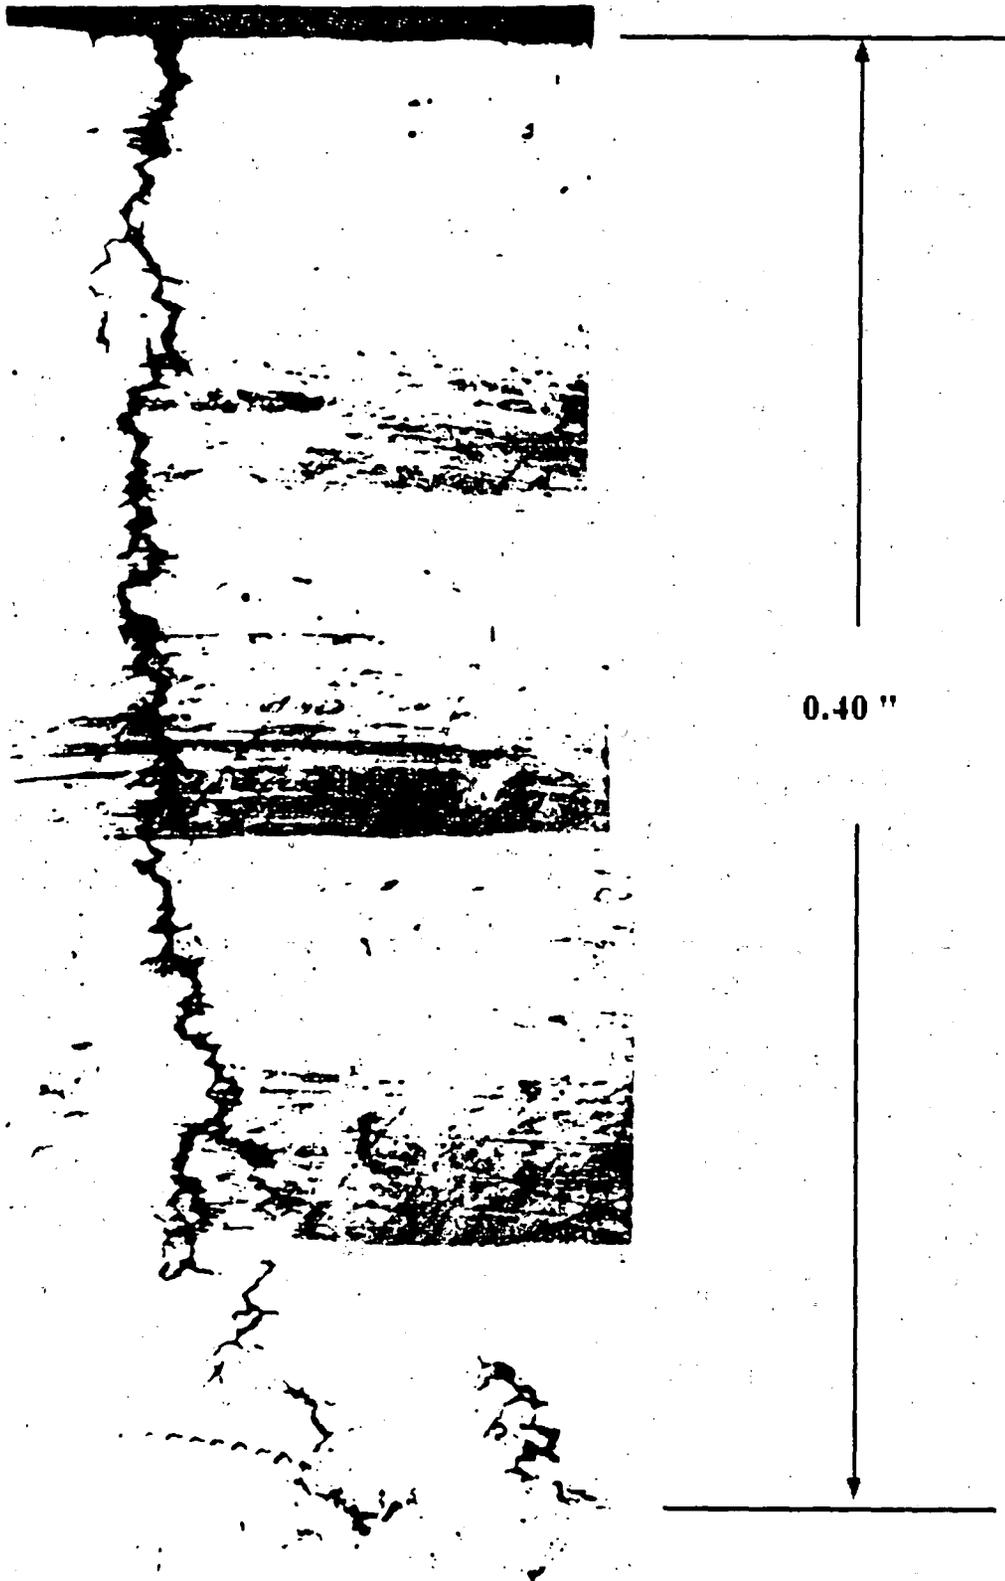
**Figure 6 - Quad Cities Unit 1, 342 Degree Azimuth Showing Intergranular Cracking, Branching and Grain Encirclement**

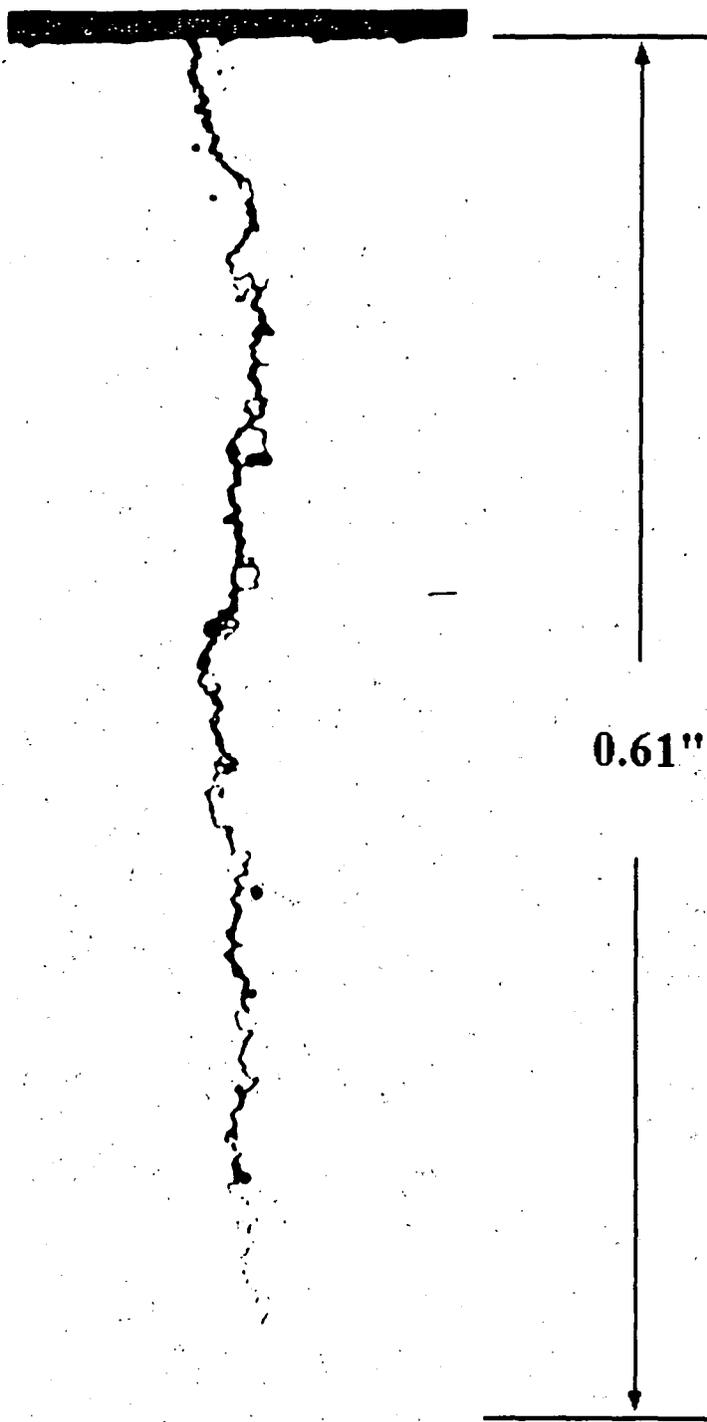
**Figure 7 - Dresden Unit 3, 153 Degree Azimuth Showing Open Intergranular Cracking and Minor Branching**

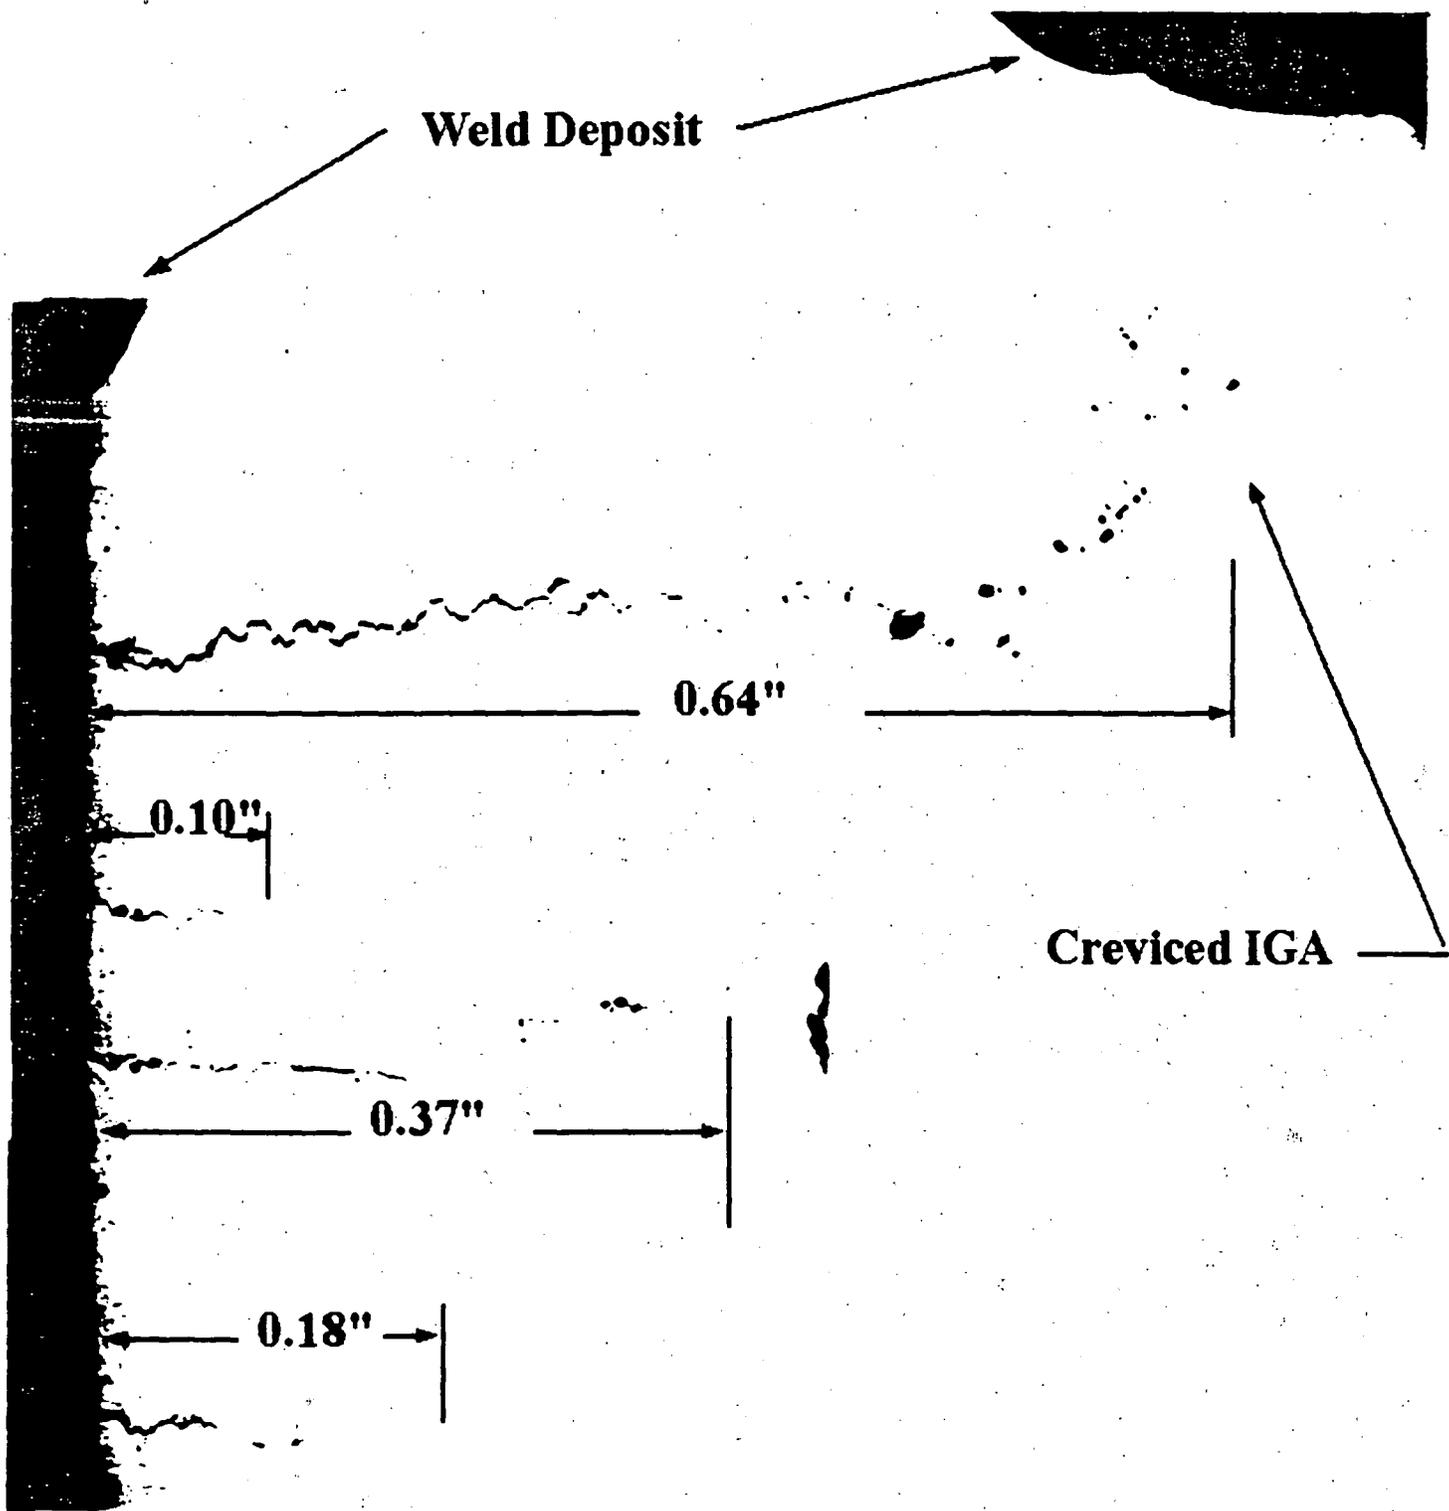
**Figure 8 - Dresden Unit 3, 324 Degree Azimuth Showing Multiple Crack Initiation, Open Cracks, Branching and Grain Encirclement**
