LICENSEE EVENT REPORT (LER)

FACILITY NAME (1)
Dresden Nuclear Power Station, Unit 2DOCKET NUMBER (2)
05000237PAGE (3)
1 OF 10TITLE (4)
HPCI Turbine Tripped on High Exhaust Pressure Due to a Failed Exhaust Check Valve

HPCI [BJ] Turbine Tripped on High Exhaust Pressure Due to a Failed Exhaust Check Valve

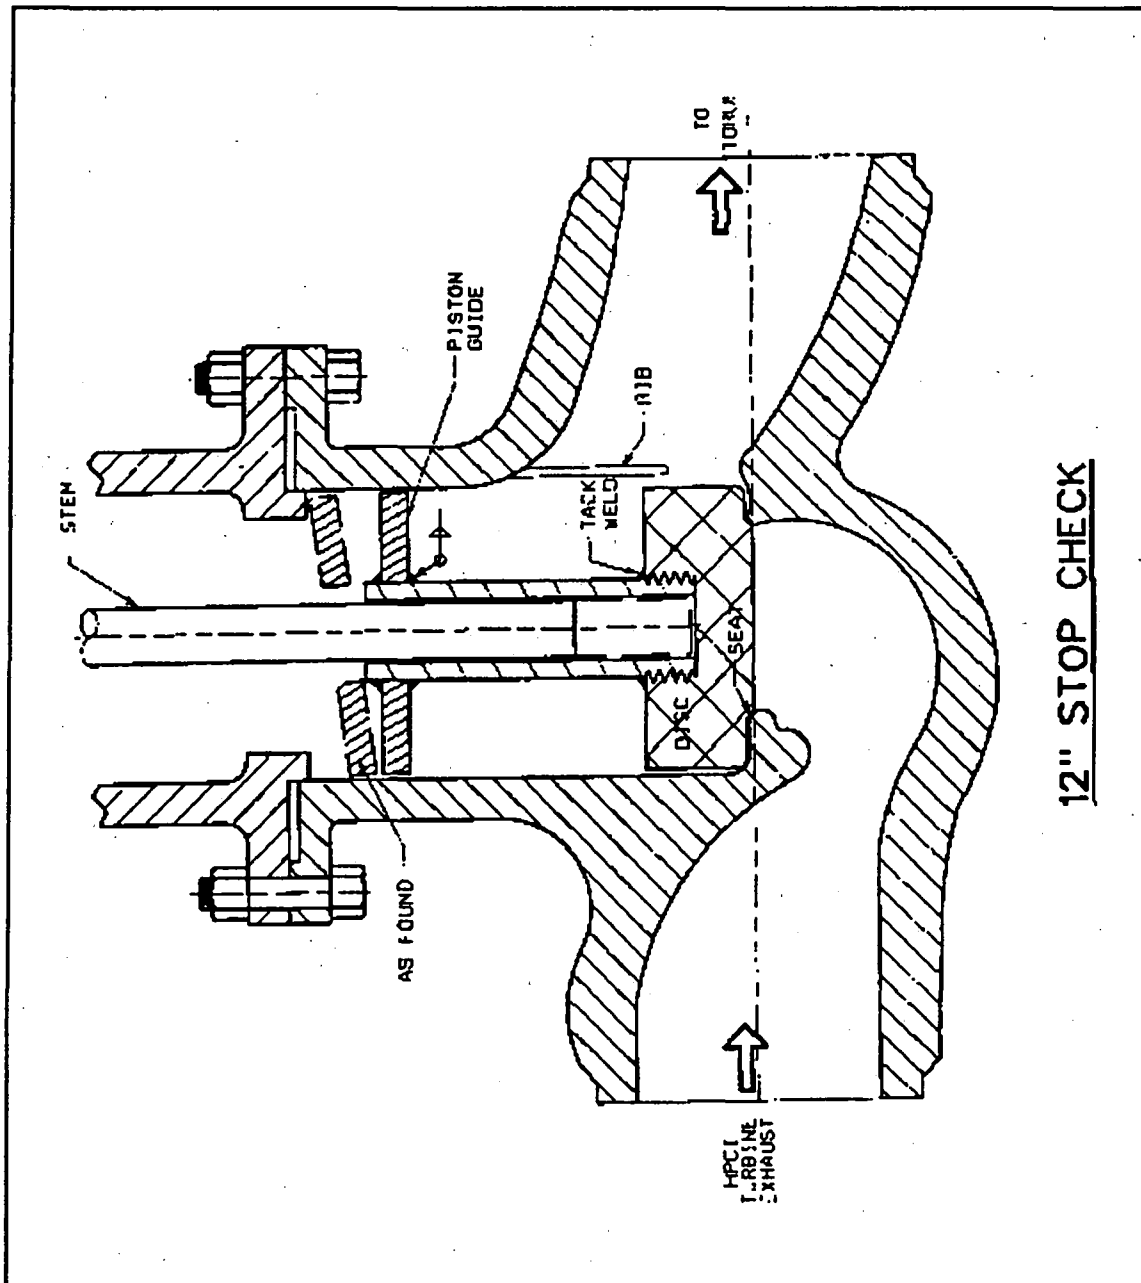
The 2-2301-74 valve HPCI Turbine Exhaust Check Valve, was disassembled and inspected under work request D26919. The valve disk was found not attached to the valve guide piston. Further inspection revealed that the four tack welds, which prevent the assembly from rotating, had broken due to fatigue.

1. The four tack welds were found broken. There was evidence of beaching marks (rough, chevron-shaped surface with curved rows extending from the initial crack area) on the surface of the tack weld fracture area. These marks are evidence that the initial cracks were caused by fatigue.
2. The tack welds were worn. Only two of the four tack welds had a surface with small remains of beaching marks.
3. The threads of the two components of the piston, which are normally covered if the two components are properly fastened, had very little corrosion. This is relative to the rest of the surface of the piston surrounding the threaded region.

From these observations, it was concluded that the fracture of the tack welds was due to fatigue, occurred recently and the separation of the two piston components occurred during the last HPCI turbine operation.

SMAD believed that the tack welds would be likely to fracture after twenty years of service in a high vibration, low cyclic stress environment. A tack weld fracture in this environment is not abnormal. The cause for the vibrations in the weld area is the loosening of the two piston components. Originally, the two components of the piston are tightened and tack welded, however, after time and many cycles of thermal expansion/contraction, the two components became loose. As the two components loosened, they were able to vibrate, and thereby caused cyclic stress in the tack welds, eventually initiating cracks and fracture in the welds.

The 2-2301-74, HPCI Turbine Exhaust Check Valve, was disassembled, inspected and repaired under work request D26919. The valve disk was found not attached to the valve guide piston. Further inspection revealed the tack welds, which prevent the assembly from rotating, had broken due to vibration fatigue. The valve was reassembled and tested satisfactorily during Unit 2 start-up on November 19, 1994.
