Licensee Event Report 95-001, Docket 50-249 is being submitted as required by  
Technical Specification 6.6, NUREG 1022 and 10CFR50.73(a)(2)(iv).

FACILITY NAME (1)		DOCKET NUMBER (2)	LER NUMBER (6)		PAGE (3)
Dresden Nuclear Power Station, Unit 3		05000249	YEAR	SEQUENTIAL NUMBER	REVISION NUMBER
			95	-- 001 --	00
					2 OF 9

Unit 3 Scram From Main Turbine Stop Valve Closure Due to Moisture Separator Level High High

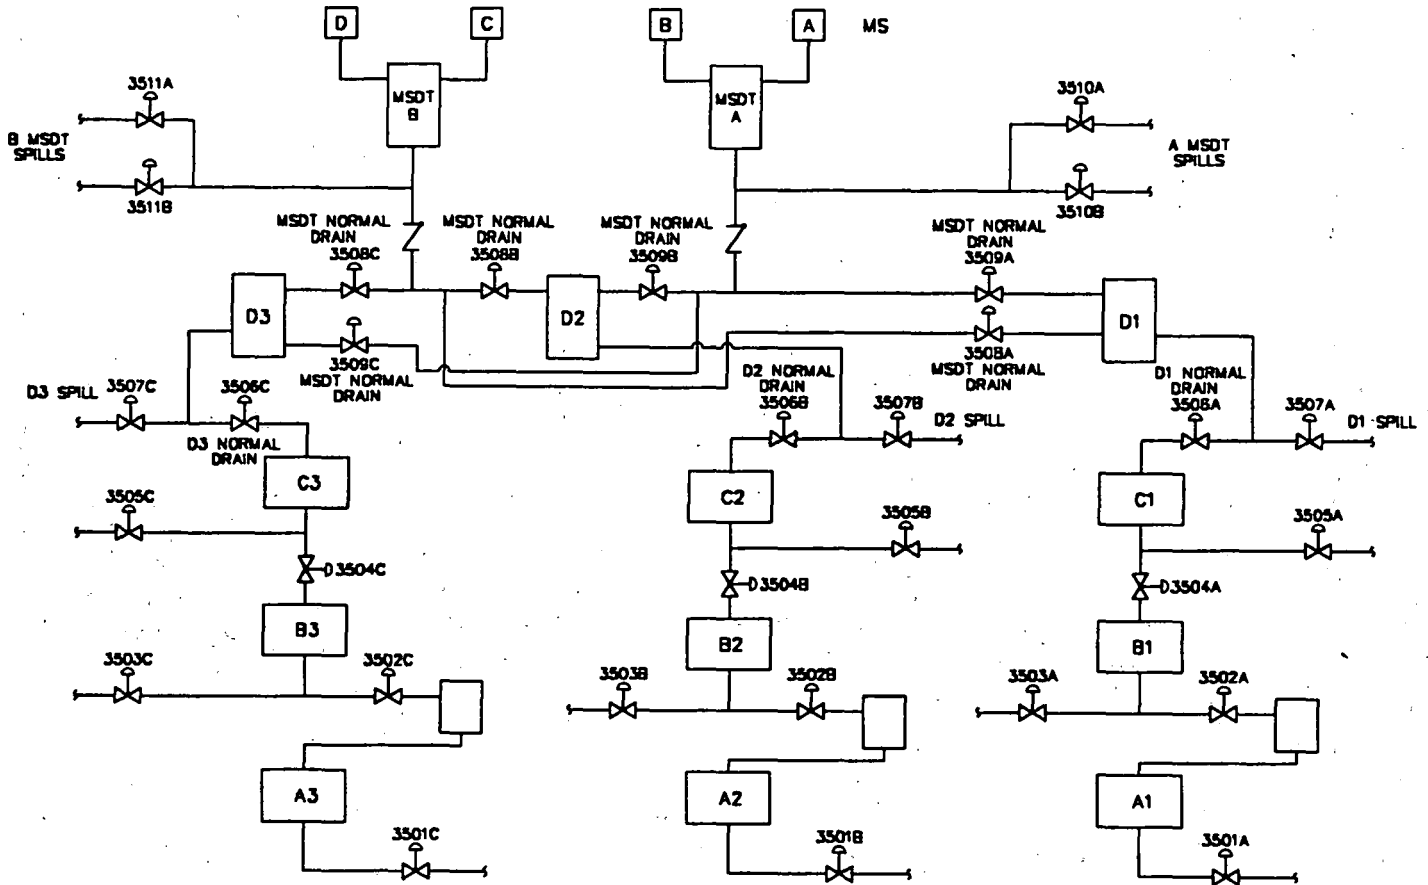
In order to replace the 3D1 high pressure feedwater heater level switch, the 3D2 and 3D3 high pressure feedwater heaters needed to be removed from service. (Refer to the attached sketch for heater layout information.) Removal of the 3D2 and 3D3 high pressure feedwater heaters from service and the 3D1 high pressure feedwater heater level switch replacement were scheduled for the afternoon shift on January 9, 1995.

Upon completing the isolation of the 3D2 high pressure feedwater heater extraction steam, the 3D2 high pressure feedwater heater, unexpectedly to the crew, automatically isolated the 3A and 3B MSDTs drain valves (3-3508B and 3-3509B) on high level. Isolating the steam to the 3D2 high pressure feedwater heater removed the driving force pushing the water through the drain, resulting in a high level in the 3D2 high pressure feedwater heater and the 3A and 3B MSDTs normal drain path isolation (this was not understood by the crew before they isolated the extraction steam to the heater). After the 3D2 high pressure feedwater heater was isolated, the only remaining normal drain path for the 3A and 3B MSDTs was through the 3D3 high pressure feedwater heater.

The resulting increase in drainage to the 3D3 high pressure feedwater heater caused its level to increase and a high level alarm was received in the Control Room (CR) [NA] at 1822 hours. With the level in the 3D3 high pressure feedwater heater high and all the normal MSDT drains isolated, no normal drain paths for the 3A and 3B MSDTs remained (3D1 was isolated on January 7, 1995). The Unit 3 NSO took control of the 3D3 high pressure feedwater heater extraction valve for the 3D3 high pressure feedwater heater and closed it slowly, to reduce input into the heater and to reduce the possibility of water induction into the turbine.

The 3A MSDT high level alarm was received in the CR, the 3-3511A and 3-3511B spills opened as designed and provided a drain path for the B MSDT. However, the 3-3510A and 3-3510B spills for the 3A MSDT failed to open, causing the water level to rise into the 3A and 3B MS. At 1830 and 1831, high level alarms were received in the control room for the 3A and 3B MS (which drain to the 3A MSDT). At 1832 a high high 3B MS alarm was received in the CR and the Main Turbine [TA] tripped resulting in a scram of Unit 3, at 1833 hours, from 89% rated core thermal power, on Turbine Stop Valve [JJ] closure. All equipment functioned as expected, except for the Reactor level [JB] rising to a maximum 57.6 inches and
