Subject: Dresden Nuclear Power Station Units 2 and 3

ComEd's Assessment of Potential Impact of High Pressure
Coolant Injection (HPCI) Turbine Exhaust Rupture Disk
Opening

NRC Dockets 50-237 and 50-249

Potential Impact of Rupture Disk Opening

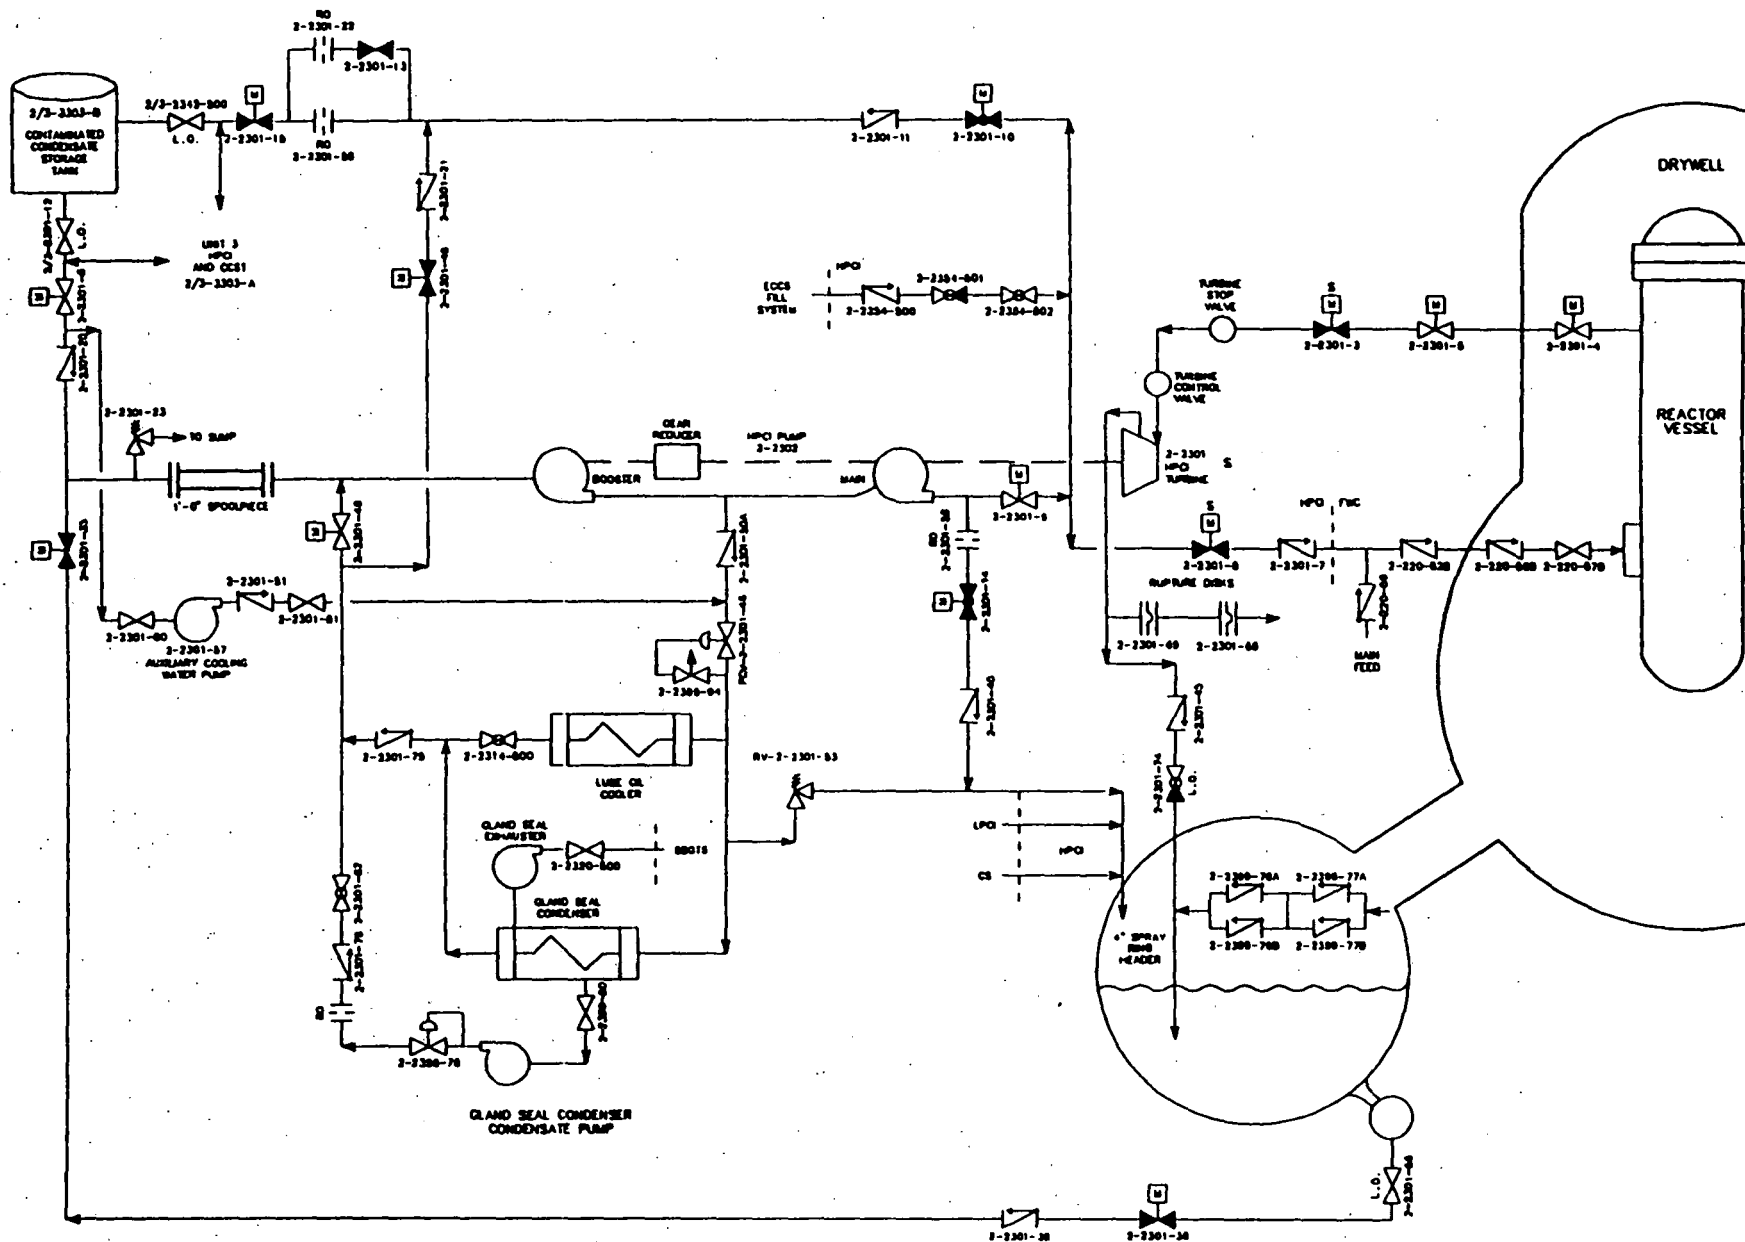
Fig. A-1. Simplified Diagram of Dresden 2 High Pressure Coolant Injection System.

Two rupture disks, in series, are located in a tee off the High Pressure Coolant Injection (HPCI) steam exhaust line. The rupture disks vent to the HPCI room to provide HPCI turbine protection should steam exhaust line blockage occur. See Fig. A-1 for simplified diagram of the Dresden 2 HPCI system showing the rupture disks. The Dresden 3 and Quad Cities 1 and 2 HPCI systems are similar. Two check valves are located in the steam exhaust line downstream of the rupture disk tee. Failure of either of these check valves, for example, could block steam exhaust line flow.

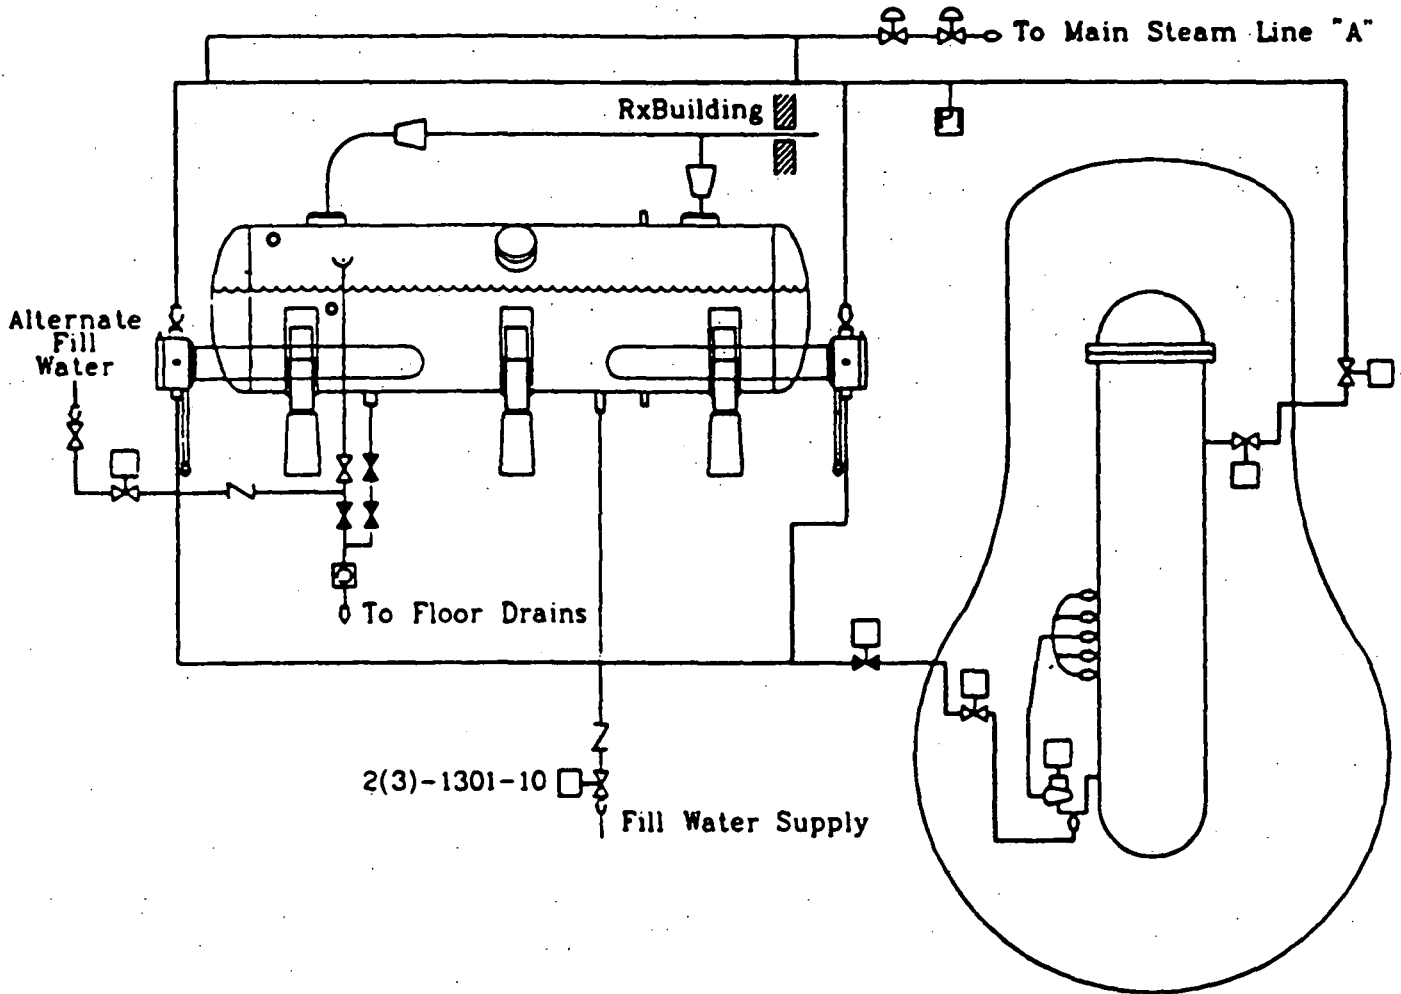
FIG. G-1 ISOLATION CONDENSER SYSTEM SIMPLIFIED SCHEMATIC

The Isolation Condenser system piping that falls under the scope of Generic Letter 88-01 is as follows (see Fig. G-1 provided for reference):

- The steam supply piping from the RPV to Isolation Condenser Steam inlet nozzle.
- The condensate return piping from the outboard containment isolation valve to the tie in with the Shutdown Cooling system piping.

Note: The condensate return piping from the Isolation Condenser condensate return outlet nozzle to the outboard containment isolation valve contains reactor coolant at temperatures less than 200F during power operation and as such, does not fall under the scope of Generic Letter 88-01.
