Commonwealth Edison Company
Dresden Generating Station
6500 North Dresden Road
Morris, IL 60450
Tel 815-942-2920

July 3, 1995

Subject: Dresden Nuclear Power Station Units 2 and 3

ComEd's Assessment of Potential Impact of High Pressure
Coolant Injection (HPCI) Turbine Exhaust Rupture Disk
Opening

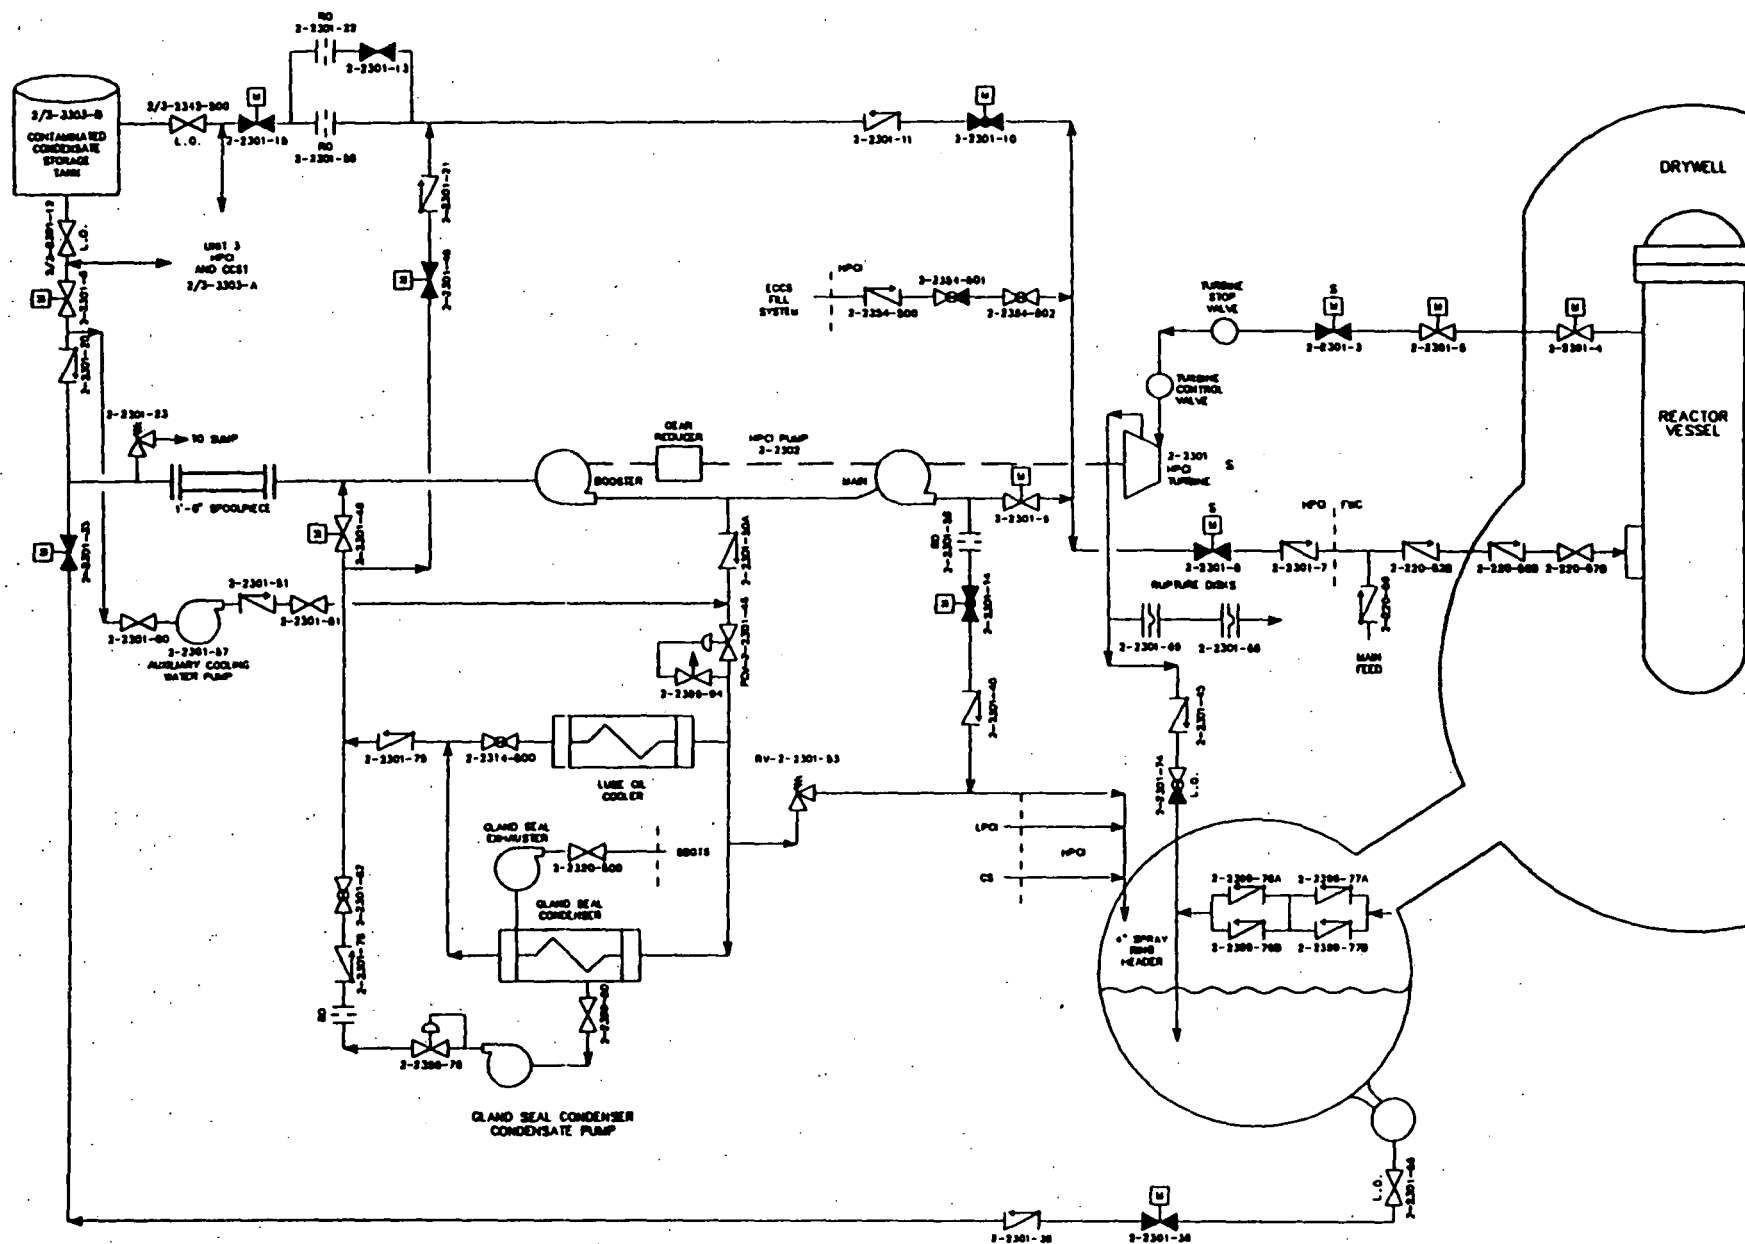
Fig. A-1. Simplified Diagram of Dresden 2 High Pressure Coolant Injection System.

Two rupture disks, in series, are located in a tee off the High Pressure Coolant Injection (HPCI) steam exhaust line. The rupture disks vent to the HPCI room to provide HPCI turbine protection should steam exhaust line blockage occur. See Fig. A-1 for simplified diagram of the Dresden 2 HPCI system showing the rupture disks. The Dresden 3 and Quad Cities 1 and 2 HPCI systems are similar. Two check valves are located in the steam exhaust line downstream of the rupture disk tee. Failure of either of these check valves, for example, could block steam exhaust line flow.

The Dresden HPCI exhaust line rupture disks are located downstream of the turbine exhaust, and are located in a standpipe that tees off a horizontal section of the exhaust pipe. This configuration does not allow direct water slug impingement on the disks in the event of a water intrusion event. The set pressure for the disks is approximately 140 psig, and the intent is to provide overpressure protection for the exhaust line in the event the exhaust line was isolated via a manual isolation, or due to failure of the check valve in the line. Pressure switches in the line will trip the turbine if the exhaust pressure exceeds 100 psig. Normal operating exhaust line pressure is approximately 25 psig.

Therefore, the principal modes of failure are failure of the check valve, or isolation of the line causing a pressure transient on the line, or material failure of the disks at normal operating pressure. It should be noted that the material failure of the rupture disks is considered unlikely, since two disks are located in series, with a pressure switch alarm to warn of incipient failure of the inboard disk. Given the geometry of the Dresden exhaust lines, a water intrusion event would need to nearly fill the exhaust lines in order to achieve the transient pressure needed to fail the rupture disks.

Furthermore, Dresden preventive maintenance requirements were strengthened in response to the June 1993 Quad Cities event. The HPCI rupture disks are now replaced every refueling outage and also if the burst pressure is approached but not reached. For example, a HPCI exhaust line stop check valve failed in August 1994 as detailed in Dresden 2 LER 94-021. The failure resulted in an automatic high exhaust pressure HPCI turbine trip at 2500 rpm. (Note that the turbine speed is 4000 rpm at full power conditions on the HPCI turbine.) The HPCI rupture disks were replaced due to reaching a pressure greater than 80% of their burst pressure value.

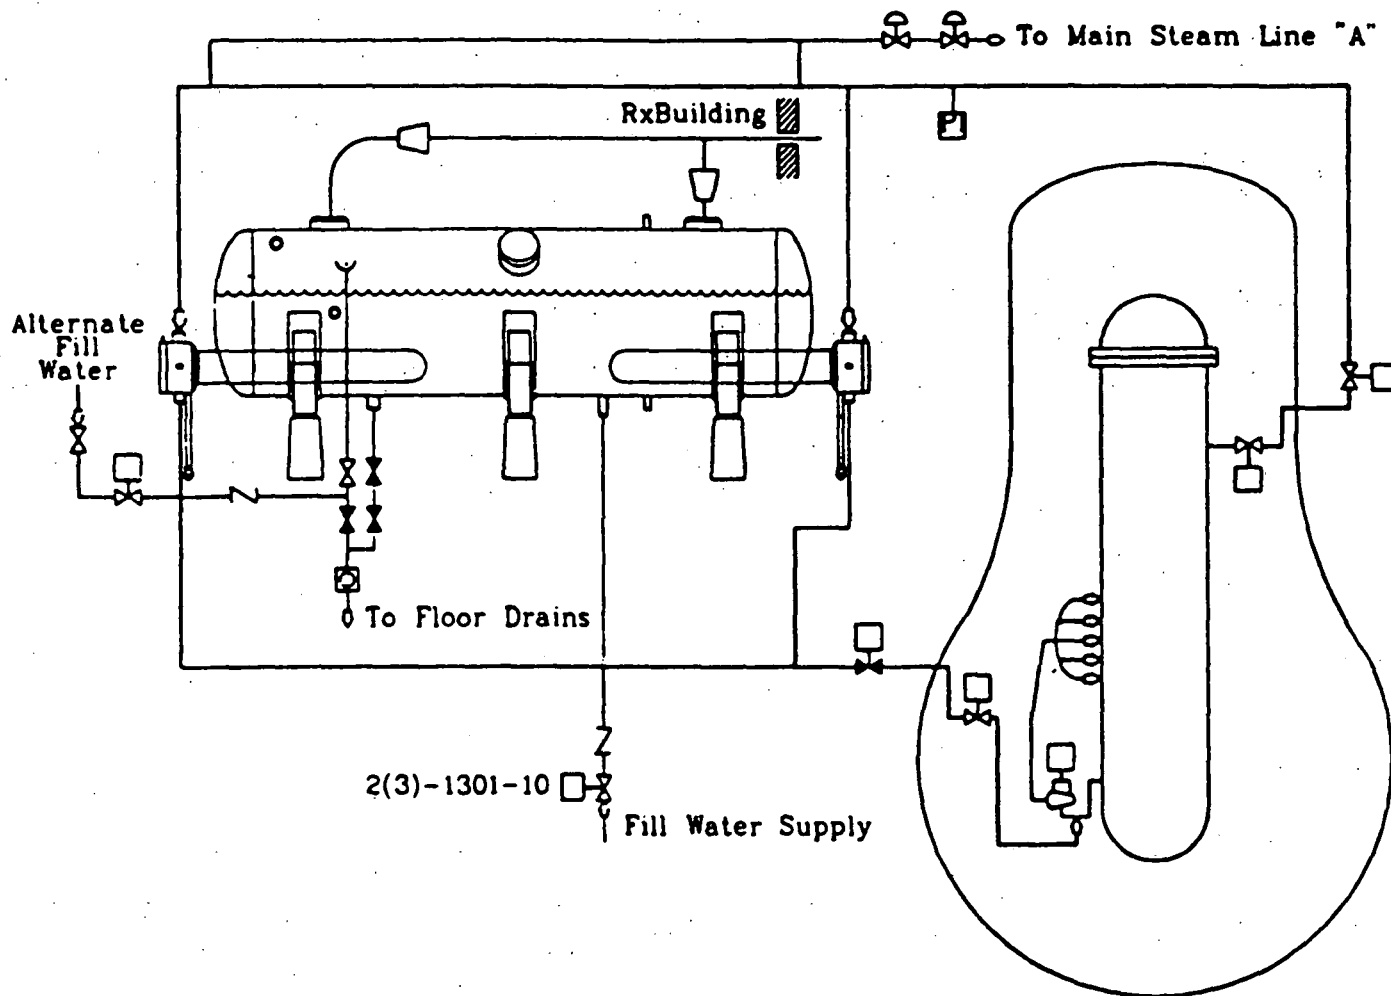
FIG. G-1 ISOLATION CONDENSER SYSTEM SIMPLIFIED SCHEMATIC

The Isolation Condenser system piping that falls under the scope of Generic Letter 88-01 is as follows (see Fig. G-1 provided for reference):

- The steam supply piping from the RPV to Isolation Condenser Steam inlet nozzle.
- The condensate return piping from the outboard containment isolation valve to the tie in with the Shutdown Cooling system piping.

Note: The condensate return piping from the Isolation Condenser condensate return outlet nozzle to the outboard containment isolation valve contains reactor coolant at temperatures less than 200F during power operation and as such, does not fall under the scope of Generic Letter 88-01.

The Isolation Condenser system piping welds have undergone extensive, periodic ultrasonic examination by EPRI qualified examiners since issuance of Generic letter 88-01. These examinations have not identified any cracking to date in the system piping welds.

- All accessible (accessible to the Mechanical Stress Improvement Fixture) Isolation Condenser system welds considered to be highly susceptible to IGSCC have been stress improved.
- Corrosion resistant inlays have been applied to the wetted surfaces of inaccessible welds located on the inside of containment penetrations.

• The Unit 3 condensate return piping from the outboard containment isolation valve to the tie in with the Shutdown Cooling system piping has been replace with IGSCC resistant material.
