**LICENSEE EVENT REPORT (LER)**

**FACILITY NAME (1)**  
Dresden Nuclear Power Station, Unit 2 and 3

**TITLE (4)**  
HPCI Room Cooler Fan Minimum Starting Voltage Above Second Level Undervoltage Relay Setpoint

**HPCI Room Cooler Fan Minimum Starting Voltage Above Second Level Undervoltage Relay Setpoint**

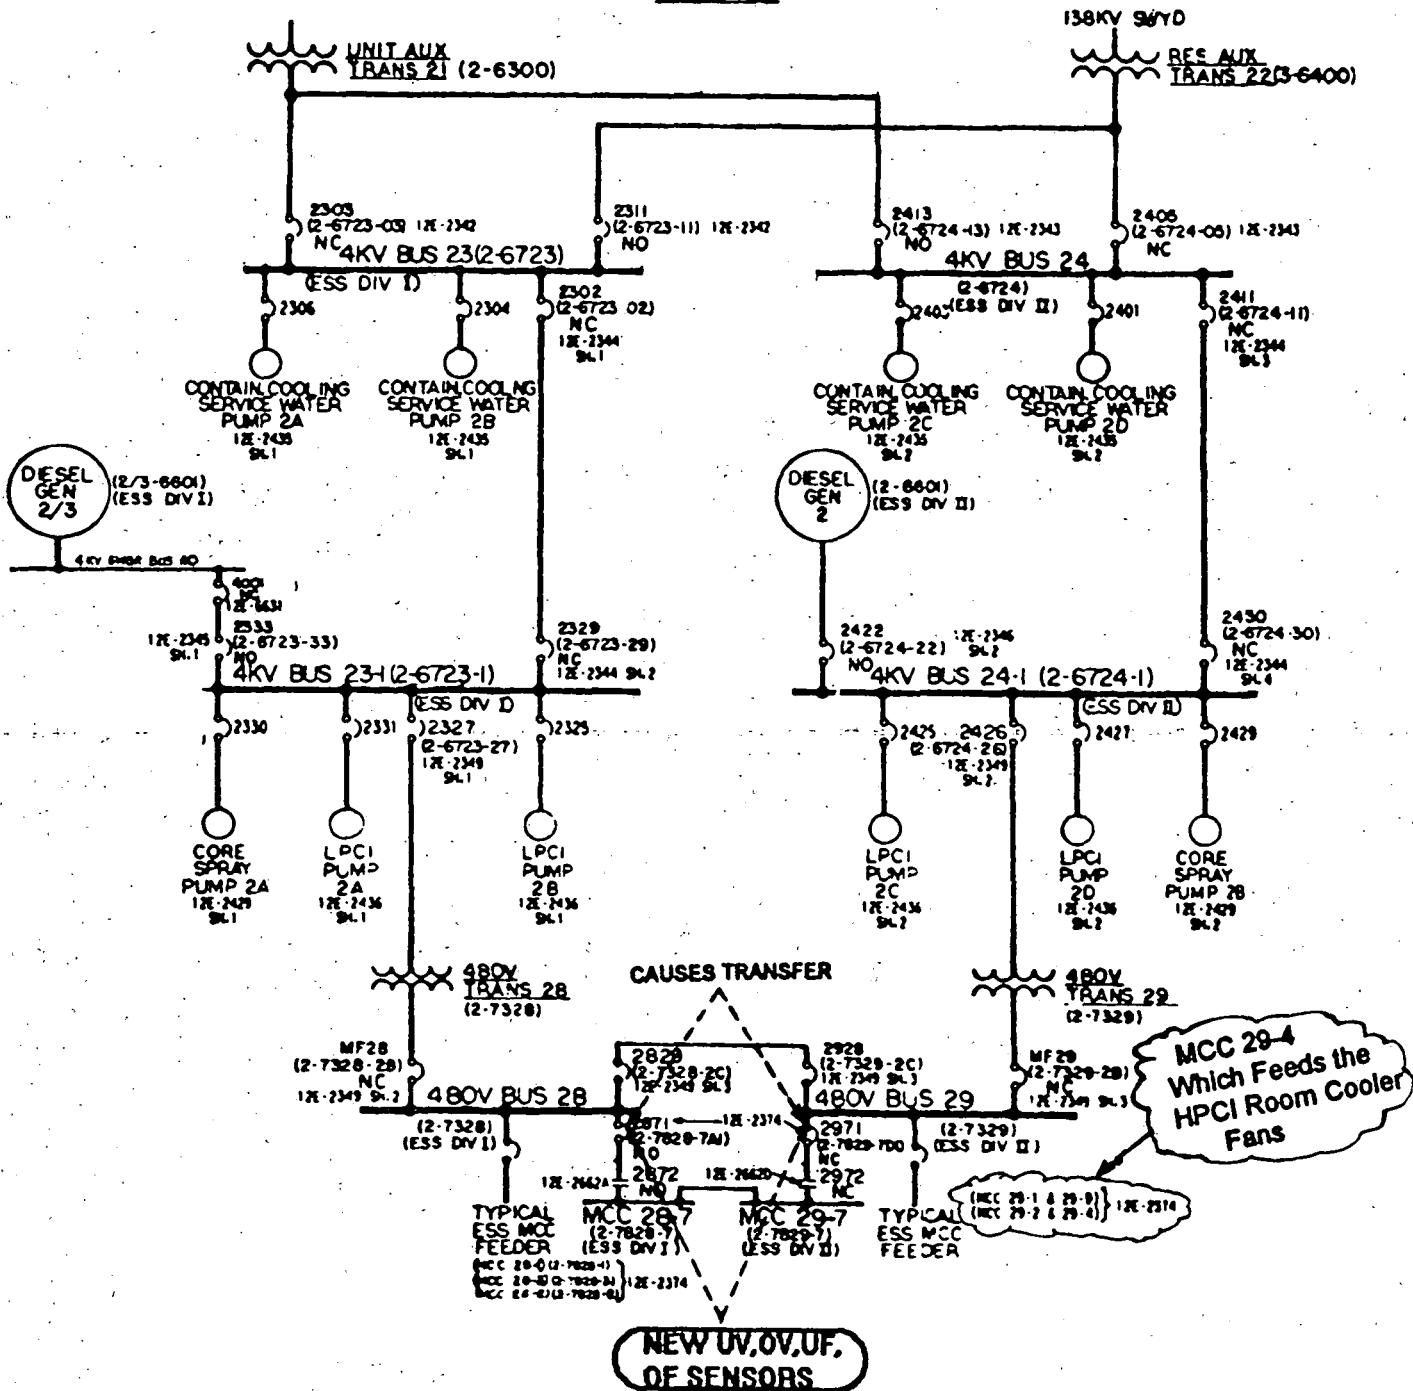
UNIT 2

In response to an NRC unresolved item in Engineering and Technical Support Inspection 237(249) 94-003, the August 1989 High Pressure Coolant Injection (HPCI) [BG] Room Cooler Fans second level degraded voltage relay settings calculations were being reviewed. It was discovered in Sargent and Lundy calculation 8982-19-19-2 that the control circuit contactor (motor starter) pick up voltages were above the set point. Specifically, the review identified that under degraded voltage conditions for Unit 2, only 86.8 Volts (V) AC is postulated to be available at the control circuit contactor. 97.72 VAC is required to assure its operation. For Unit 3, only 87.7 VAC is postulated to be available at the motor starter with 97.70 VAC required to assure its operation. Therefore, it could not be assured that the Unit 2 & 3 HPCI Room Cooler Fans would start.

The review confirmed that the concern was isolated to the 120 VAC motor starters, and that the voltages at the 480 VAC HPCI Room Cooler Fan motors were calculated to be acceptable.

According to Commonwealth Edison's (ComED) Nuclear Engineering Department Mechanical Structural Group (NED M&S) letter concerning the Emergency Core Cooling System (ECCS) Room Cooler Operability Requirements, dated February 3, 1993, CHRON #198404, the HPCI room cooler fans are required to function in the event of a Designed Basis Accident (DBA) Loss Of Coolant Accident (LOCA). These room cooler fans are fed from Unit 2 480 VAC Bus 29 (MCC 29-4) and Unit 3 480 VAC Bus 39 (MCC 39-1); both of these busses are affected by their respective second level degraded voltage relay settings. (See attached sketch, Unit 3 is similar).

The HPCI Room Cooler Fan's control circuit contactors were replaced under Nuclear Work Request (NWR) numbers D25259 and D25260 for Unit 2 and Unit 3, respectively. The existing Size 2 full voltage non-reversing contactors were replaced by new General Electric (GE) Series 300 Size 1 contactors. The HPCI Room Cooler Fans are rated at 3 horsepower (hp); GE vendor data indicates that a Size 1 contactor may be utilized for all motor sizes up to 10 hp. These motor starters are equipped with 75 percent pickup coils. By reducing the contactor size and improving the pickup of the coil, the burden on the control circuit is reduced and the contactor voltage is improved to the extent that the existing set points for the second level degraded voltage relays do not affect the operation of the HPCI Room Cooler Fans.
