Subject: Dresden Nuclear Power Station Unit 2,
Core Shroud Examination Final Results
NRC Docket No. 50-237

TABLE 1

DRESDEN UNIT 2 CORE SHROUD EXAMINATION SUMMARY

DRESDEN UNIT 2 CORE SHROUD EXAMINATION ROLL OUT

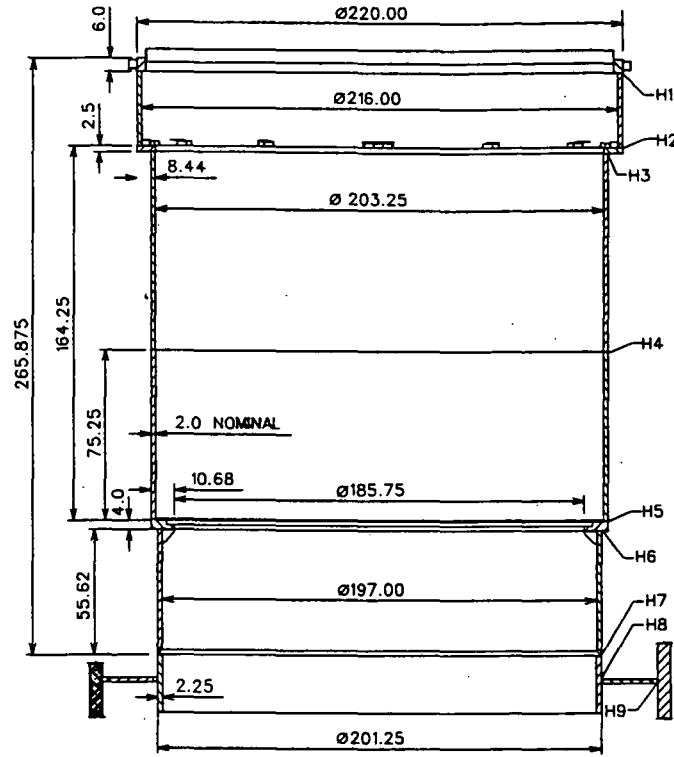
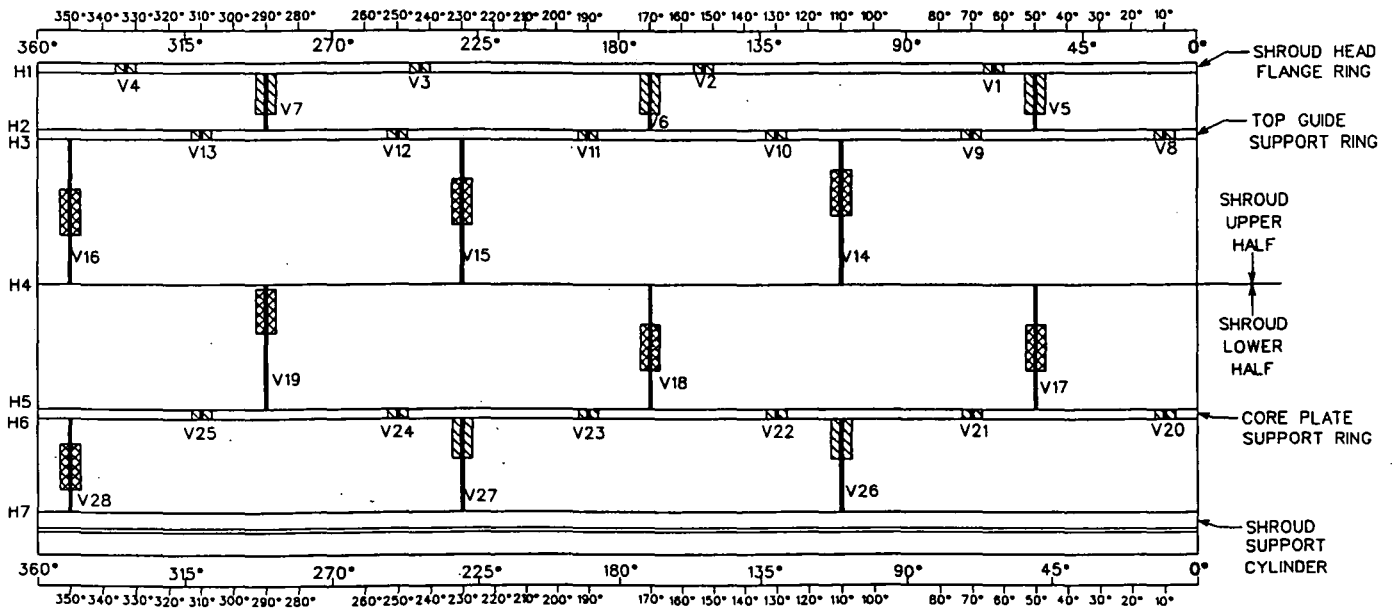
FIGURE 1

The following is a summary of the core shroud examination scope and results. Details of the specific areas examined and the results of the examinations are presented in the attached Table 1 and Figure 1.

- o The ultrasonic examination scope consisted of shroud vertical welds V14 through V19 (located in the beltline region between horizontal welds H3 and H5), and V28 (located between horizontal welds H6 and H7). Approximately 27 inches, or between 30% and 50% of the total length of each vertical weld, was examined. These examinations resulted in no reportable indications.
- o The enhanced visual examination scope consisted of the ring segment welds associated with the shroud head flange ring, top guide support ring, and core plate support ring; vertical welds V1, V2, V3, V26, and V27; the H8 and H9 horizontal welds at the shroud repair hardware locations; and the shroud repair hardware attachment sites at the shroud head flange ring and the jet pump support plate. These examinations resulted in no reportable indications in the area of interest.

However, circumferential cracking associated with the H3 and H5 welds was identified during performance of the ring segment weld examinations. The H3 and H5 welds were not part of the core shroud examination scope per the Reference 4 Inspection Plan, because the installed comprehensive shroud repair was designed to structurally replace horizontal shroud welds H1 through H7. Therefore, the observed cracking has no adverse impact on core shroud structural integrity. Details of the cracking observed in the H3 and H5 welds are provided below.

One circumferential crack indication approximately 2 inches long was identified in the core plate support ring, and significant circumferential cracking (approximately 60 inches, or 85% of the of the area examined) was identified in the top guide support ring. The crack indication in the core plate support ring is located on the OD surface and is associated with the lower heat affected zone (HAZ) of the horizontal H5 weld. The cracking in the top guide support ring is located on the ID surface and is predominantly associated with the upper HAZ of the horizontal H3 weld, although some minor cracking (less than 12 inches) was also identified in the shroud plate material associated with the lower HAZ of the H3 weld.
