Rev. 1
September 18, 1995

Dresden Unit 2 Core Spray Flaw Evaluation Report

CORE SPRAY FLAW EVALUATION REPORT
REVISION 1

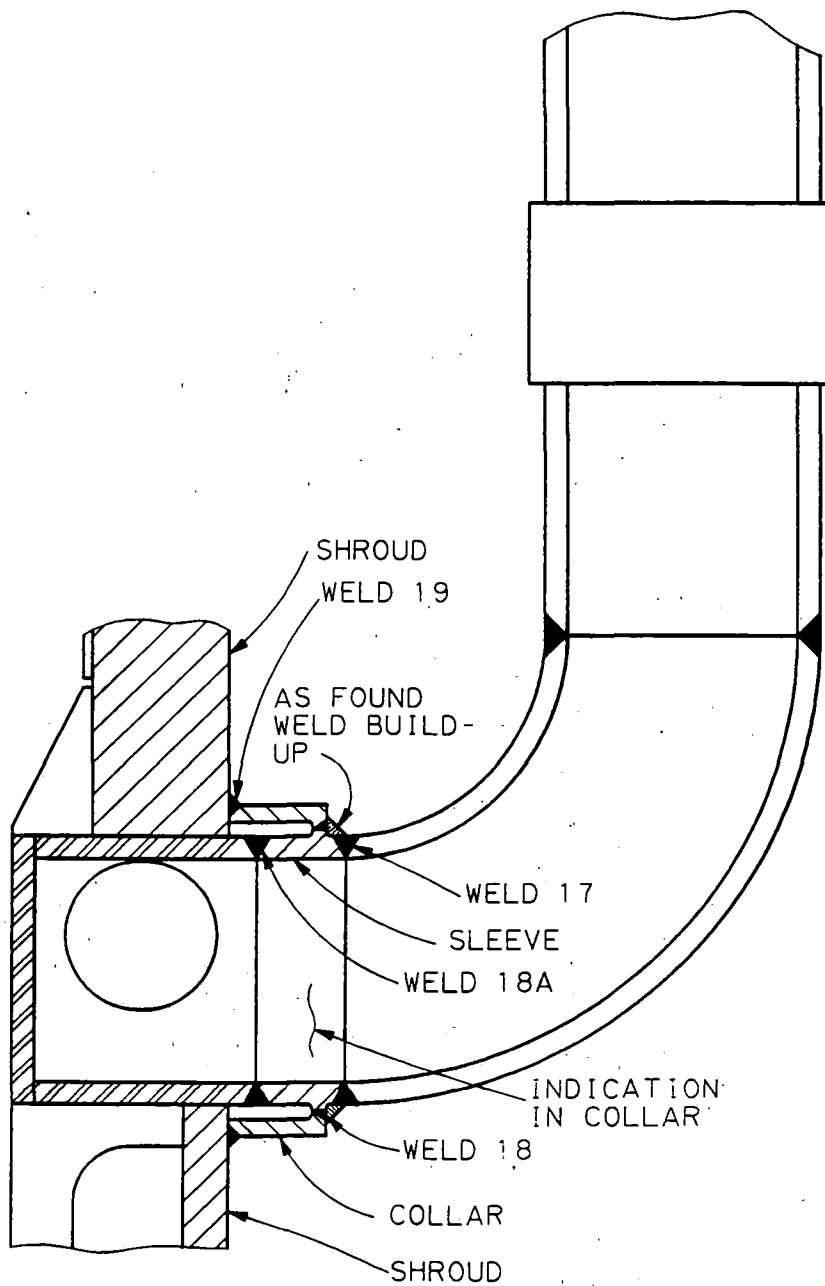
Figure 2.1 Core Spray A-Loop 290° Upper Sparger Inlet Thermal Sleeve

The enhanced visual examination detected a crack in the thermal sleeve collar, approximately 0.5 inches back from the face of the collar, between the 4:00 and 5:00 position with an estimated total length of 2 inches. The UT examination of this thermal sleeve, Figure 2.3, confirmed the presence of the crack and indicated it to be ID connected. The crack was identified by UT to extend from approximately 4:00 to 5:00 (same location as OD visual examination) with an estimated length of 2 inches. The UT examination covered 360° of the thermal sleeve circumference, with no additional flaw indications detected.

Cracks were found in the core spray loop A 290° upper sparger inlet thermal sleeve collar, the core spray loop B 260° lower sparger inlet thermal sleeve collar, and core spray loop B 260° lower sparger inlet elbow, (See Figures 2.1 and 2.2). A detailed review of the video tapes of all three crack locations revealed surface crack characteristics that were both jagged and branched. All of the cracks observed were initiated in the base material heat affected zones (HAZ). The thermal sleeve collar cracking appears to have initiated at the inside corner of the collar next to the collar to sleeve weld. The collar was machined from heavy wall tube resulting in a radius located in the HAZ, where large axisymmetric residual stresses may be present. Consequently both the appearance and location of the cracking is consistent with Intergranular Stress Corrosion Cracking (IGSCC). This particular degradation mechanism is well documented for stainless steel components exposed to the high temperature reactor water of BWRs. Several other BWRs including Dresden Unit 3 and Quad Cities 1 have reported core spray piping cracks which were identified as IGSCC.

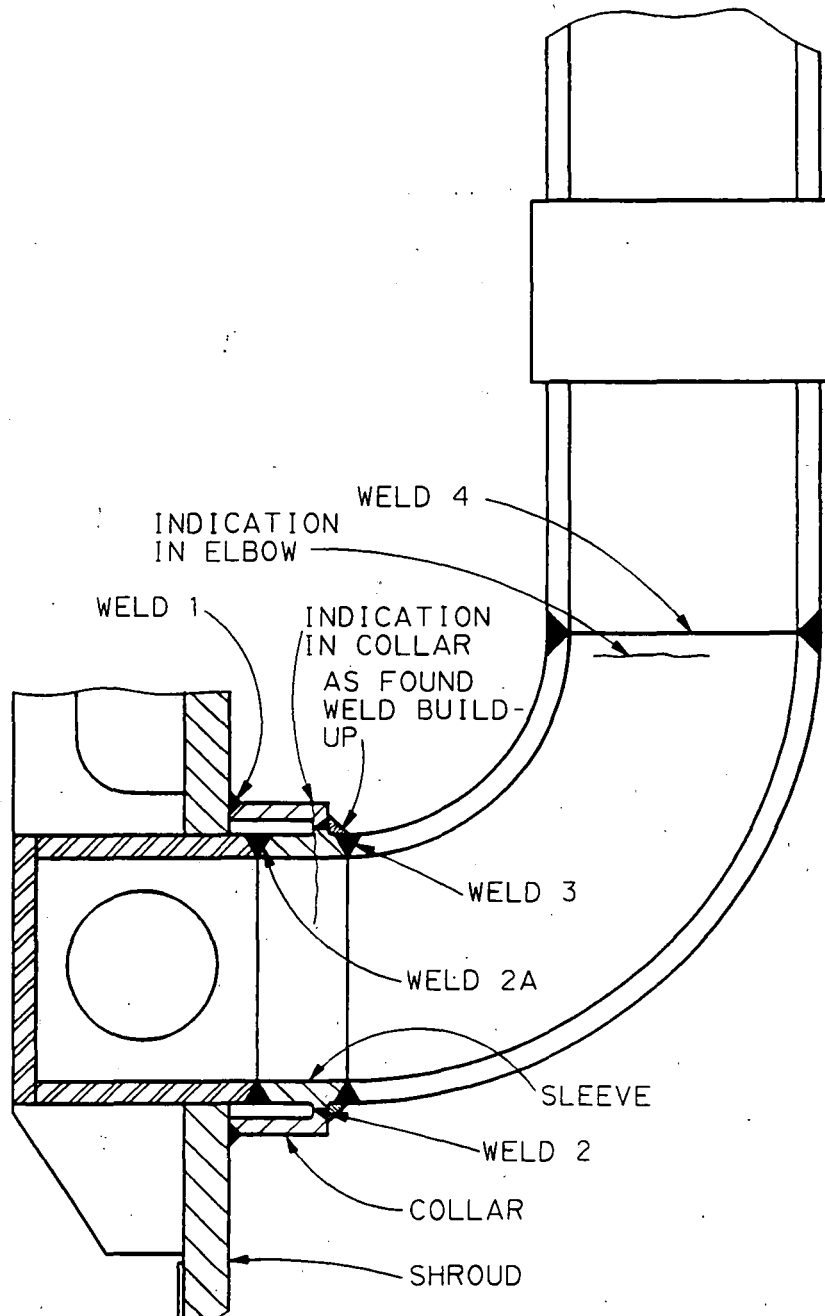
Figure 2.2 Core Spray B-Loop 260° Lower Sparger Inlet Thermal Sleeve & Elbow

The flaw is located in the thermal sleeve collar at approximately 0.5 inches back from the face of the collar adjacent to weld 2 (See Figure 2.2). The flaw is located between the 9:00 and the 10:00 position. Multiple branching was observed at the 9:00 position. The total flaw length (including the branching) is estimated to be 2.25 inches.

The flaw is located in the elbow side of the pipe to elbow weld, within the heat affected zone of weld 4 (See Figure 2.2). The flaw is located between the 9:30 position and the 12:00 position. Significant branching was observed within the length of the flaw. The total flaw length is estimated to be 3.5 inches.

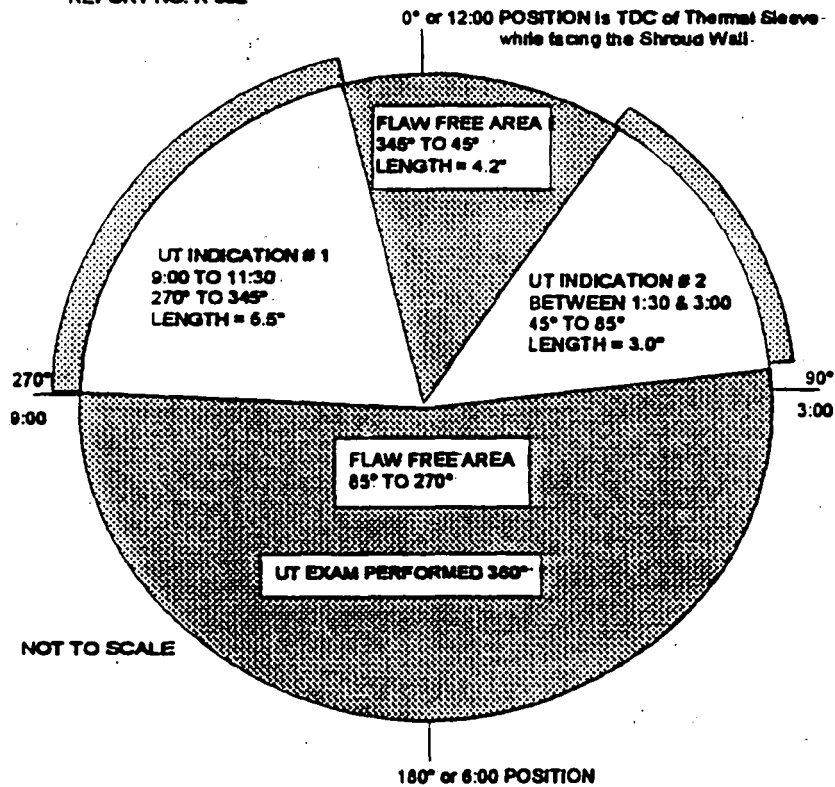
Figure 2.4 Ultrasonic Testing Examination Area And Flaw Location Thermal Sleeve Weld 2

The enhanced visual examination detected a crack in the thermal sleeve collar at approximately 0.5 inches back from the face of the collar, between the 9:00 and 10:00 positions with an estimated flaw length of 2.25 inches. The UT examination of this thermal sleeve, Figure 2.4, confirmed the presence of this crack and indicated it to be ID connected. The crack was identified by UT to extend from approximately 9:00 to 11:30 with an estimated length of 5.5 inches. The UT examination also detected another crack indication (believed to be ID connected) that was not visually detected. The crack was identified by UT to extend from approximately 1:30 to 3:00 with an estimated length of 3 inches. The UT examination covered 360° of the thermal sleeve, with no additional flaw indications detected.

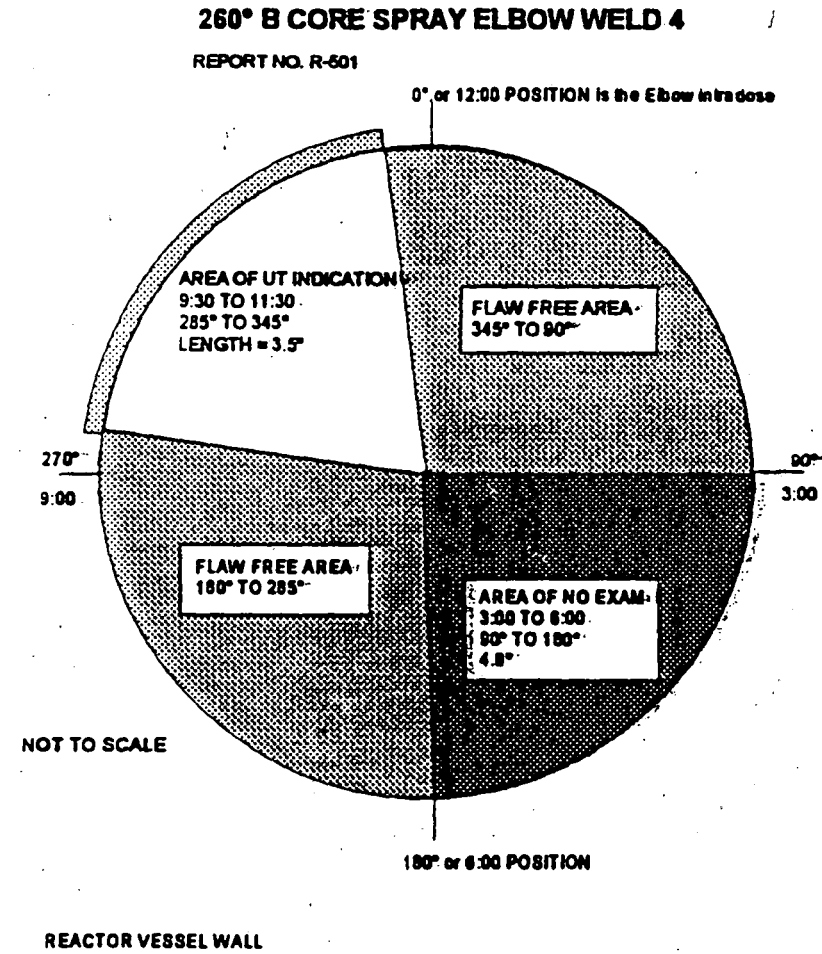
Figure 2.5 Ultrasonic Testing Examination Area And Flaw Location Elbow Weld 4

The enhanced visual examination detected a crack in the pipe to elbow weld, within the heat affected zone of weld 4, between the 9:30 and 12:00 position with an estimated length of 3.5 inches. The UT examination of this elbow weld, Figure 2.5, confirmed the presence of the crack and indicated it to be ID connected. The crack was identified by UT to extend from approximately 9:30 to 11:30 (same approximate location as OD visual examination) with an estimated length of no more than 3.5 inches. The UT examination covered approximately 270° of the elbow weld circumference, with no additional flaw indications detected.

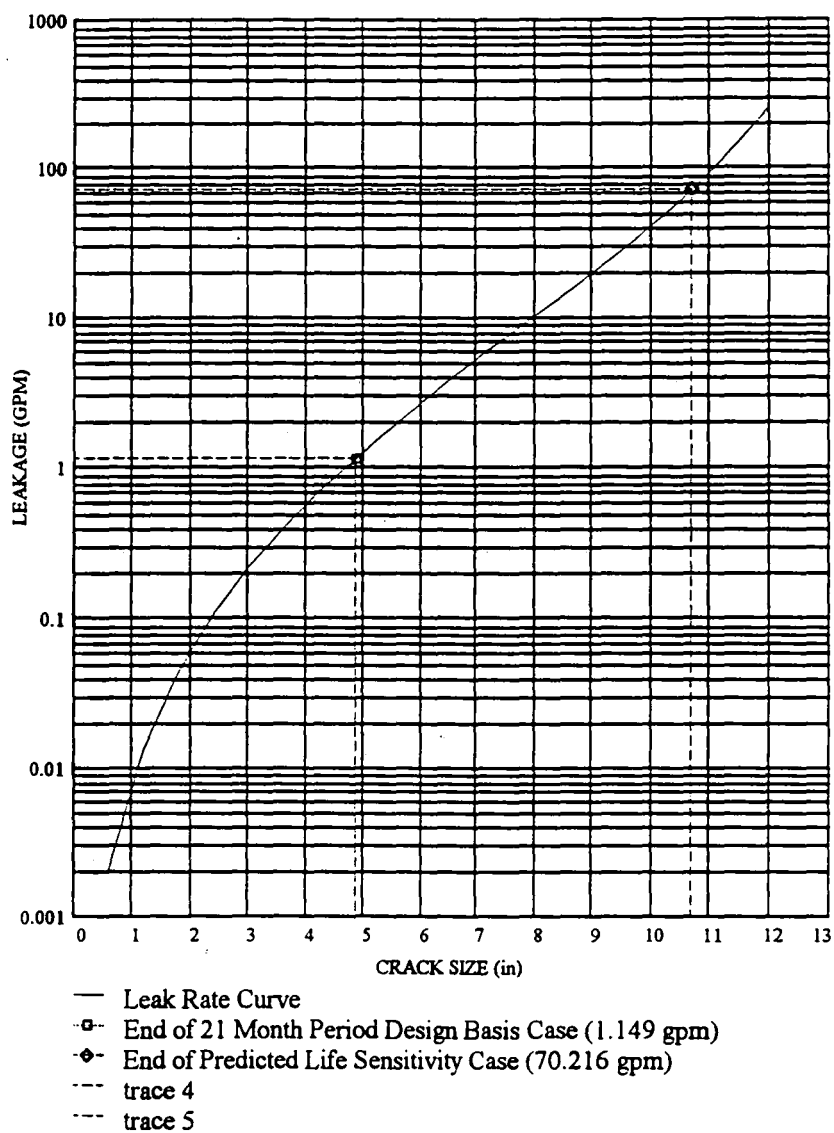
Figure 8.1 Leakage Rate at a Differential Pressure of 47psi

The leakage was calculated based on the previously described loads and material properties and presented in Figures 8.1 and 8.2 for an injection pressure of 47psid and 64 psid respectively. From Figure 8.1, the leak rate for the end of evaluation flaw size is 1.15 gpm and at the end of life is 70.22 gpm. From Figure 8.2, the leak rate for the end of evaluation flaw size is 1.38 gpm and at the end of life is 82.53 gpm. The end of life flow rates calculated here are based the conservative thermal stresses generated from a more rigid model. Since the end of life flaw length is significantly larger than the 60° flaw used in the piping model, the flexibility of the model could be increased, thus reducing the piping membrane and bending stresses and the corresponding leakage flows. The results of this leakage evaluation are compared to the system capacity in Section 9.0 of this report.
