Rev. 1
September 18, 1995

Dresden Unit 2 Integrated Evaluation Report of Core Spray Flaws

Dresden Unit 2
Core Spray Flaws Integrated Evaluation Report

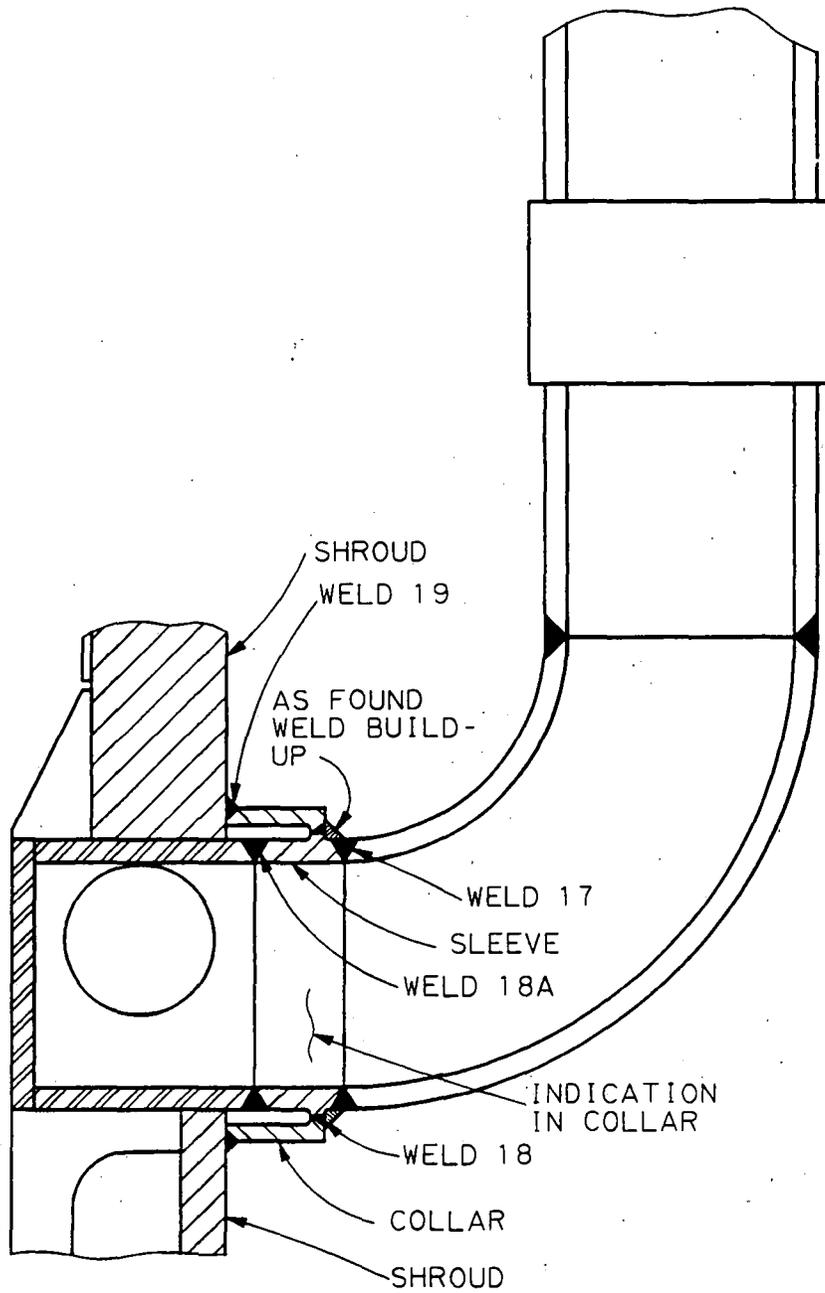
Figure 3.1 Core Spray A-Loop 290° Upper Sparger Inlet Thermal Sleeve

Crack like indications were observed at three locations on the core spray downcomers. One each in the "B" loop lower sparger inlet elbow and thermal sleeve collar, and one in the "A" loop upper sparger thermal sleeve collar. The elbow is made of stainless steel and is 6 inches in diameter. The affected piping is located in the reactor annulus between the reactor vessel wall and the core shroud wall. The elbow is not part of the reactor coolant pressure boundary nor is it part of the core shroud. The thermal sleeve collar is attached to the shroud on one side and to the 6 inch diameter pipe on the other side. The thermal sleeve collar has the function of providing a leakage seal between the pipe and the annulus as shown in Figures 2.1 and 2.2. All three of the indications are circumferential.

A detailed review of the video tapes of all three crack locations revealed surface crack characteristics that were both jagged and branched. All of the cracks observed were initiated in the austenitic stainless steel base material heat affected zones (HAZ). Consequently, the appearance and location of the cracking is consistent with Intergranular Stress Corrosion Cracking (IGSCC). This particular degradation mechanism is well documented for stainless steel components exposed to the high temperature reactor water of BWRs. Several other BWRs, including Dresden 3 and Quad Cities 1 have reported core spray piping cracks which were identified as IGSCC.

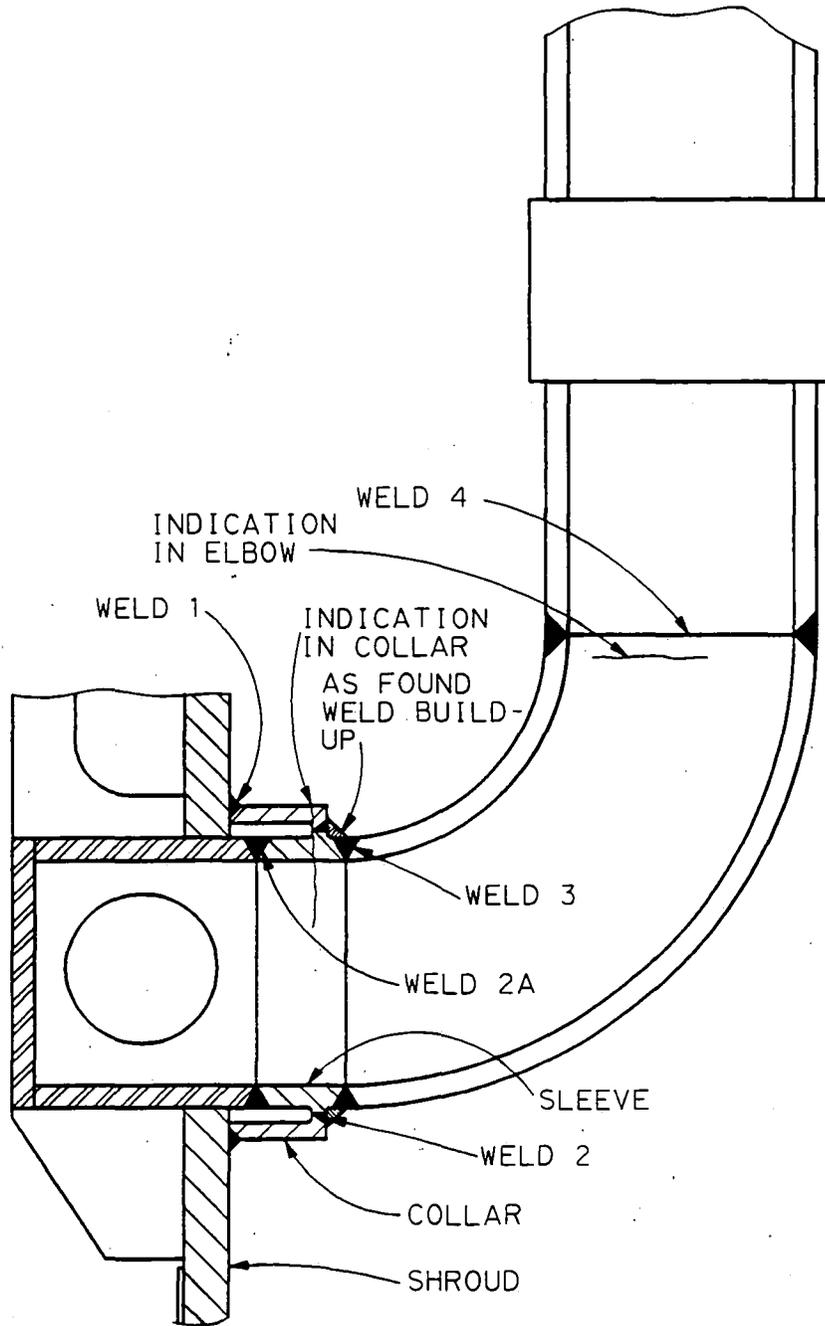
Figure 3.2 Core Spray B-Loop 260° Lower Sparger Inlet Thermal Sleeve & Elbow

The details of the visual and ultrasonic examination results are defined in Section 2 of this report. The critical flaw identified was a 3.5 inch long crack in the B-loop inlet elbow. This crack was conservatively assumed to be through wall and was extended using a bounding IGSCC crack growth rate of 5.0×10^{-5} for a 21 month operating cycle to a evaluated flaw length of 4.86 inches. The UT methodology developed and utilized as part of the flaw characterization was prequalified and independently verified by industry experts. The approach and methods used represent the best available in the industry and provide an accurate basis for performing a flaw evaluation.

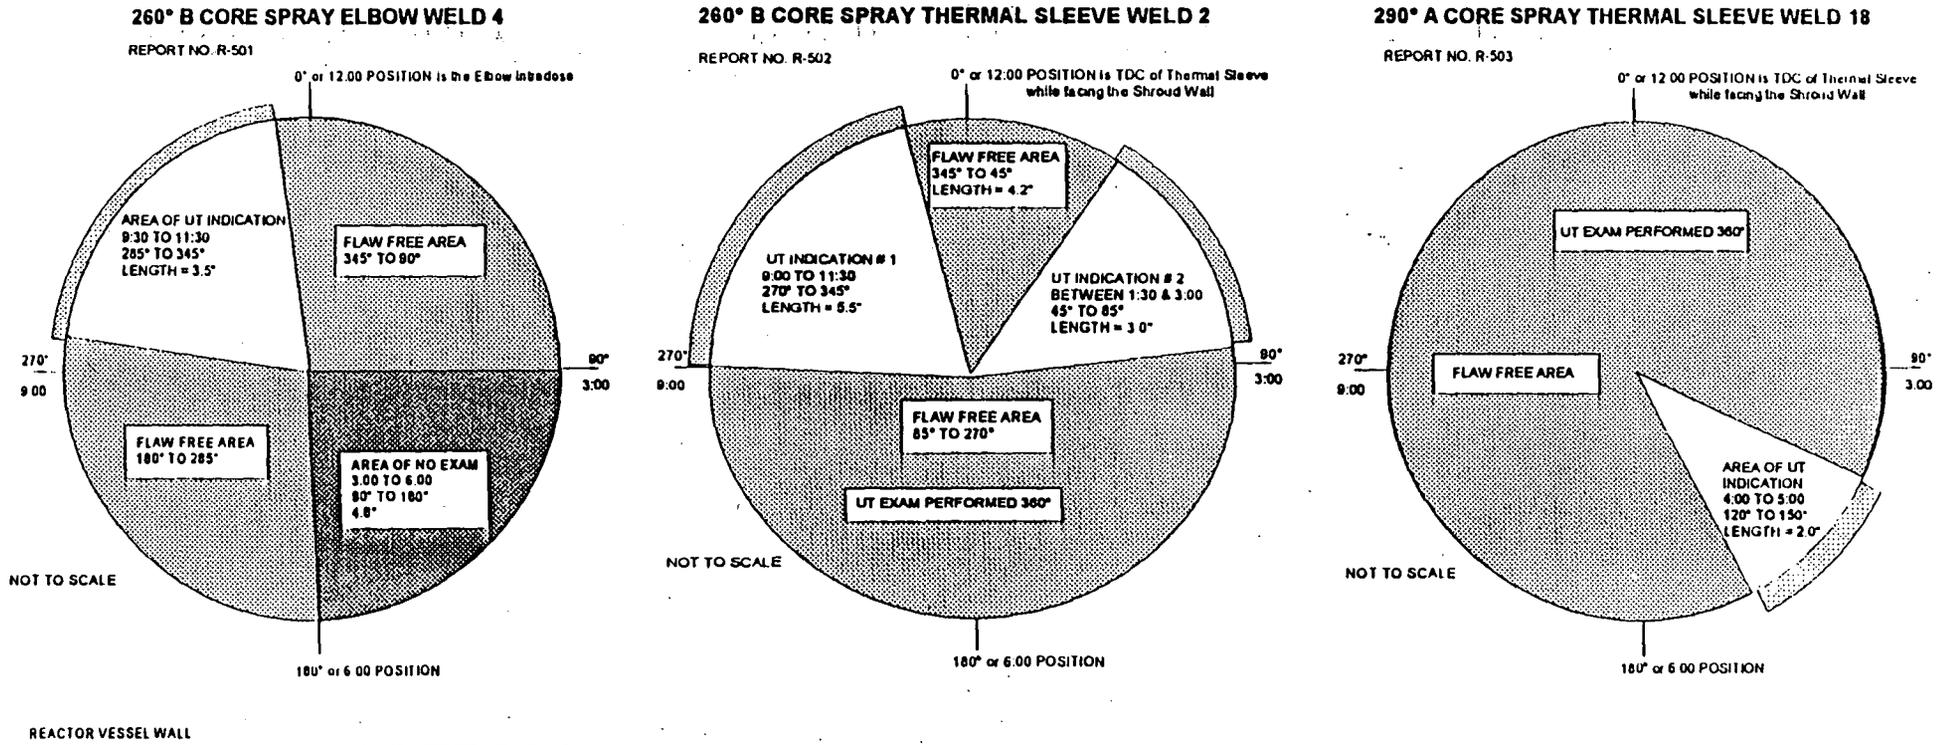
Figure 3.3 Ultrasonic Testing Examination Results

A description of the examination details and results is provided in Section 2 of Reference 1. Figure 3.3 provides a summary of the bounding UT examination results.
