# STRUCTURAL FLAW EVALUATION OF HEAD FLANGE WELD AT DRESDEN NUCLEAR POWER STATION, UNIT 2

### STRUCTURAL FLAW EVALUATION OF HEAD FLANGE WELD AT DRESDEN NUCLEAR POWER STATION, UNIT 2

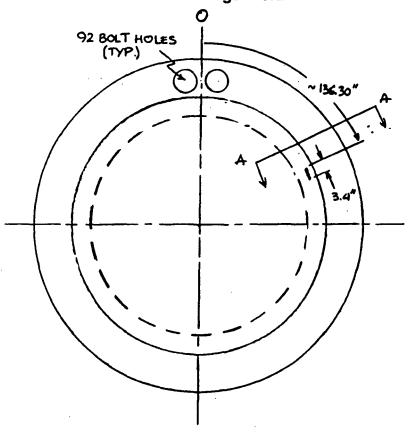
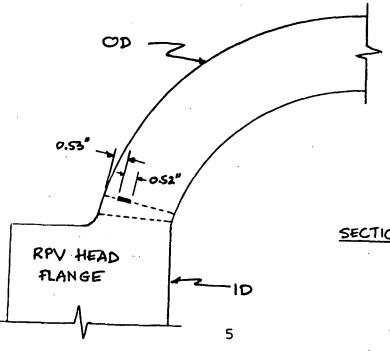
SECTION A-A

No recordable indications were detected by MT. However, one subsurface flaw exceeding the acceptance criteria delineated in subarticle IWB-3510 of ASME Section XI, 1989 Edition was detected by UT in the RPV Head-to-Flange weld. This flaw exhibits typical characteristics of slag inclusions; such as flaw location in the fusion zone, series of small reflectors, wide and low amplitude signal responses, and signal responses to straight beam examination. Based on these examination results, this flaw is considered to be an original construction flaw which was not service induced. However, because the slag inclusion exceeded the acceptance standards of the Code a flaw evaluation based on the requirements of Reference 2 was performed.

Planar depth (2a for subsurface flaw):	0.52"
Distance from OD surface (S):	0.53"
Length:	3.40"

See Figure 2.1 for a graphical presentation of this flaw.

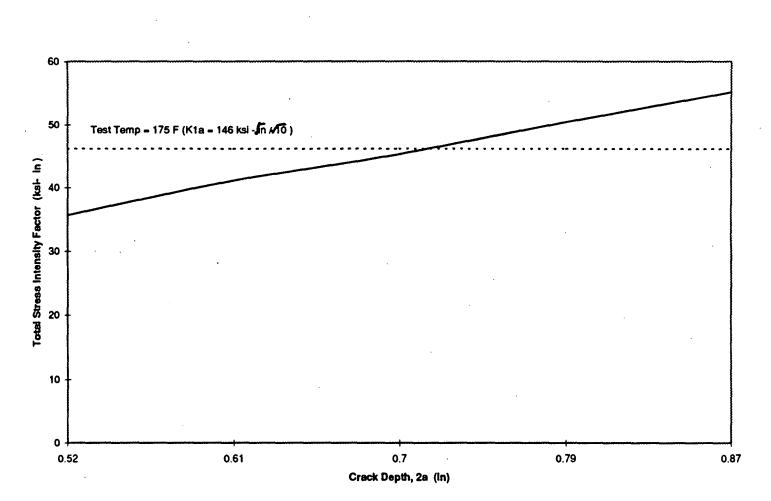
Figure 4.1 K vs. 2a for Pressure Test Condition

The stress intensity factor K<sub>1</sub> for the detected flaw geometry is calculated based on the flat plate model provided in Article A-3000 of the ASME code (Ref. 2). The radius to thickness (R/t) ratio for the head flange region is about 30, therefore the effect of RPV head curvature is negligible. The total stress intensity at the flaw location is 35.7 ksi- $\sqrt{i}$ n, which is less than the allowable K<sub>1</sub> of 46.0 ksi $\sqrt{i}$ n provided in the 1990 analysis. The allowable K<sub>I</sub> was based on: (i) the top head RT<sub>NDT</sub> of 20°F and the required test temperature of 175°F at 1171 psi, and (ii) a safety factor of  $\sqrt{10}$  for normal conditions (including upset and test conditions). It should be pointed out here that this allowable K<sub>1</sub> is conservative for the flaw evaluation. Since the top head experiences little irradiation embrittlement effects, the fracture toughness requirement of the vessel is largely determined by the K<sub>1</sub> value of the vessel in the active fuel region (beltline). As fluence accumulation in the beltline increases, the shift in fracture toughness would require increasing test pressure temperature above 175°F. This, in turn, increases the allowable K<sub>1</sub> value used for the evaluation in accordance with Figure A-4200-1 of the Code. Table 4.1 shows the stress intensity factors for other flaw sizes which are calculated based on the following assumptions: (i) same aspect ratio as the detected flaw, i.e. a/I = 0.076, (ii) the growth direction of the flaw depth is radially outward towards the O.D. surface where the bending stress is highest. In the table, the flaw depth of 0.87 inch is the maximum depth that the flaw can reach and still be classified

as subsurface flaw according to ASME code Section IWB-3600. These results are plotted in Figure 4.1 and the maximum allowable flaw depth is 0.715 inch.
