U.S. NUCLEAR REGULATORY COMMISSION

REPORT NOS. 50-237/249/96007(DRS); 50-254/265/96007(DRS)

Dresden Nuclear Station, Units 2 and 3  
Quad Cities Nuclear Station, Units 1 and 2  
License Nos. DPR-19; DPR-25; DPR-29; DPR-30

Predecisional Enforcement Conference  
May 1, 1996  
Region III Office  
801 Warrenville Road  
Lisle, IL 60532-4351

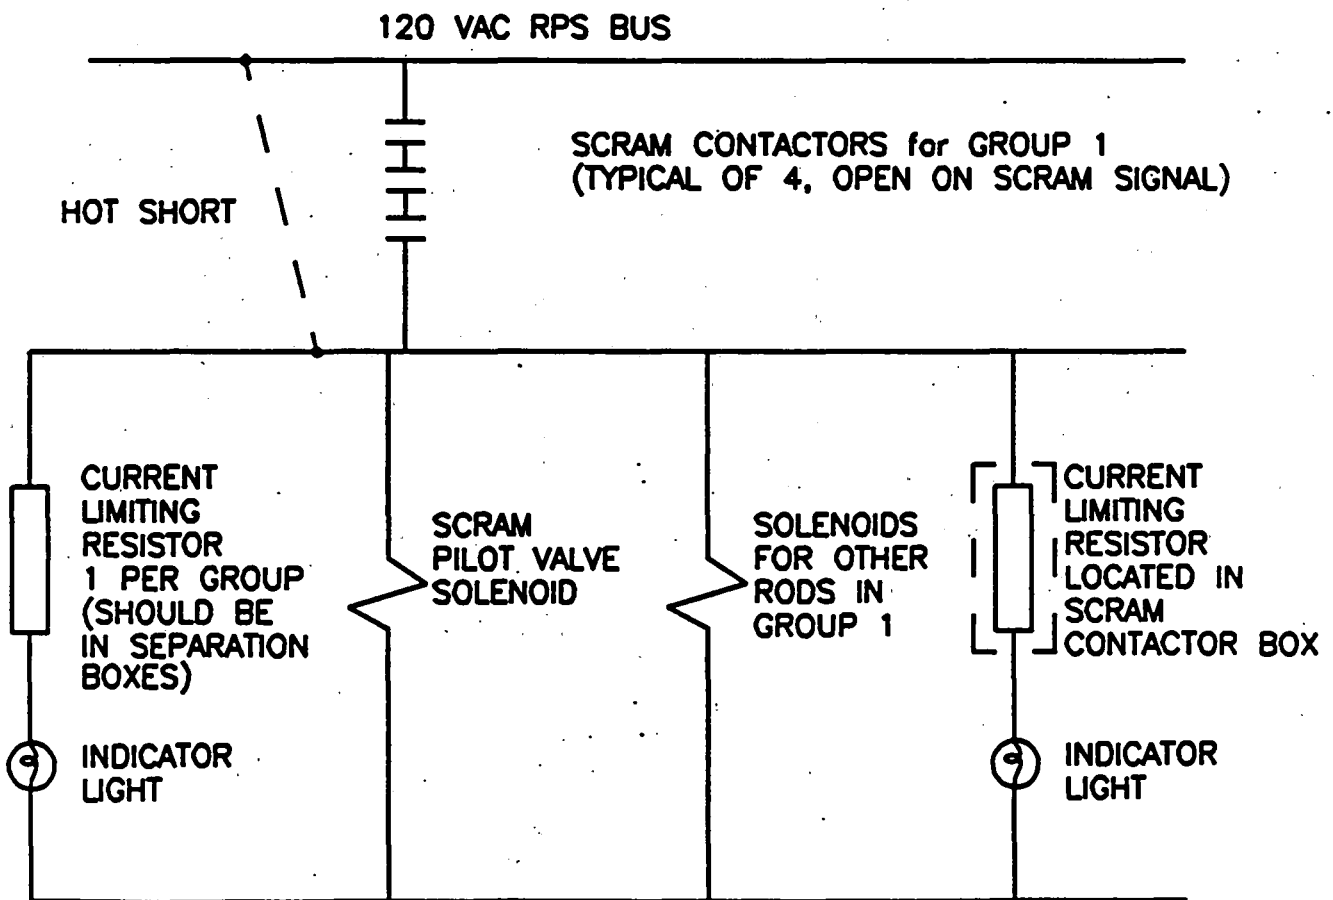
SCRAM PILOT VALVE SOLENOID CIRCUIT  
(TYPICAL OF "A" AND "B".)

- **GE Notifies Dresden of Potential Inadequate Separation in RPS**
