NRC FORM 366 (5-92)		U.S. NUCLEAR REGULATORY COMMISSION			APPROVED BY OMB NO. 3150-0104 EXPIRES 5/31/95					
<b>LICENSEE EVENT REPORT (LER)</b>										
FACILITY NAME (1) Dresden Nuclear Power Station, Unit 2					DOCKET NUMBER (2) 05000237		PAGE (3) 1 OF 8			
TITLE (4) Unit 2 Shutdown Performed Because of Inability to Meet Allowed LCO Time for High Pressure Coolant Injection System Testing										
EVENT DATE (5)			LER NUMBER (6)			REPORT DATE (7)			OTHER FACILITIES INVOLVED (8)	
MONTH	DAY	YEAR	YEAR	SEQUENTIAL NUMBER	REVISION NUMBER	MONTH	DAY	YEAR	FACILITY NAME	DOCKET NUMBER
04	18	96	96	-- 002 --	00	05	16	96	None	
OPERATING MODE (9)		N	THIS REPORT IS SUBMITTED PURSUANT TO THE REQUIREMENTS OF 10 CFR §: (Check one or more) (11)							
POWER LEVEL (10)		001	20.2201(b)			20.2203(a)(3)(i)		50.73(a)(2)(iii)		73.71(b)

Unit 2 Shutdown Performed Because of Inability To Meet Allowed LCO Time for High Pressure Coolant Injection System Testing.

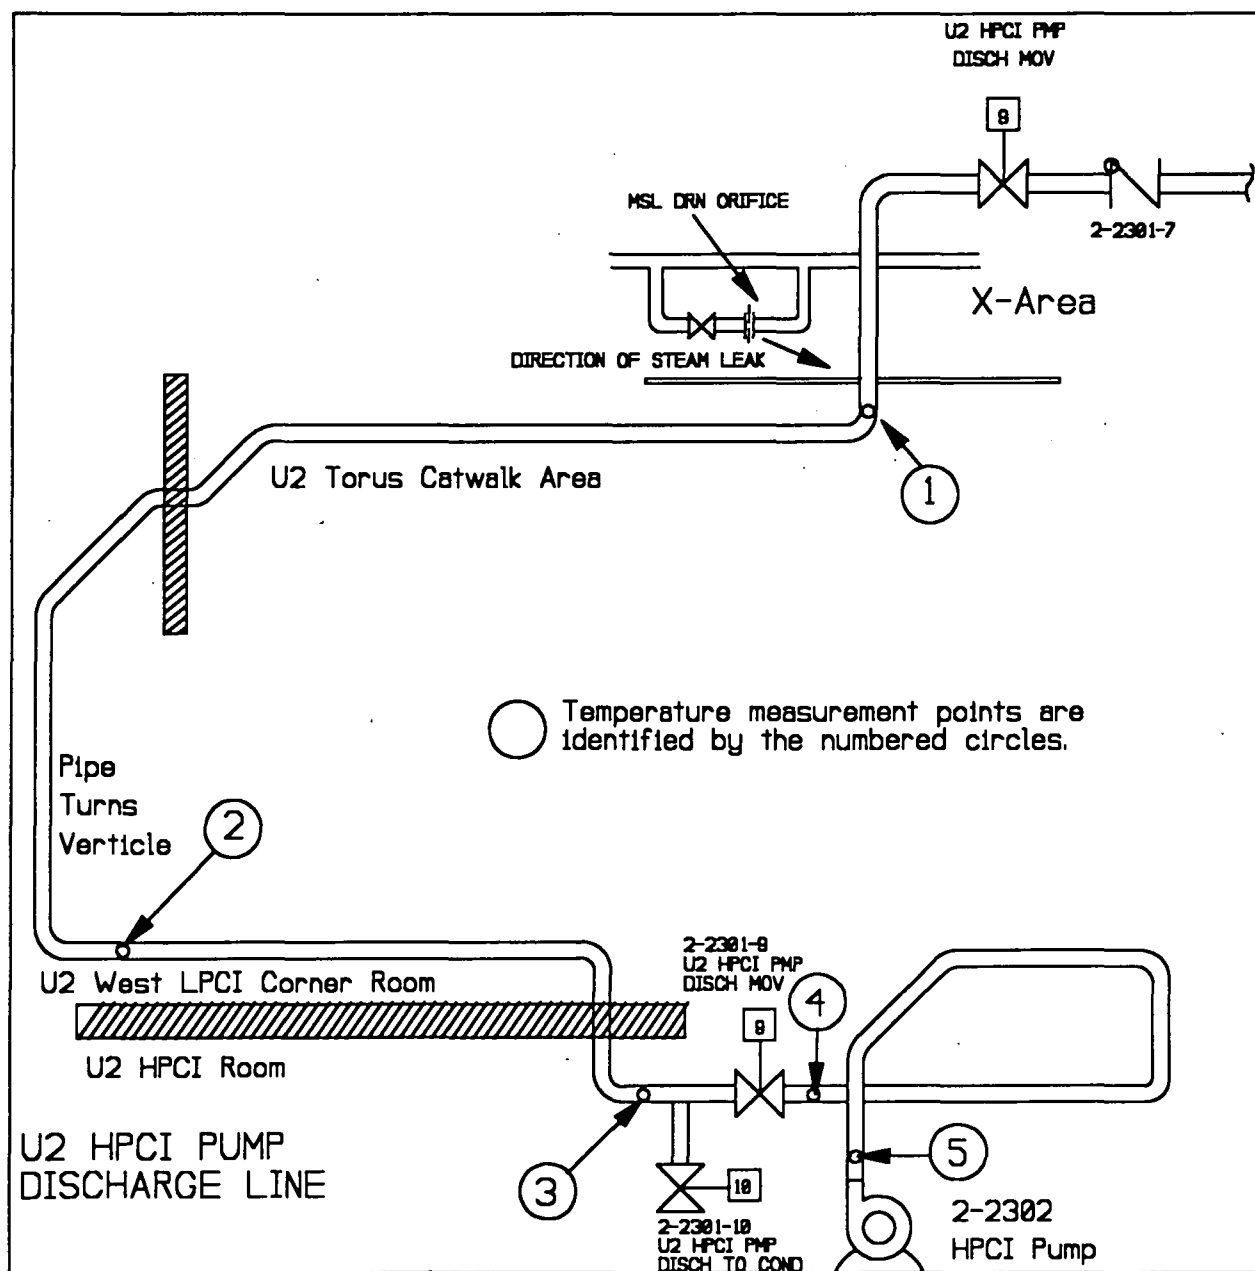
FIGURE 1  
UNIT 2 HPCI PUMP DISCHARGE LINE

An Engineering analysis of the data indicates that some minor leakage through the 2-2301-07 check valve, past the open 2-2301-8 valve, and through the 2-2301-10 valve, may have been occurring. The leakage, known to be less than .5 gpm, was derived by the performance of an augmented leak test during D2R14. This test also determined that there was no leakage past the 2-2301-8 or 2-2301-9 valves. Additionally, thermal conductive heat transfer from the check valve back through the 2-2301-8 valve in the normally insulated line can account for some of the temperature gradient that has been observed. However, various hand-held pyrometer readings taken in the X-area on 4/23/96 shows conclusively that voiding was not occurring in the HPCI injection piping in the X-area. Additionally, temperature readings taken at Points 2,3,4 and 5 (Figure 1) showed conclusively that voiding was not occurring in the HPCI piping located in the HPCI room.

The cause of this event was as a result of a combination of two problems: (1) steam leakage impinging on the HPCI discharge line piping, which produced an inaccurate and higher than actual thermocouple indication, and (2) some minor leakage past the 2-2301-7 check valve, the open 2-2301-8 valve, and the 2-2301-10 valve, which was previously calculated to be less than .5 gpm, as determined by a leak test during D2R14.

Engineering will relocate the Pt.1 thermocouple away from the floor slab and onto the elbow in the torus to provide a more representative indication of fluid temperature in the HPCI piping in the Torus area. (2371809600202)
