Subject: Dresden Nuclear Power Station, Unit 3  
Weld Overlay on RWCU Non-Regenerative Heat Exchanger 3-1204AB  
Tubeside Inlet Nozzle.  
NRC Docket No. 50-249

**ComEd Response to  
NRC's REQUEST FOR ADDITIONAL INFORMATION  
CONCERNING THE REACTOR WATER CLEANUP SYSTEM HEAT  
EXCHANGER REPAIR**

**COMMONWEALTH EDISON COMPANY  
DRESDEN NUCLEAR POWER STATION, UNIT 3  
DOCKET NO. 50-249**

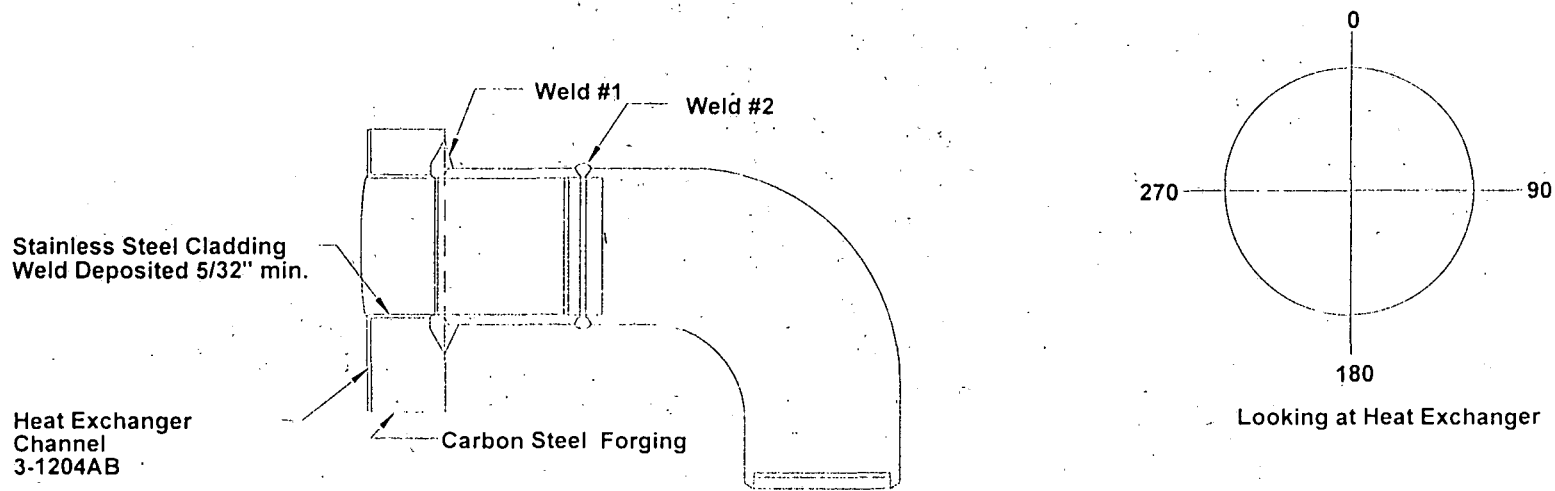
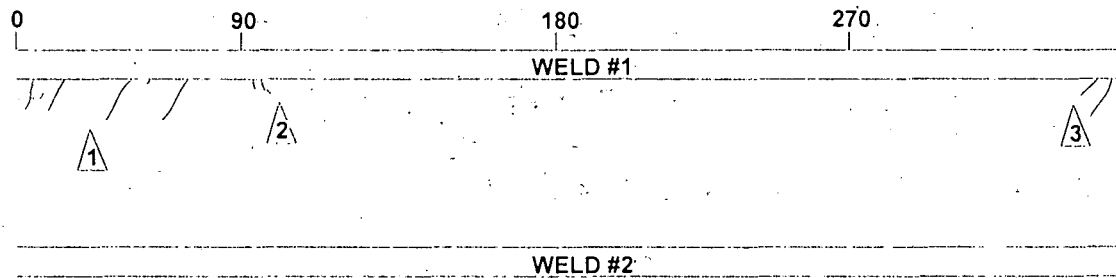
**Figure 1**  
**Through Wall Indications on 3-1204-AB Inlet Nozzle**

Response: The attached Figure No. 1 contains a map and description of the flaws. The two indications closest to 0° in area 1 of this report are believed to be the throughwall flaws. Positive identification of throughwall flaws was not made since the flaws were not excavated.

- ① 5 linear indications ranging in size from 1/8" to 1". Indications extend from the toe of the weld on the pipe side.
- ② 2 linear indications ranging in size from 1/4" to 5/8". Indications extend from the toe of the weld on the pipe side.
- ③ 2 linear indications ranging in size from 3/16" to 3/4". Indications extend from the toe of the weld on the pipe side at approximately 350 degrees.

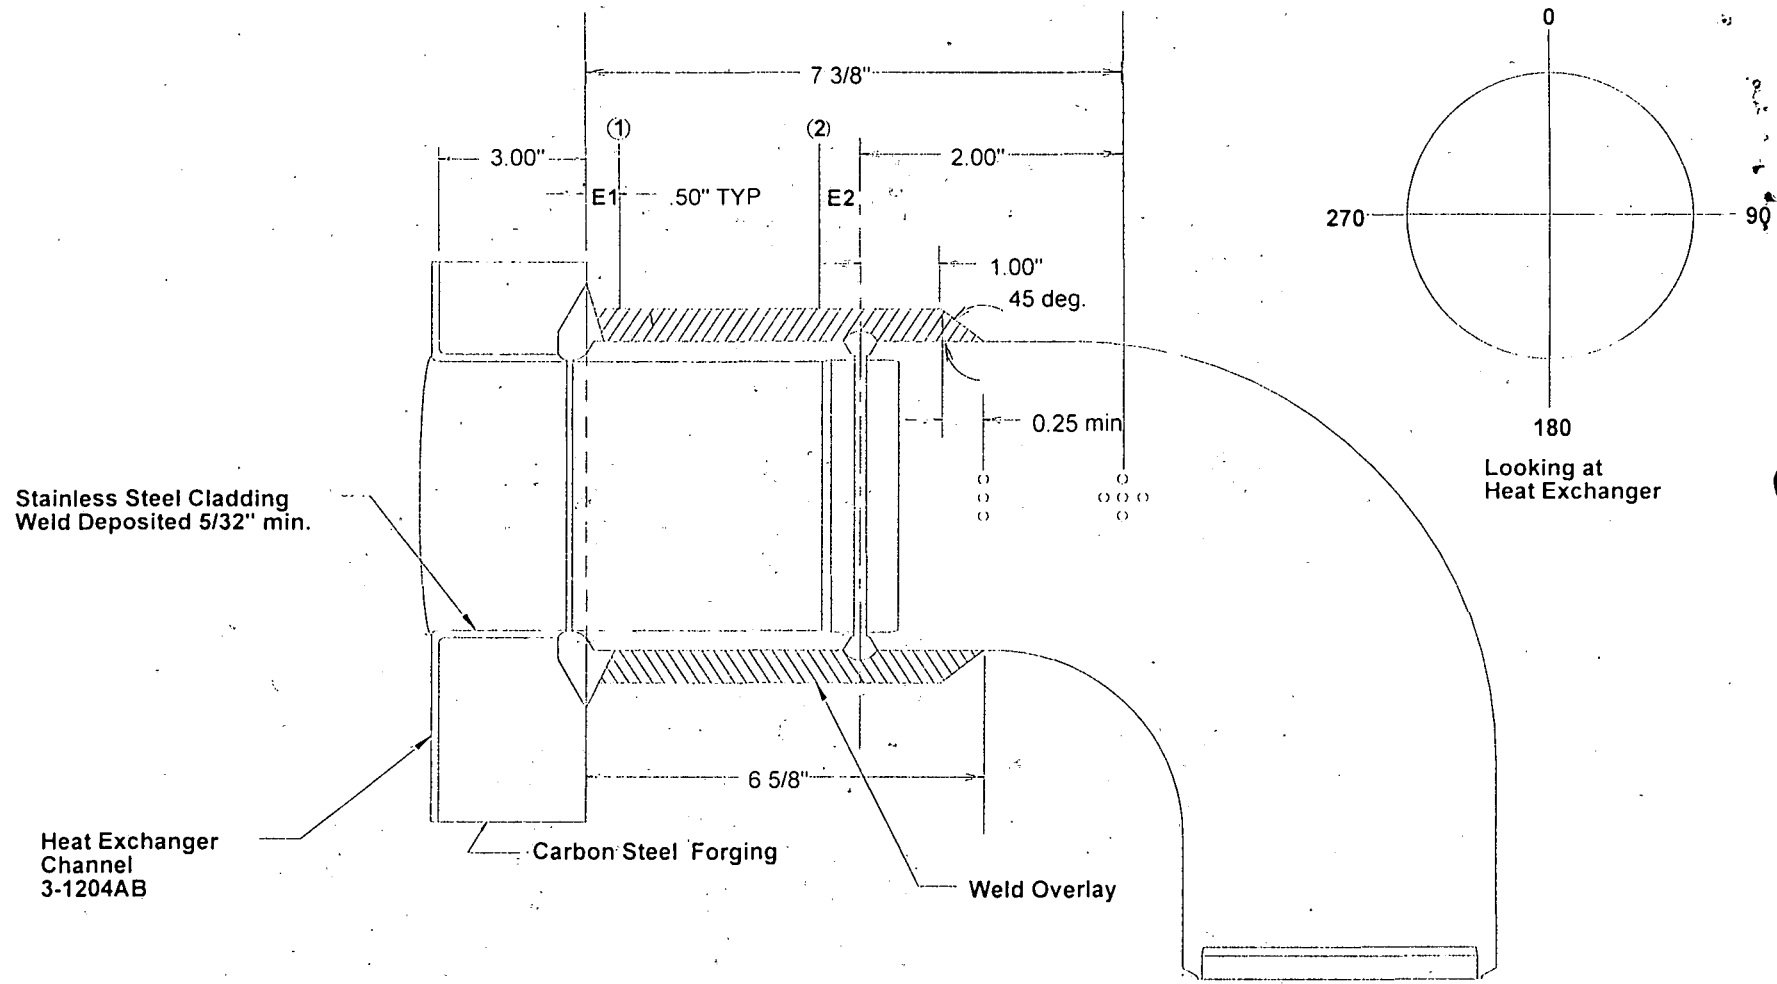
Figure 2  
As Measured Overlay Dimensions

Response: The as-measured weld overlay dimensions are provided in Figure No. 2.

THICKNESS MEASUREMENT AFTER FIRST 2 LAYERS

0	90	180	270
(1)	0.566	0.581	0.561	0.591
(2)	0.521	0.506	0.465	0.495

FINAL THICKNESS MEASUREMENT

0	90	180	270
(1)	0.891	0.966	0.986	0.916
(2)	0.816	0.901	0.896	0.891
