Subject: Dresden Nuclear Power Station, Unit 3
Weld Overlay on RWCU Non-Regenerative Heat Exchanger 3-1204AB
Tubeside Inlet Nozzle.
NRC Docket No. 50-249

ComEd Response to NRC's REQUEST FOR ADDITIONAL INFORMATION CONCERNING THE REACTOR WATER CLEANUP SYSTEM HEAT EXCHANGER REPAIR

**COMMONWEALTH EDISON COMPANY
DRESDEN NUCLEAR POWER STATION, UNIT 3
DOCKET NO. 50-249**

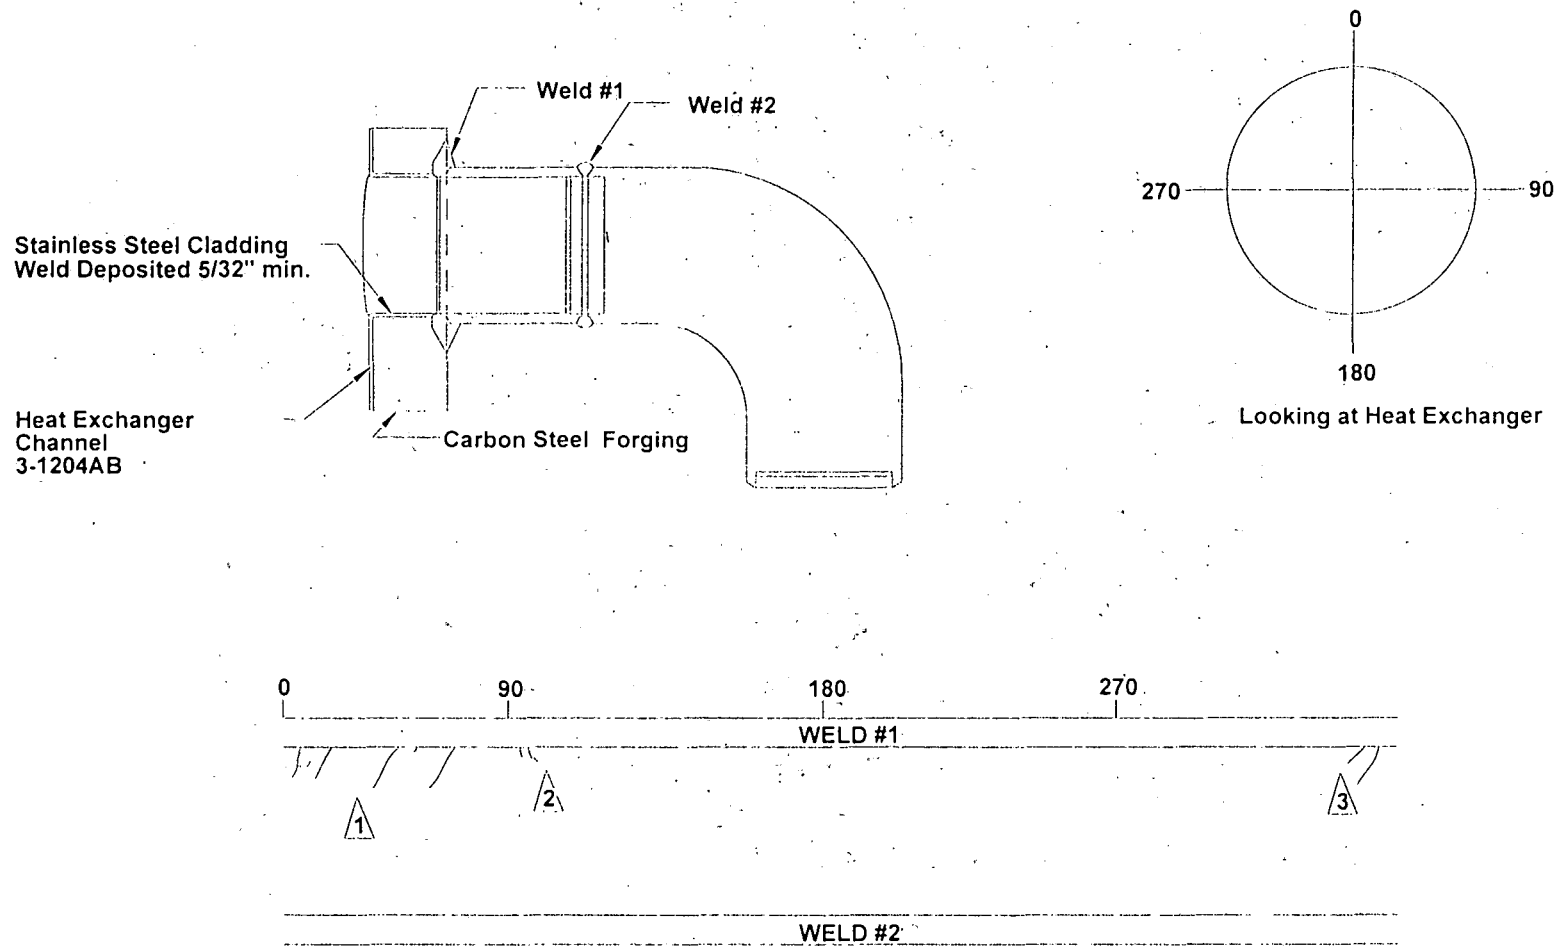
Figure 1
Through Wall Indications on 3-1204-AB Inlet Nozzle

Response: The attached Figure No. 1 contains a map and description of the flaws. The two indications closest to 0° in area 1 of this report are believed to be the throughwall flaws. Positive identification of throughwall flaws was not made since the flaws were not excavated.

- ① 5 linear indications ranging in size from 1/8" to 1". Indications extend from the toe of the weld on the pipe side.
- ② 2 linear indications ranging in size from 1/4" to 5/8". Indications extend from the toe of the weld on the pipe side.
- ③ 2 linear indications ranging in size from 3/16" to 3/4". Indications extend from the toe of the weld on the pipe side at approximately 350 degrees.

Response: A seal layer was used to seal the through-wall flaws and other surface flaws.

Response: The design and fabrication of the weld overlay repair met the requirements of code case N-504-1 without exception. The overlay design thickness met the requirements of IWB-3640 for 100% through-wall flaws. The overlay design axial length and taper met the $.75\sqrt{Rt}$ and 45°, respectively. Details of the overlay fabrication are provided in the responses to questions 3 - 8 and demonstrate compliance with the fabrication requirements of the code case.

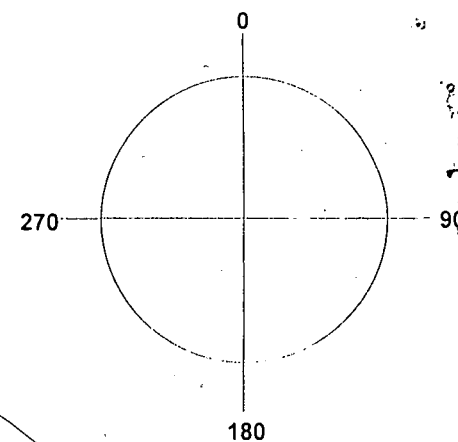
Figure 2
As Measured Overlay Dimensions

Response: The as-measured weld overlay dimensions are provided in Figure No. 2.

THICKNESS MEASUREMENT AFTER FIRST 2 LAYERS

0	90	180	270
(1)	0.566	0.581	0.561	0.591
(2)	0.521	0.506	0.465	0.495

FINAL THICKNESS MEASUREMENT

0	90	180	270
(1)	0.891	0.966	0.986	0.916
(2)	0.816	0.901	0.896	0.891
