Subject: Dresden Nuclear Power Station, Unit 3
Core Shroud Examination Final Results
NRC Docket No. 50-249

DRESDEN UNIT 3 CORE SHROUD EXAMINATION FINAL RESULTS

GE NUCLEAR ENERGY - ROOT CAUSE EVALUATION OF CORE PLATE SUPPORT
RING VERTICAL CRACKING

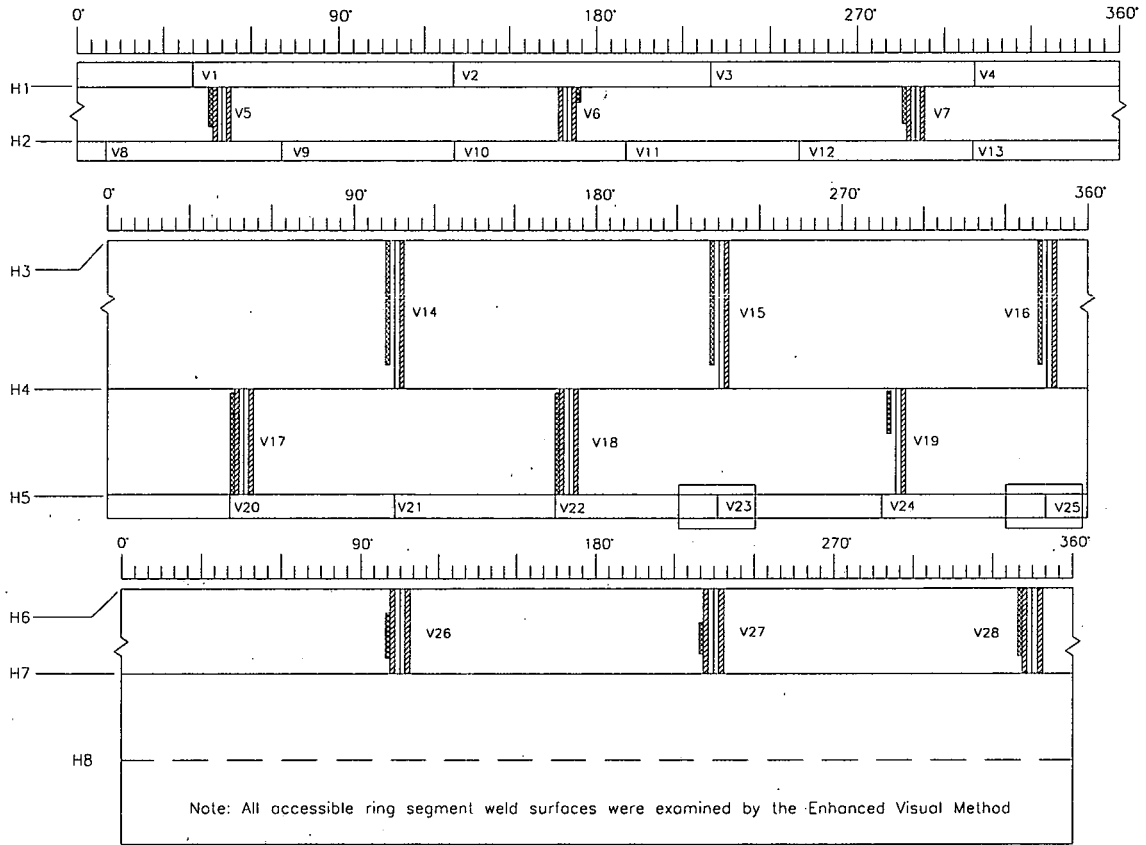
DRESDEN UNIT 3 CORE SHROUD EXAMINATION ROLL OUT

- The ultrasonic examination scope consisted of shroud vertical welds V5 through V7 (located between the H1 and H2 circumferential welds), V14 through V19 (located in the beltline region between circumferential welds H3 and H5), and V26 through V28 (located between circumferential welds H6 and H7). A total of 551 inches of the 760 inches of total cumulative vertical weld length (or 72.5%) was examined by at least one search unit from one side of the weld. Individual UT length coverage of all 12 vertical shroud welds ranged from between 34% and 96% per weld. These examinations resulted in no reportable indications.

- The enhanced visual examination scope consisted of the ring segment welds associated with the shroud head flange ring (V1 through V4), top guide support ring (V8 through V13), and core plate support ring (V20 through V25); the H8 and H9 circumferential welds at the shroud repair hardware locations; and the OD surface of all 12 vertical shroud welds on the side of the weld opposite from the UT search unit. These examinations resulted in no reportable indications in the area of interest.

Component	Area Inspected	Inspection Results
Shroud Head Flange Ring Segment Welds: V1 Through V4	Enhanced visual examination of ~ 12" length of ring material encompassing each weld. Inspected OD, ID and top of ring.	No Reportable Indications
Top Guide Support Ring Segment Welds: V8 Through V13	Enhanced visual examination of ~ 12" length of ring material encompassing each weld. Inspected OD, ID and bottom of ring.	No Reportable Indications in Area of Interest
Core Plate Support Ring Segment Welds: V20 Through V25	Enhanced visual examination of ~ 12" length of ring material encompassing each weld. Inspected OD and bottom of ring. Supplemental UT examination of V23 and V25	See Note 1
Vertical Welds V5 Through V7 (Between H1 & H2)	Ultrasonic examination of between 34% and 69% of the length of each weld. Enhanced visual examination of entire weld length from shroud OD on side of weld opposite of UT search unit.	No Reportable Indications

Vertical Welds: V14 Through V19 (Beltline Area)	Ultrasonic examination of between 40% and 95% of the length of each weld. Enhanced visual examination of entire weld length from shroud OD on side of weld opposite of UT search unit.	No Reportable Indications
Vertical Welds: V26 Through V28 (Between H6 and H7)	Ultrasonic examination of between 47% and 75% of the length of each weld. Enhanced visual examination of entire weld length from shroud OD on side of weld opposite of UT search unit.	No Reportable Indications
Jet Pump Support Plate to Shroud Support Ring Weld H8	Enhanced visual examination of ~ 12" of weld in area of repair hardware attachments at 4 locations: 20°, 110°, 200°, and 290° azimuths.	No Reportable Indications
Jet Pump Support Plate to RPV Weld H9	Enhanced visual examination of ~ 12" of weld in area of repair hardware attachments at 4 locations: 20°, 110°, 200°, and 290° azimuths.	No Reportable Indications

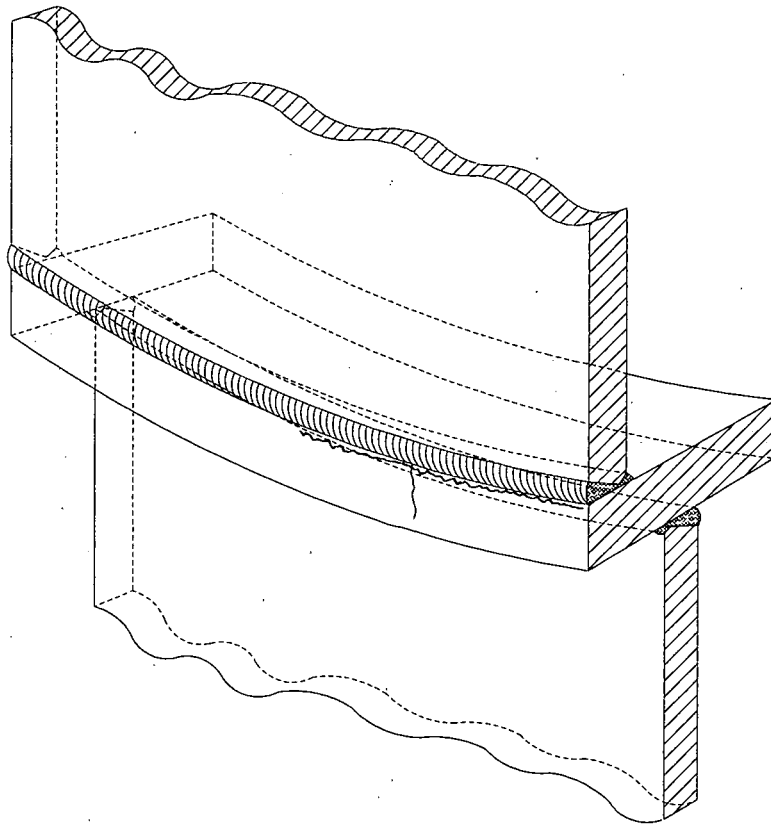
CORE PLATE SUPPORT RING INDICATION (TYPICAL)

The vertically oriented cracking identified in the vicinity of the V23 and V25 ring segment welds was contained in an area of heavy localized grinding on the OD surface of the ring. The cracking is confined to this area of localized grinding and branches down from the circumferentially oriented cracking in the lower heat affected zone (HAZ) of the H5 weld (see Figure 2).

- V23 - 2.8 inches in vertical length extending downward from the H5 circumferential weld. Maximum radial through wall depth was 0.50 inches, with average depth between 0.25 inches and 0.40 inches.
- V25 - Exact vertical length could not be determined due to shallow depth and flaw orientation, however, the area of flaw length sized was 1.2 inches in vertical length extending downward from the H5 circumferential weld. Maximum radial through wall depth was 0.25 inches, with average depth between 0.15 inches and 0.25 inches.

Note 1: Vertically oriented cracking was identified visually in the vicinity of the V23 and V25 ring segment welds. Supplemental UT sizing provided the following information:

V23 - 2.8 inches in vertical length extending downward from the H5 circumferential weld. Maximum radial through wall depth was 0.50 inches, with average depth between 0.25 inches and 0.40 inches.

V25 - Exact vertical length could not be determined due to shallow depth and flaw orientation, however, the area of flaw length sized was 1.2 inches in vertical length extending downward from the H5 circumferential weld. Maximum radial through wall depth was 0.25 inches, with average depth between 0.15 inches and 0.25 inches.

Austenitic stainless steels susceptibility to IGSCC crack initiation are influenced by several factors. The most common contributors in un-creviced geometries are HAZ sensitization due to welding and surface cold work. For the two locations in the core support plate ring with vertical crack indications, many of the surface features support the case that this cracking is associated with localized grinding leading to cold working which in turn served to initiate IGSCC. These features include the visual appearance of the surface, some of the branching characteristics of the crack and the UT measured crack depths. The other important factor that supports this mechanism for crack initiation is the apparent absence of a vertical weld in the area of cracking. Without a weld, there is no ring segment HAZ that would have led to sensitization. The absence of a weld is based on the UT examination which did not show the presence of a weld. This examination technique has been shown to be effective in detecting ring segment welds with no weld crown. The absence of a weld is also supported by the behavior of the H5 crack which traveled through the ground region in the V23 region. Based on this information, it is reasonable to conclude that these crack indications were initiated by cold working and surface condition and were not located in the weld sensitized HAZ associated with the core plate ring segment welds.
