Commonwealth Edison Company
Dresden Generating Station
6500 North Dresden Road
Morris, IL 60450
Tel 815-942-2920

Subject: Dresden Nuclear Power Station, Unit 3
Core Shroud Examination Final Results,
Revision 1.
NRC Docket No. 50-249

DRESDEN UNIT 3 CORE SHROUD EXAMINATION FINAL RESULTS

GE NUCLEAR ENERGY - ROOT CAUSE EVALUATION OF CORE PLATE SUPPORT
RING VERTICAL CRACKING

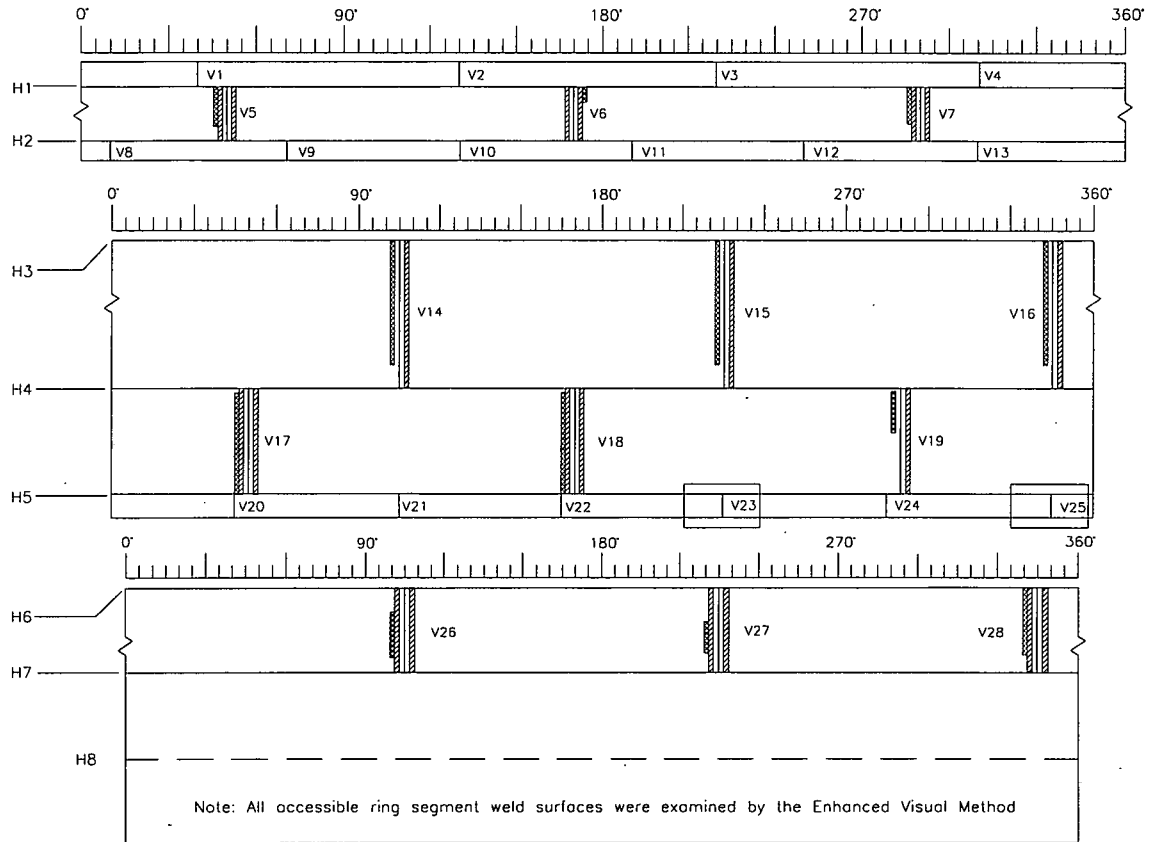
FIGURE 1

The following is a summary of the core shroud examination scope and results. Details of the specific areas examined and the results of the examinations are presented in Table 1 and Figure 1.

- The ultrasonic examination scope consisted of shroud vertical welds V5 through V7 (located between the H1 and H2 circumferential welds), V14 through V19 (located in the beltline region between circumferential welds H3 and H5), and V26 through V28 (located between circumferential welds H6 and H7). A total of 551 inches of the 760 inches of total cumulative vertical weld length (or 72.5%) was examined by at least one search unit from one side of the weld. Individual UT length coverage of all 12 vertical shroud welds ranged from between 34% and 96% per weld. These examinations resulted in no reportable indications.

- The enhanced visual examination scope consisted of the ring segment welds associated with the shroud head flange ring (V1 through V4), top guide support ring (V8 through V13), and core plate support ring (V20 through V25); the H8 and H9 circumferential welds at the shroud repair hardware locations; and the OD surface of all 12 vertical shroud welds on the side of the weld opposite from the UT search unit. These examinations resulted in no reportable indications in the area of interest.

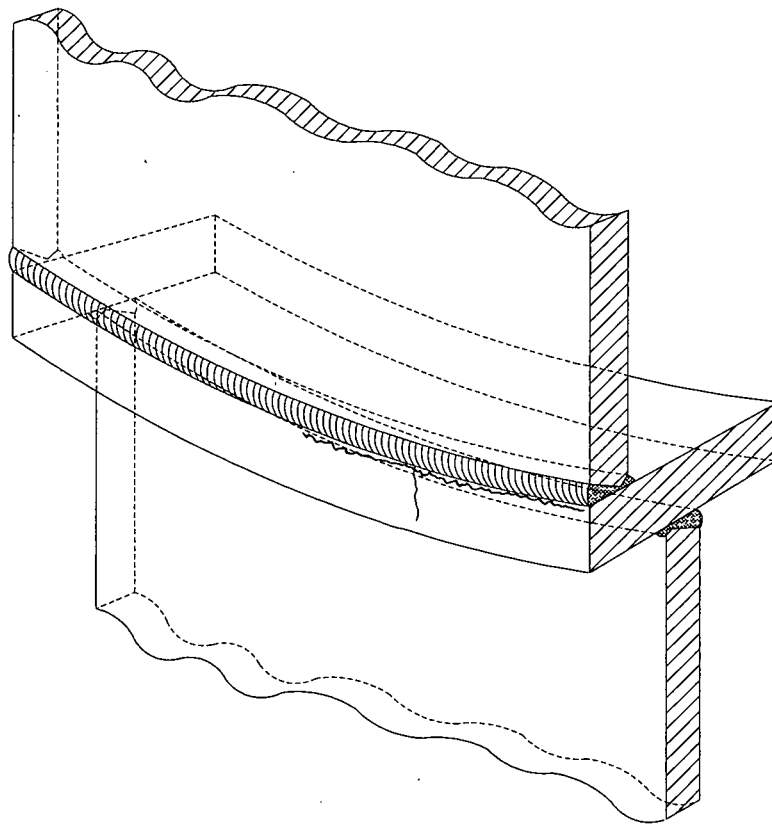
FIGURE 2

The vertically oriented cracking identified in the vicinity of the V23 and V25 ring segment welds was contained in an area of heavy localized grinding on the OD surface of the ring. The cracking is confined to this area of localized grinding and branches down from the circumferentially oriented cracking in the lower heat affected zone (HAZ) of the H5 weld (see Figure 2).

V23 - 2.8 inches in vertical length extending downward from the H5 circumferential weld. Maximum radial through wall depth was 0.50 inches, with average depth between 0.25 inches and 0.40 inches.

V25 - Exact vertical length could not be determined due to shallow depth and flaw orientation, however, the area of flaw length sized was 1.2 inches in vertical length extending downward from the H5 circumferential weld. Maximum radial through wall depth was 0.25 inches, with average depth between 0.15 inches and 0.25 inches.

The UT technique employed was only able to scan a five inch area adjacent to the cracking due to interference with the jet pump mixers. However, these scans did not reveal any evidence of a ring segment weld in the ground areas containing the vertically oriented flaws, although the UT technique should have seen evidence of the weld, if it were present.

Additionally, even if it were assumed that the vertically oriented cracking was associated with the V23 and V25 ring segment welds, the radial depth of the cracking is shallow and structural margins are ensured for a minimum of 4 operating cycles after applying a radial crack growth rate of 5×10^{-5} inches per hour. The core plate support ring is 4.0 inches thick with a radial width of 10.68 inches, where only an area of 7.4 square inches of unflawed ligament is required for the ring to maintain full structural integrity under all design basis and beyond events. (Reference 8)
