March 19, 1998

JMHLTR: #98-0017

Subject: Dresden Unit 2 Hydrogen Water Chemistry Hotcell Results on Fuel Performance / Final Transmittal of Requested Information

Excerpts from EPRI Report "Hotcell Postirradiation Examination of Dresden-2 Fuel and Water Rods After Four Cycles of Hydrogen Water Chemistry," TR-108782

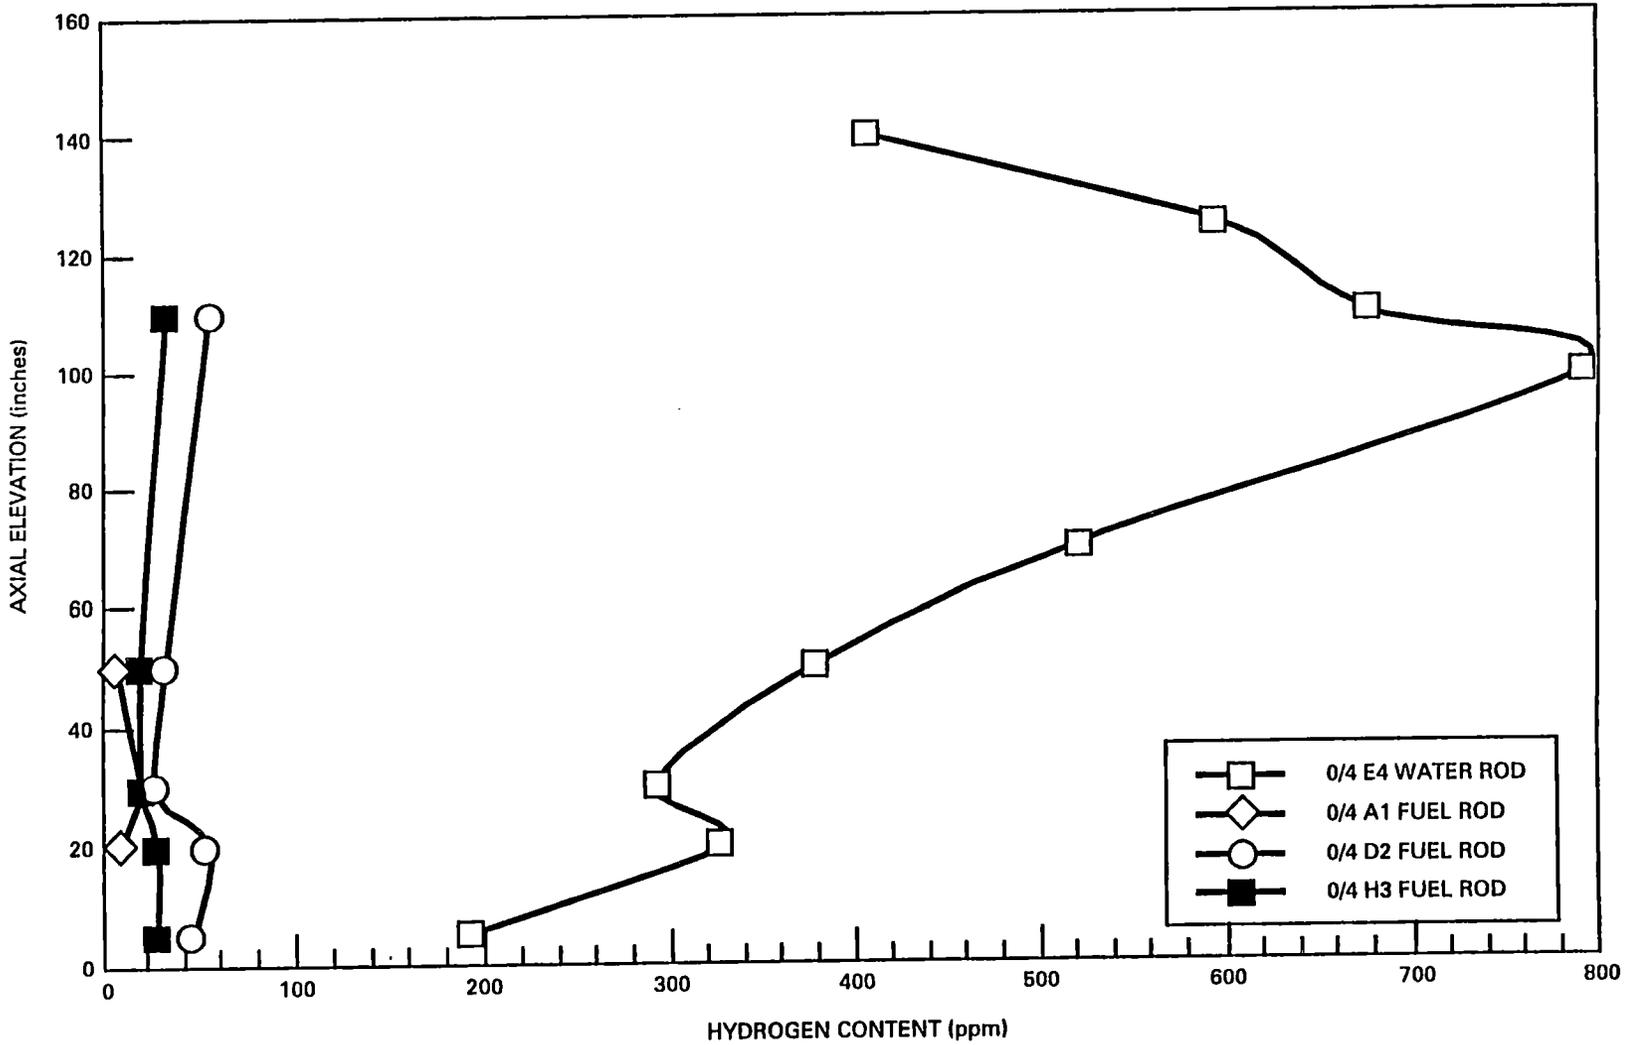
Figure 7-1. Hydrogen Distributions in LY5455 (0/4) Water Rod and Fuel Rods

Fuel cladding hydrogen contents were also low, as determined by the LECO inert gas fusion method (Table 5-3) and confirmed by metallography. In contrast, the hydrogen content of the E4 water rod was very high (Table 5-4 and, e.g., Figure 5-79). Four-cycle fuel rod and water rod results are plotted for comparison in Figure 7-1.

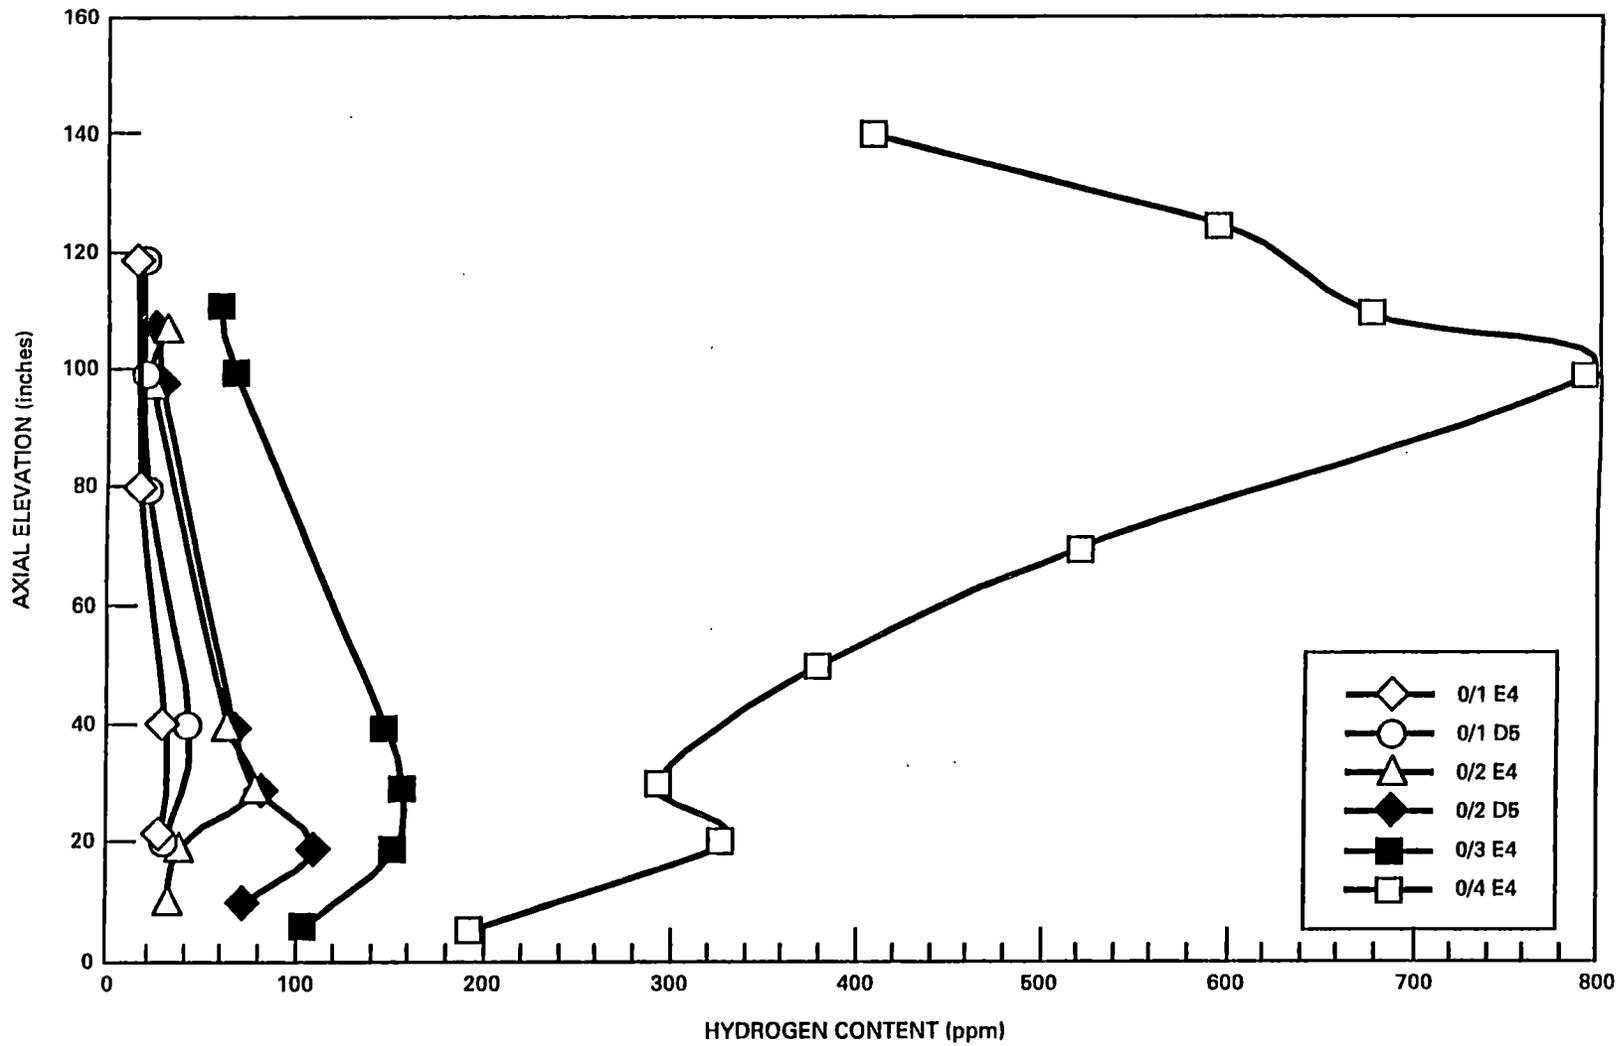
Figure 7-2. Hydrogen Distributions in LY5455/E4 Water Rod (0/4) Compared to Earlier Water Rod Results (1,2)

One water rod after four HWC cycles showed a deviation in the hydriding characteristics near the 100- to 110-in elevations at the burnup range of 38 GWd/MTU. With a maximum measured hydrogen content of 600-800 ppm, this peak hydrogen location deviated from the one-, two-, and three-HWC-cycle water rods and from water rods exposed to three cycles of normal water chemistry, where the peak hydrogen location was at 30- to 40-in elevations and less than 100 ppm.

The hydrogen contents of the four-cycle water rod samples are compared to similar measurements collected after one, two and three cycles of irradiation in Figure 7-2. Not only were the hydrogen contents much higher than previous measurements, but the axial distribution was different, peaking towards the top of the rod instead of near the bottom.

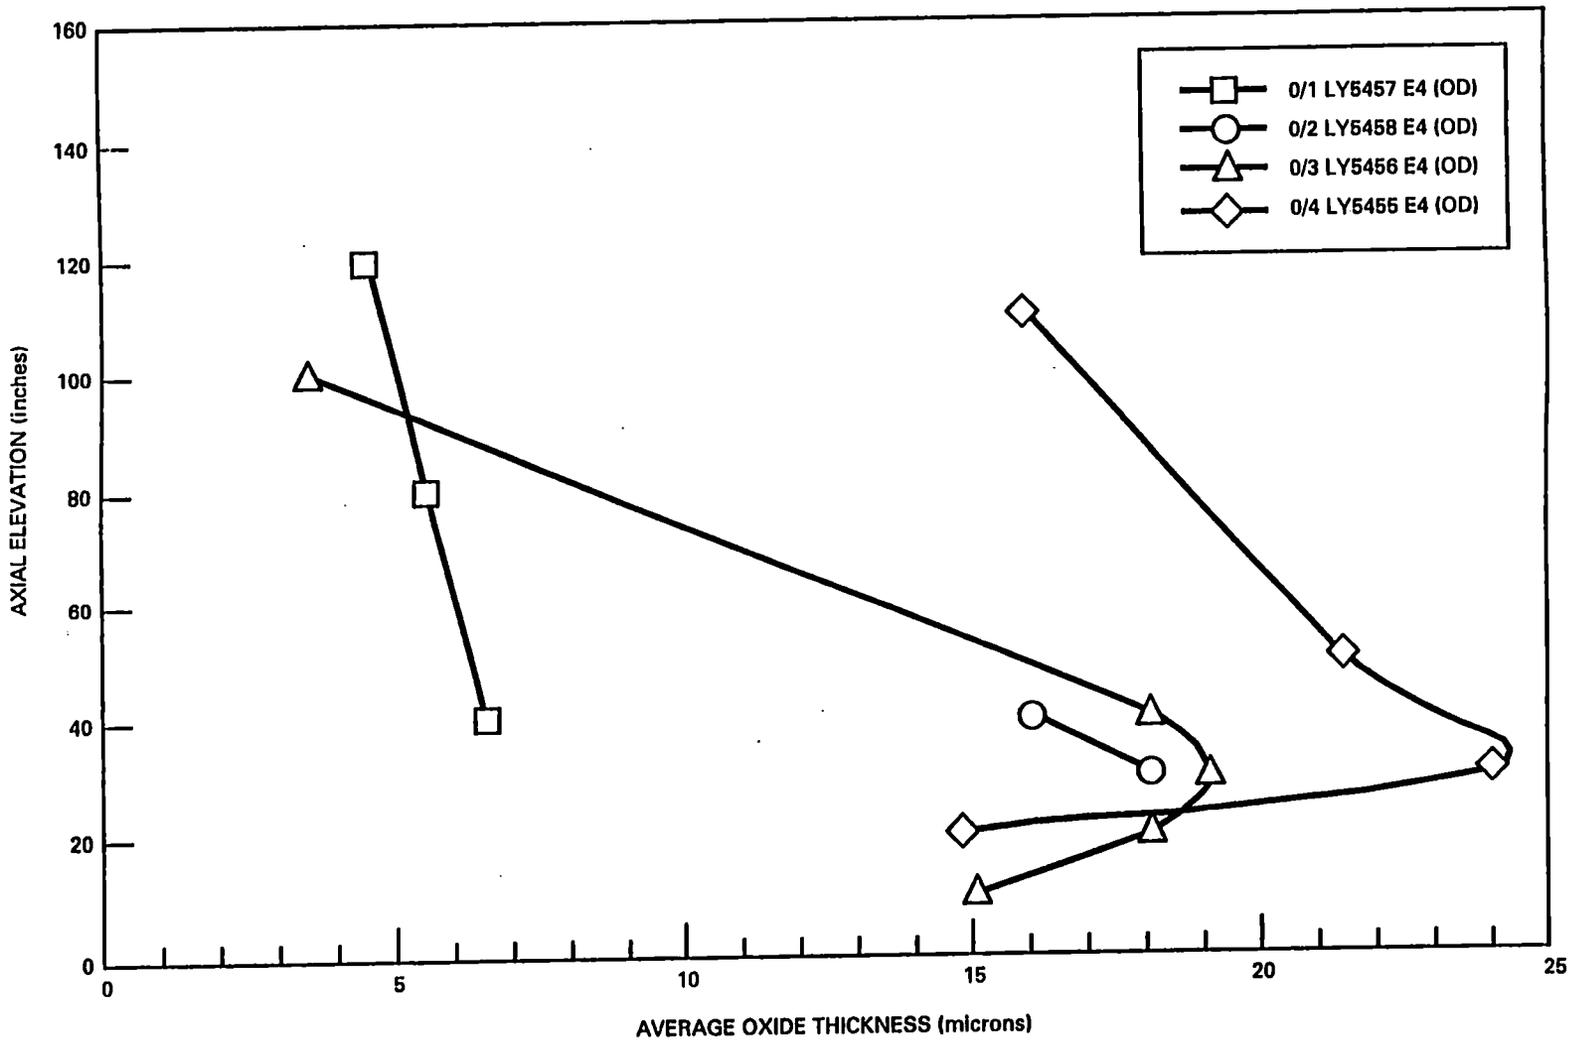
Figure 7-3. Water Rod Outer Surface Oxide Thickness versus Elevation After 1, 2, 3 and 4 Cycles of Hydrogen Water Chemistry

Metallographic oxide thickness measurements on the four-cycle water rod (Table 5-2) are compared to those on identical water rods after one⁽⁸⁾, two⁽⁶⁾ and three⁽¹⁾ cycles in Figure 7-3 (outer surface) and Figure 7-4 (inner surface). Accelerated oxidation on both surfaces occurred towards the top of the rod.

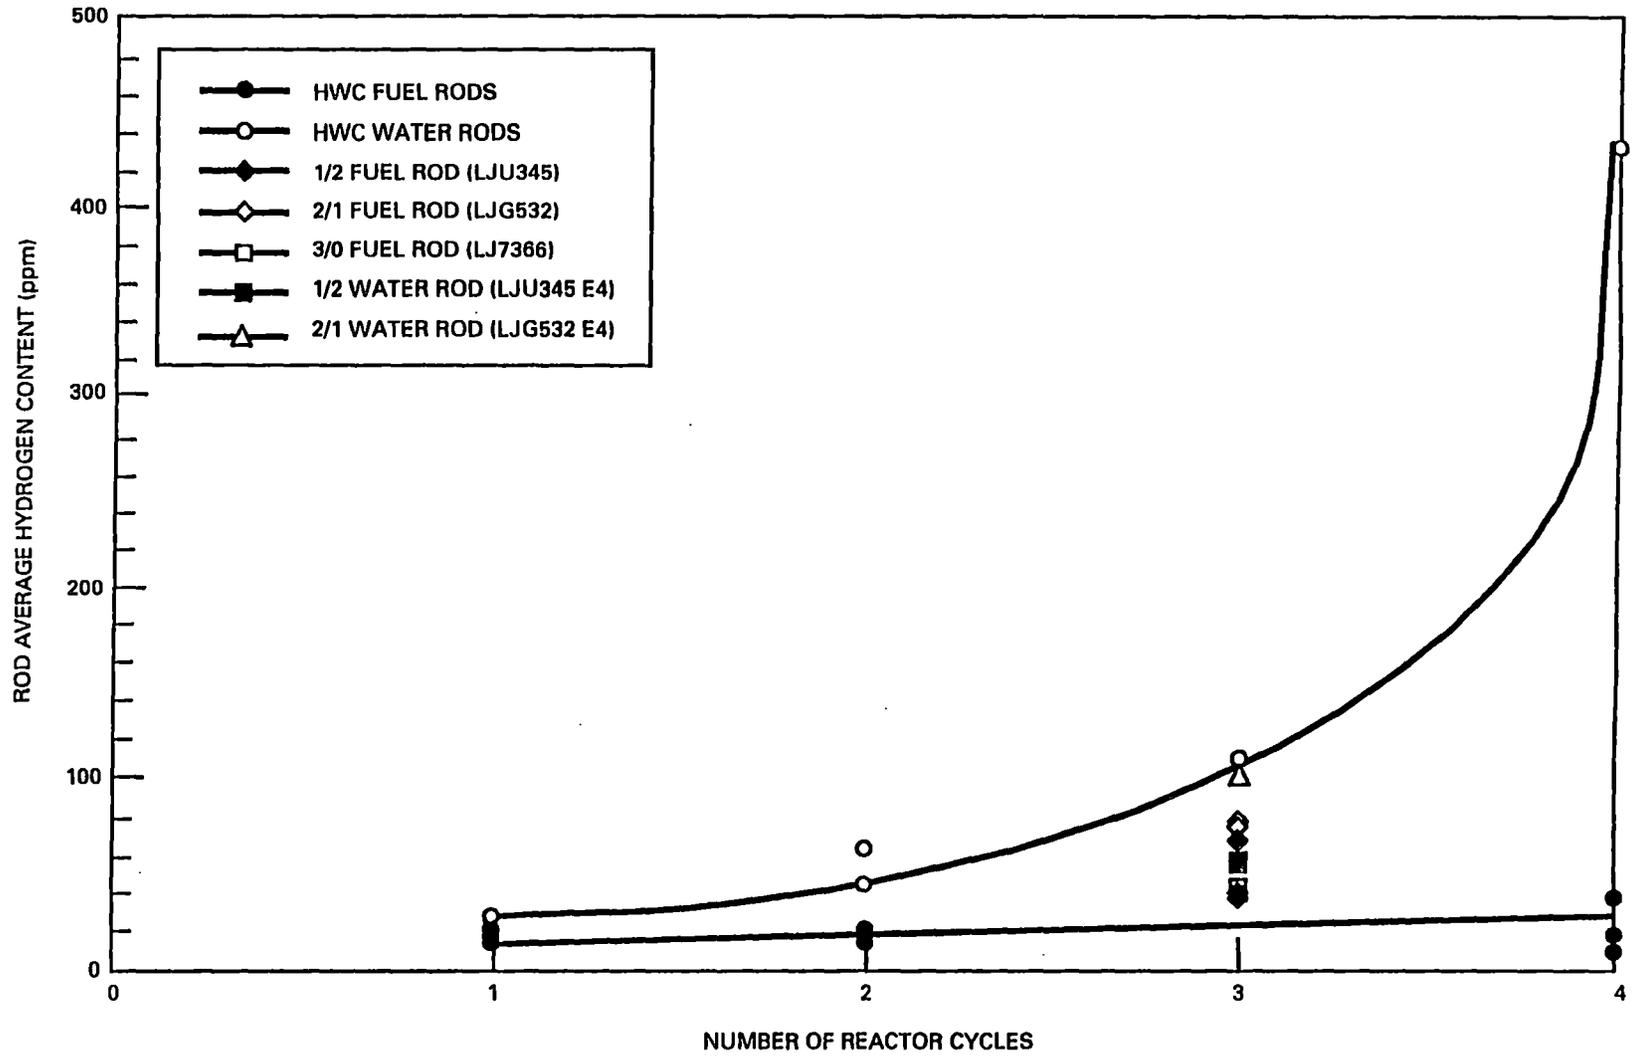
Figure 7-5. Rod Average Hydrogen Content versus Number of Cycles of Irradiation

Hydrogen concentration data collected during the current campaign are summarized and added to a previously reported plot^(1,2) in Figure 7-5. This shows that the pre-characterized (HWC) fuel cladding hydrogen contents plateaued at a low level after just one cycle, but water rod hydrogen levels continued to increase through four cycles. The trend towards high hydrogen levels was already evident after two and three cycles. [Note: The lines connecting the points are not mathematically fitted curves.]
