JMHLTR: #98-0017

Subject: Dresden Unit 2 Hydrogen Water Chemistry Hotcell Results on Fuel Performance / Final Transmittal of Requested Information

Excerpts from EPRI Report "Hotcell Postirradiation Examination of Dresden-2 Fuel and Water Rods After Four Cycles of Hydrogen Water Chemistry," TR-108782

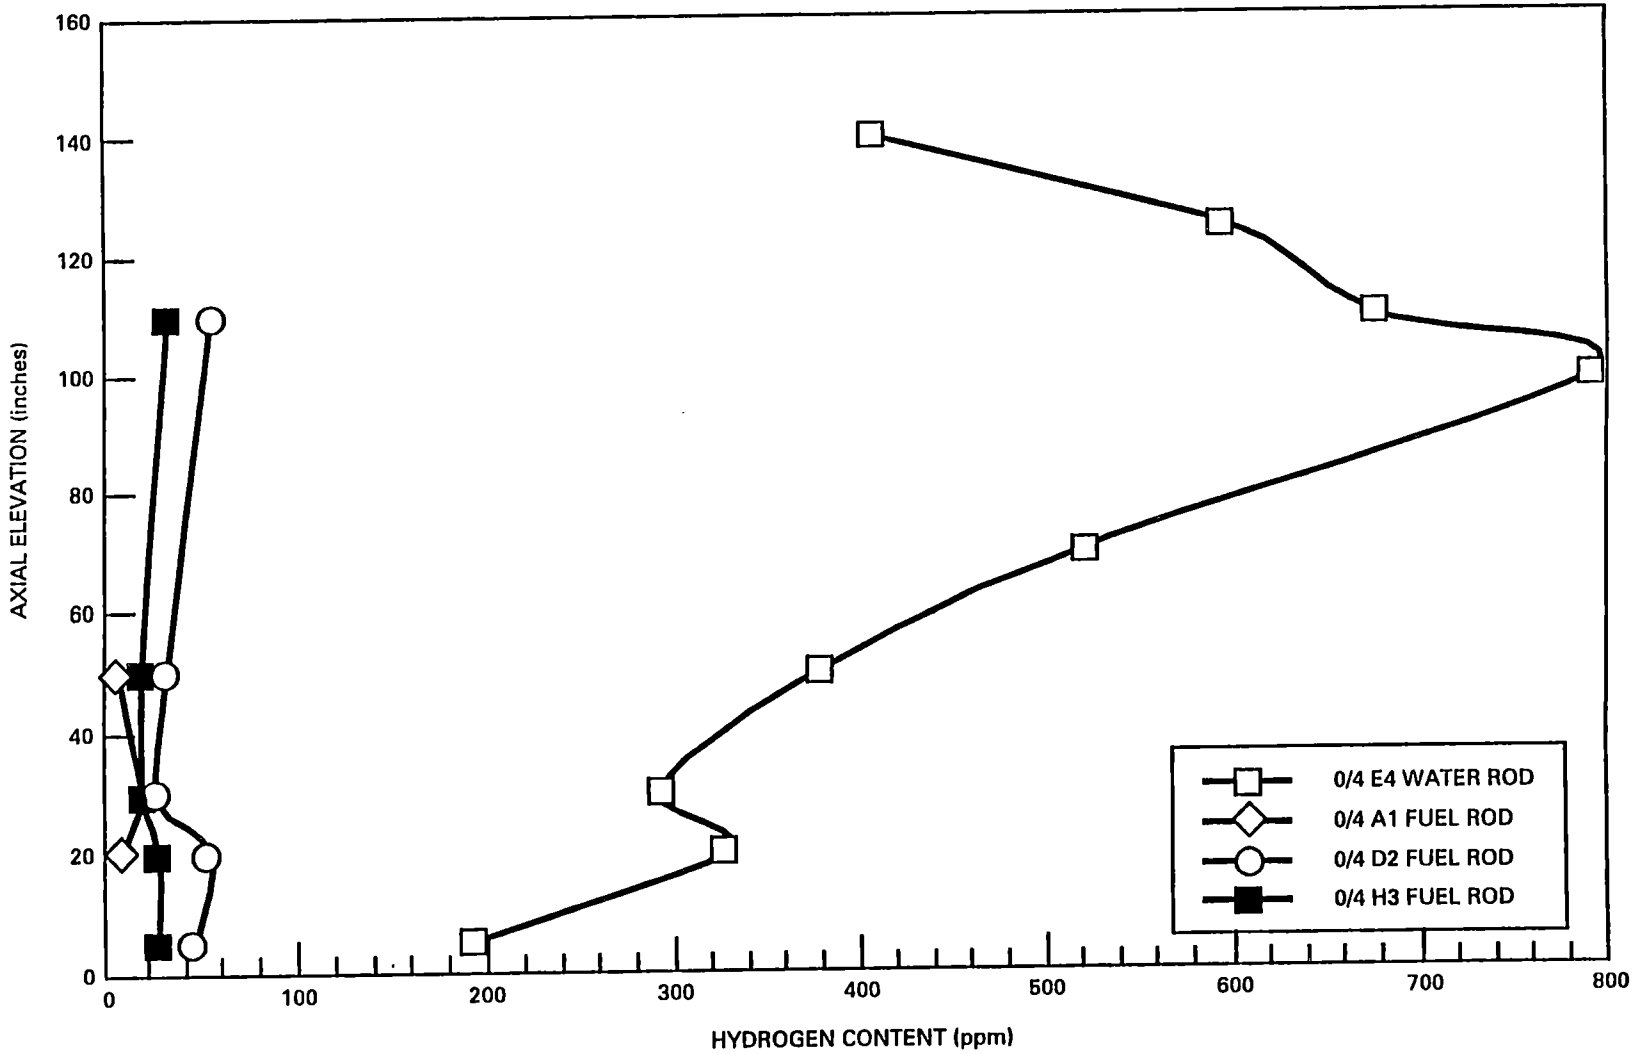
Figure 7-1. Hydrogen Distributions in LY5455 (0/4) Water Rod and Fuel Rods

Fuel cladding hydrogen contents were also low, as determined by the LECO inert gas fusion method (Table 5-3) and confirmed by metallography. In contrast, the hydrogen content of the E4 water rod was very high (Table 5-4 and, e.g., Figure 5-79). Four-cycle fuel rod and water rod results are plotted for comparison in Figure 7-1.

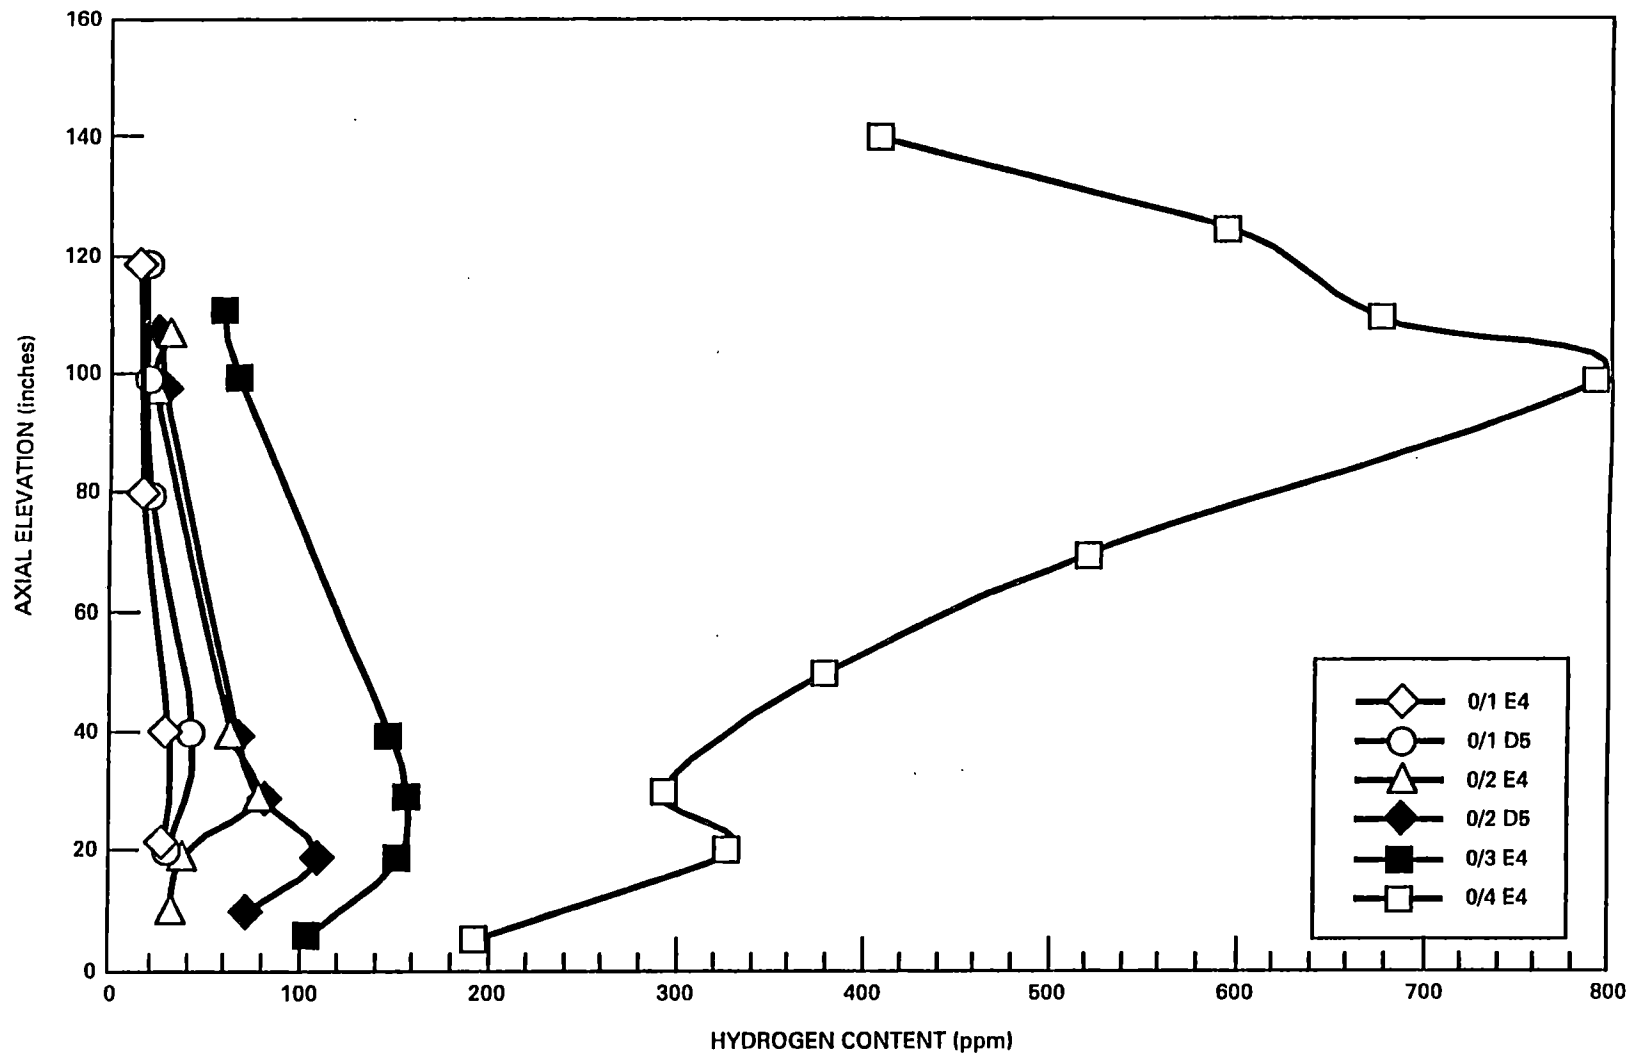
Figure 7-2. Hydrogen Distributions in LY5455/E4 Water Rod (0/4) Compared to Earlier Water Rod Results (1,2)

One water rod after four HWC cycles showed a deviation in the hydriding characteristics near the 100- to 110-in elevations at the burnup range of 38 GWd/MTU. With a maximum measured hydrogen content of 600-800 ppm, this peak hydrogen location deviated from the one-, two-, and three-HWC-cycle water rods and from water rods exposed to three cycles of normal water chemistry, where the peak hydrogen location was at 30- to 40-in elevations and less than 100 ppm.

The hydrogen contents of the four-cycle water rod samples are compared to similar measurements collected after one, two and three cycles of irradiation in Figure 7-2. Not only were the hydrogen contents much higher than previous measurements, but the axial distribution was different, peaking towards the top of the rod instead of near the bottom.

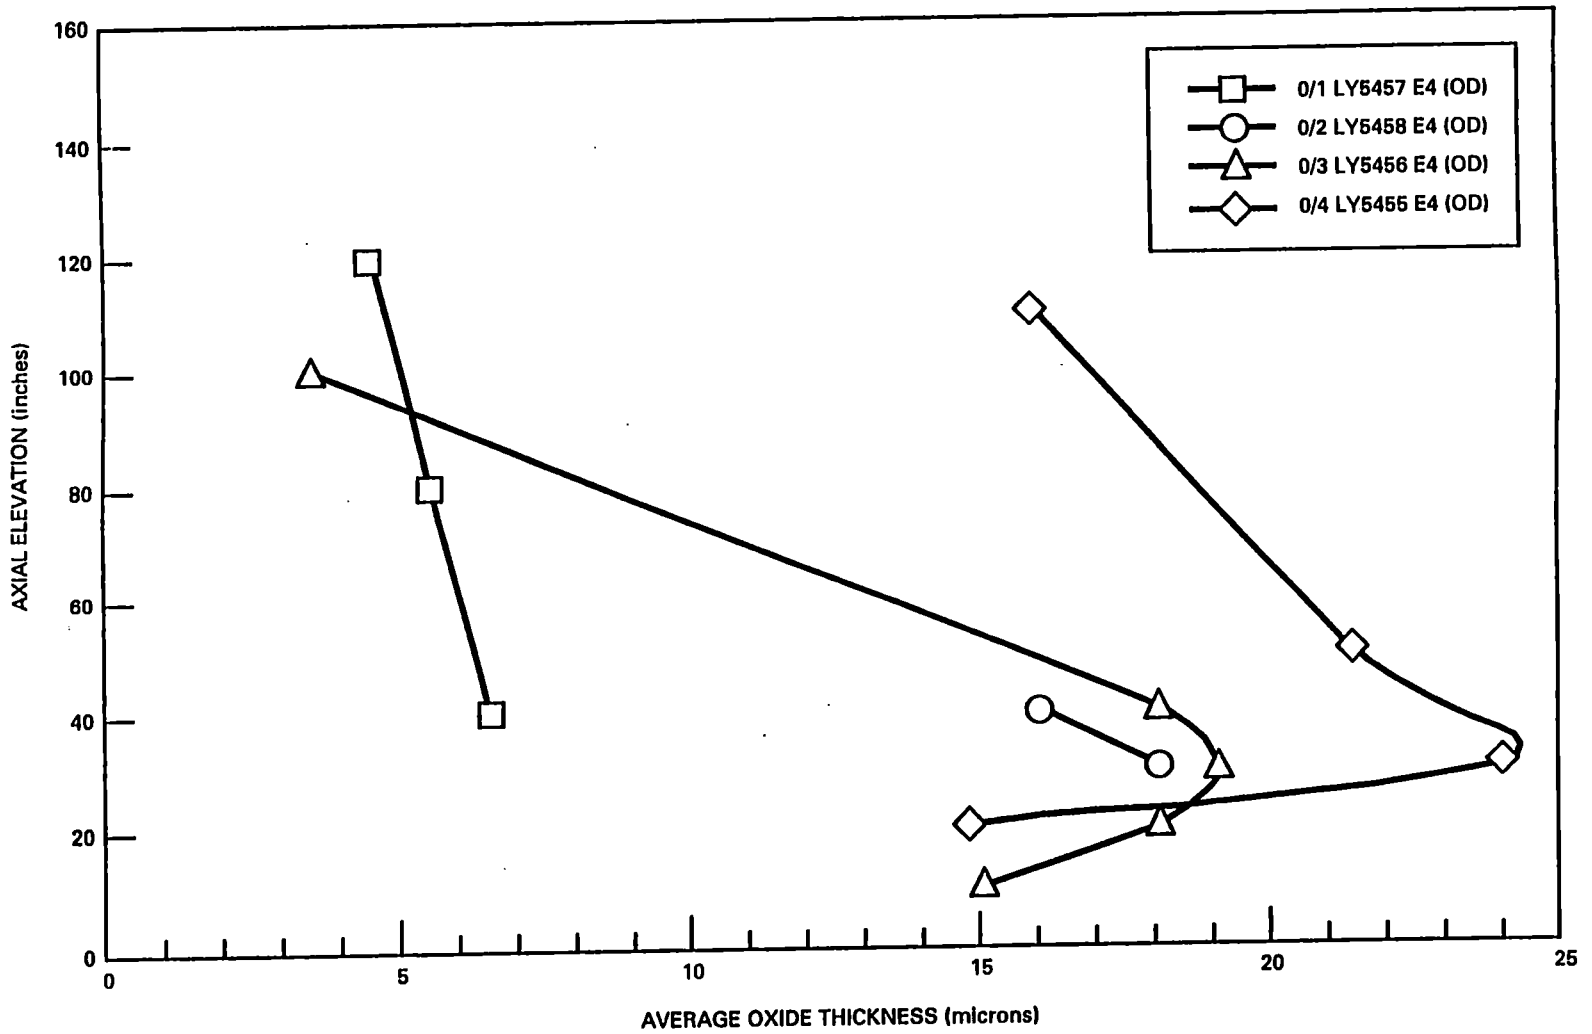
**Figure 7-3. Water Rod Outer Surface Oxide Thickness versus Elevation After 1, 2, 3 and 4 Cycles of Hydrogen Water Chemistry**

Metallographic oxide thickness measurements on the four-cycle water rod (Table 5-2) are compared to those on identical water rods after one<sup>(8)</sup>, two<sup>(6)</sup> and three<sup>(1)</sup> cycles in Figure 7-3 (outer surface) and Figure 7-4 (inner surface). Accelerated oxidation on both surfaces occurred towards the top of the rod.

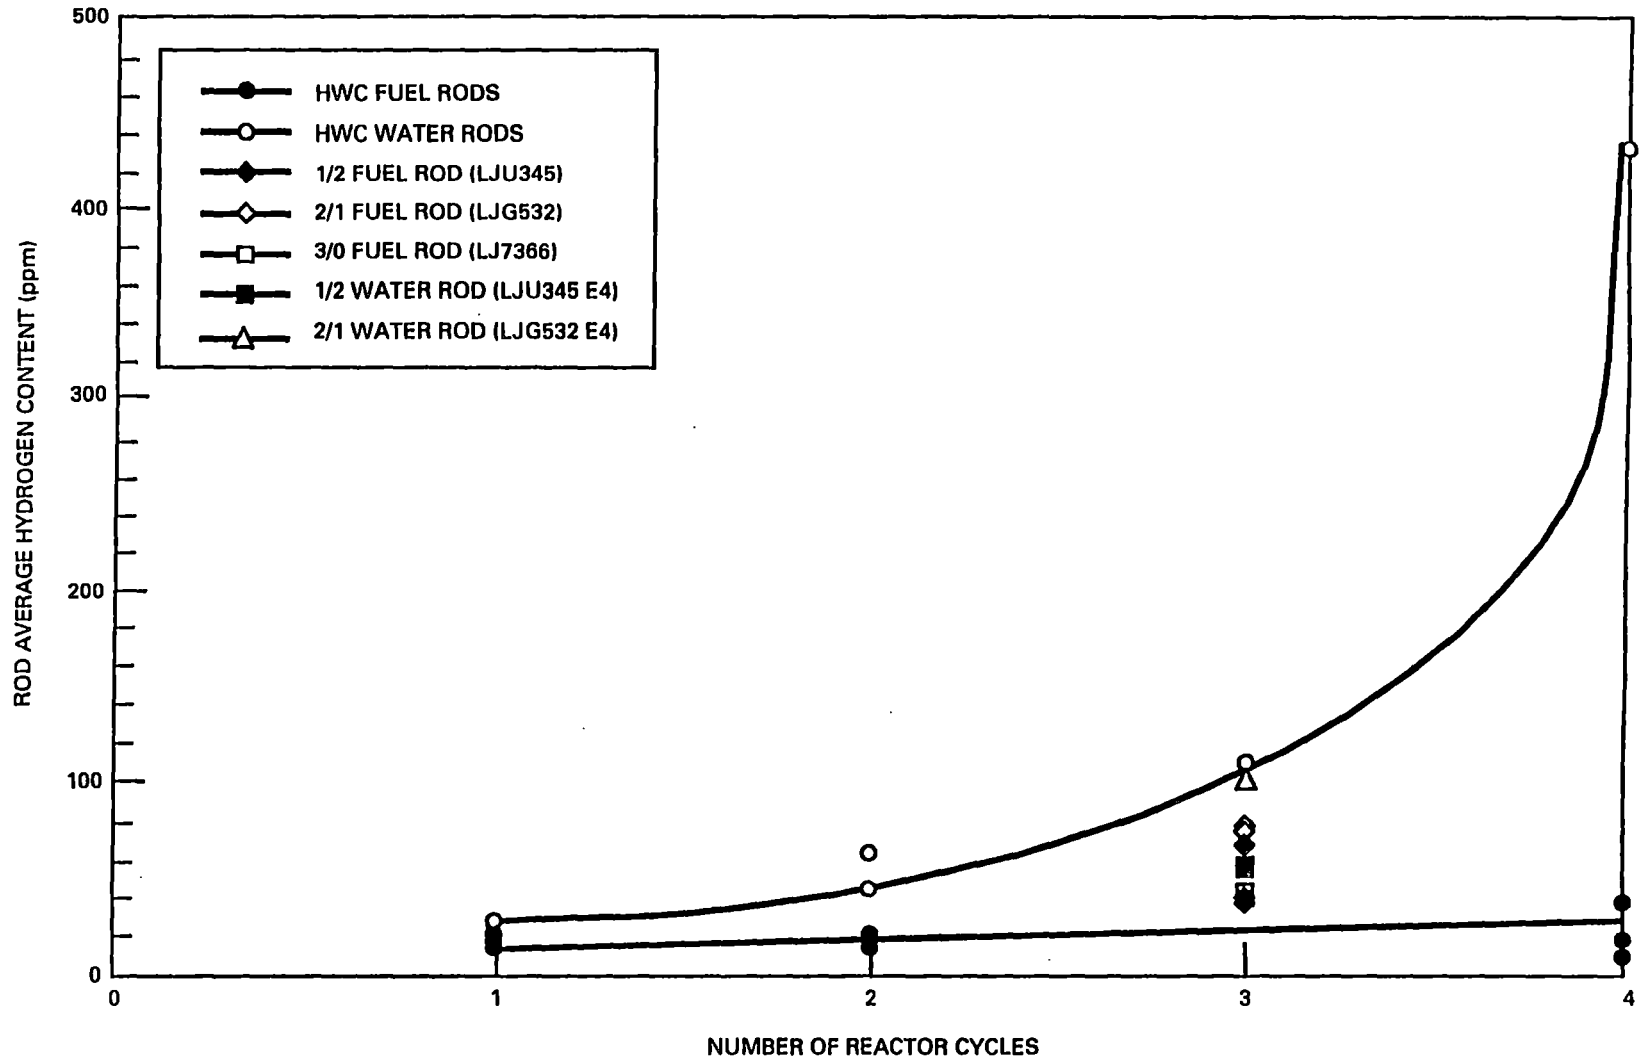
Figure 7-5. Rod Average Hydrogen Content versus Number of Cycles of Irradiation

Hydrogen concentration data collected during the current campaign are summarized and added to a previously reported plot<sup>(1,2)</sup> in Figure 7-5. This shows that the pre-characterized (HWC) fuel cladding hydrogen contents plateaued at a low level after just one cycle, but water rod hydrogen levels continued to increase through four cycles. The trend towards high hydrogen levels was already evident after two and three cycles. [Note: The lines connecting the points are not mathematically fitted curves.]
