LICENSEE EVENT REPORT (LER)

FACILITY NAME (1)
Dresden Nuclear Power Station, Unit 2

TITLE (4)
Unit 2 Reactor Scram While Shutdown from Scram Discharge Instrument Volume Level HI-HI Due to Valve Failure As a Result of Inter-Granular Stress Corrosion Cracking

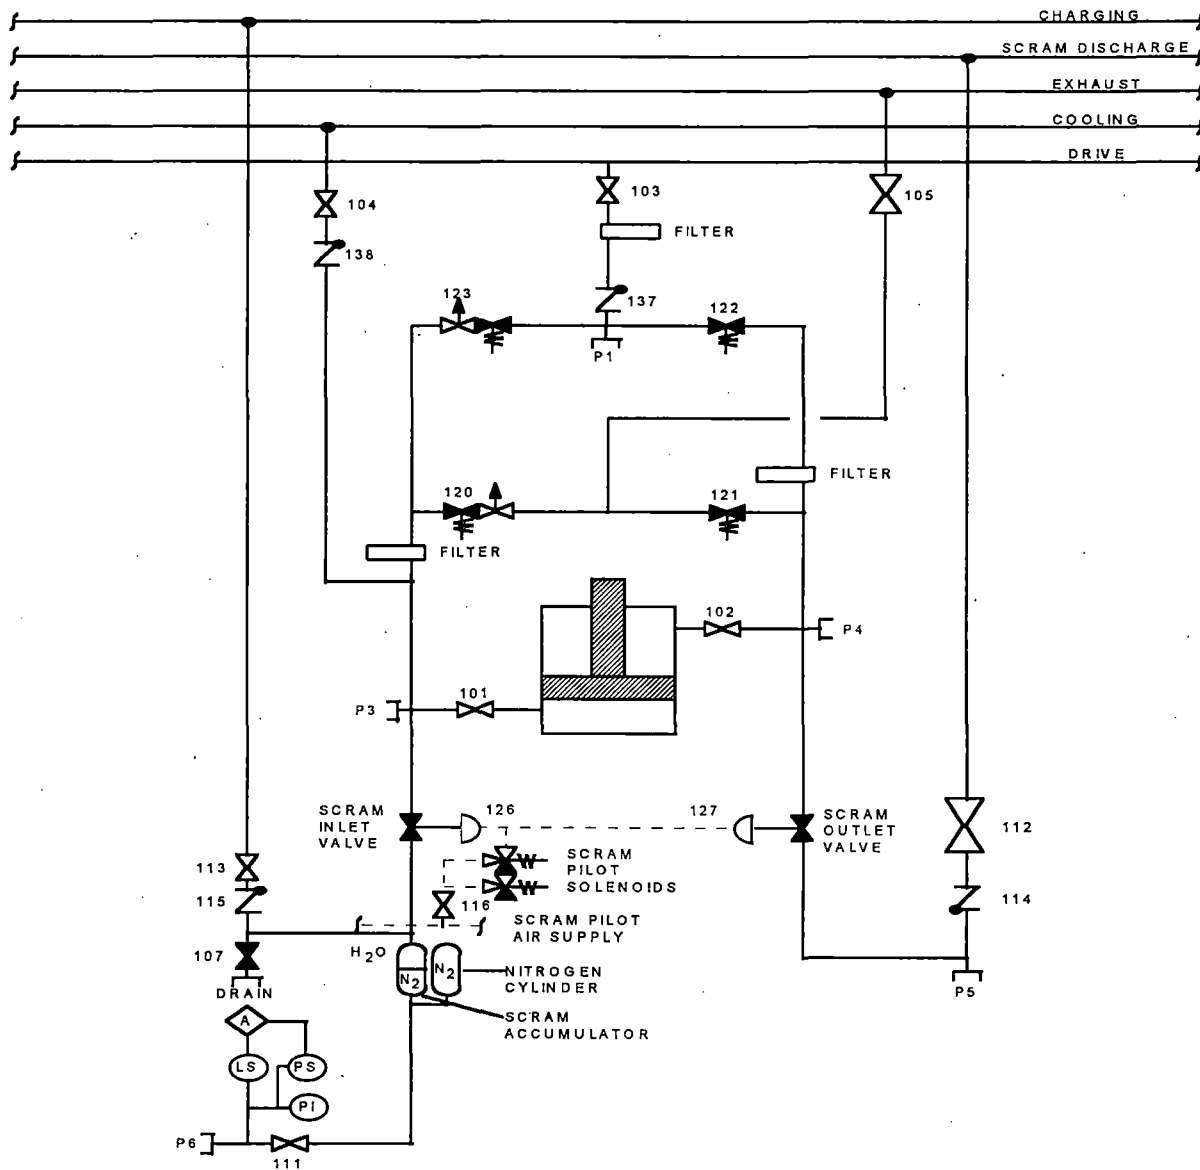
FIGURE 1
 CRD HYDRAULIC CONTROL UNIT PIPING CONFIGURATION

- SIV Volume Not Drained - Indication of rising level within the SIV causing no automatic action,
- SIV HI Level - Indication of level above the "Not Drained" alarm, and generates a Control Rod withdrawal Rod Block in the Reactor Manual Control System, and
- SIV HI-HI Level - Generates an alarm, in addition to generating a full trip of RPS logic. The function of the SIV HI-HI Level RPS trip is to cause the full insertion of all Control Rods while adequate free volume is available within the SIV to receive water exhausted from the Control Rod over-piston during insertion. (Figure 1, CRD Hydraulic Control Unit Piping Configuration)

During troubleshooting, it was discovered there was leakage through the 2-0305-102 valves (HCU WITHDRAW VLV) for Control Rod Drives 46-43 and 46-27. This leakage was identified by the System Engineer using a local, hand-held temperature indicator. This indicator was used on all suspected valves until the two in question (46-43 & 46-27, 2-0305-102 valves) were found to have a high temperature indication as a result of leakage. Action Requests were immediately prepared and the failed valves were replaced.

The cause of this event is the failure of the valves' seat insert (NRC Cause Code B). The failure of the seat insert of the valves prevented full isolation; thereby allowing leakage past the seat of the 2-0305-102 valves on Control Rod Drive 46-27 and 46-43. The leakage filled the SIV to the HI-HI level resulting in the reactor scram.
