Commonwealth Edison Company

Dresden Nuclear Power Station
R. R. #1
Morris, Illinois 60450
November 6, 1972

SUBJECT: LICENSE DPR-19, DRESDEN NUCLEAR POWER STATION, UNIT #2,
SECTION 6.6.C.1 OF THE TECHNICAL SPECIFICATIONS.

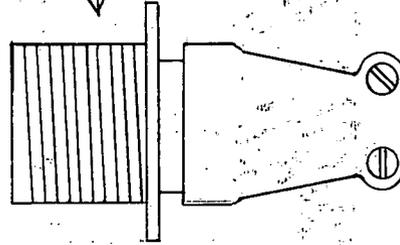
AMPHENOL CONNECTOR

The cause of the malfunction was found to be a broken wire at the amphenol connector to the solenoid. The wire broke because of improper connector fastening to the solenoid body. The solid shell straight plug was attached directly to the body of the solenoid. The straight plug should have been attached to the solid threaded backshell; the backshell would then be attached to solenoid body. This arrangement permits the coupling ring to spin freely (see attached drawing for amphenol nomenclature).

However, since the straight plug was attached to the solenoid, the coupling ring could not be properly attached to the receptacle shell. In order to thread the coupling ring to the receptacle shell, it was necessary to loosen the straight plug.

Because of this, the straight plug vibrated itself free from the solenoid body. These vibrations caused the threads on the plug to become deformed. Once the straight plug worked itself free, the wires of the solenoid were hanging from the solenoid supporting the weight of the amphenol connector and cable. The weight of the connector and the cable caused one of the wires to snap. This snapped wire in turn prevented the solenoid from receiving the signal to fast close the control valve.

The amphenol connector was repaired and attached properly to the solenoid. The threaded backshell was attached. Loctite, a thread compound, was applied to all threaded fittings of the connector. The Loctite was applied to insure that the threaded fittings would not vibrate loose.

It is now planned to apply Loctite to all threaded fittings of all the amphenol connectors for the Units 2 & 3 turbine valves, at this time Unit 3 fittings will be checked.
