Commonwealth Edison Company

Dresden Nuclear Power Station
R. R. #1
Morris, Illinois 60450
November 3, 1972

SUBJECT: LICENSE DPR-19, DRESDEN NUCLEAR POWER STATION, UNIT #2
SECTION 3.8.A.

Dresden Units 2/3 Chimney Monitor

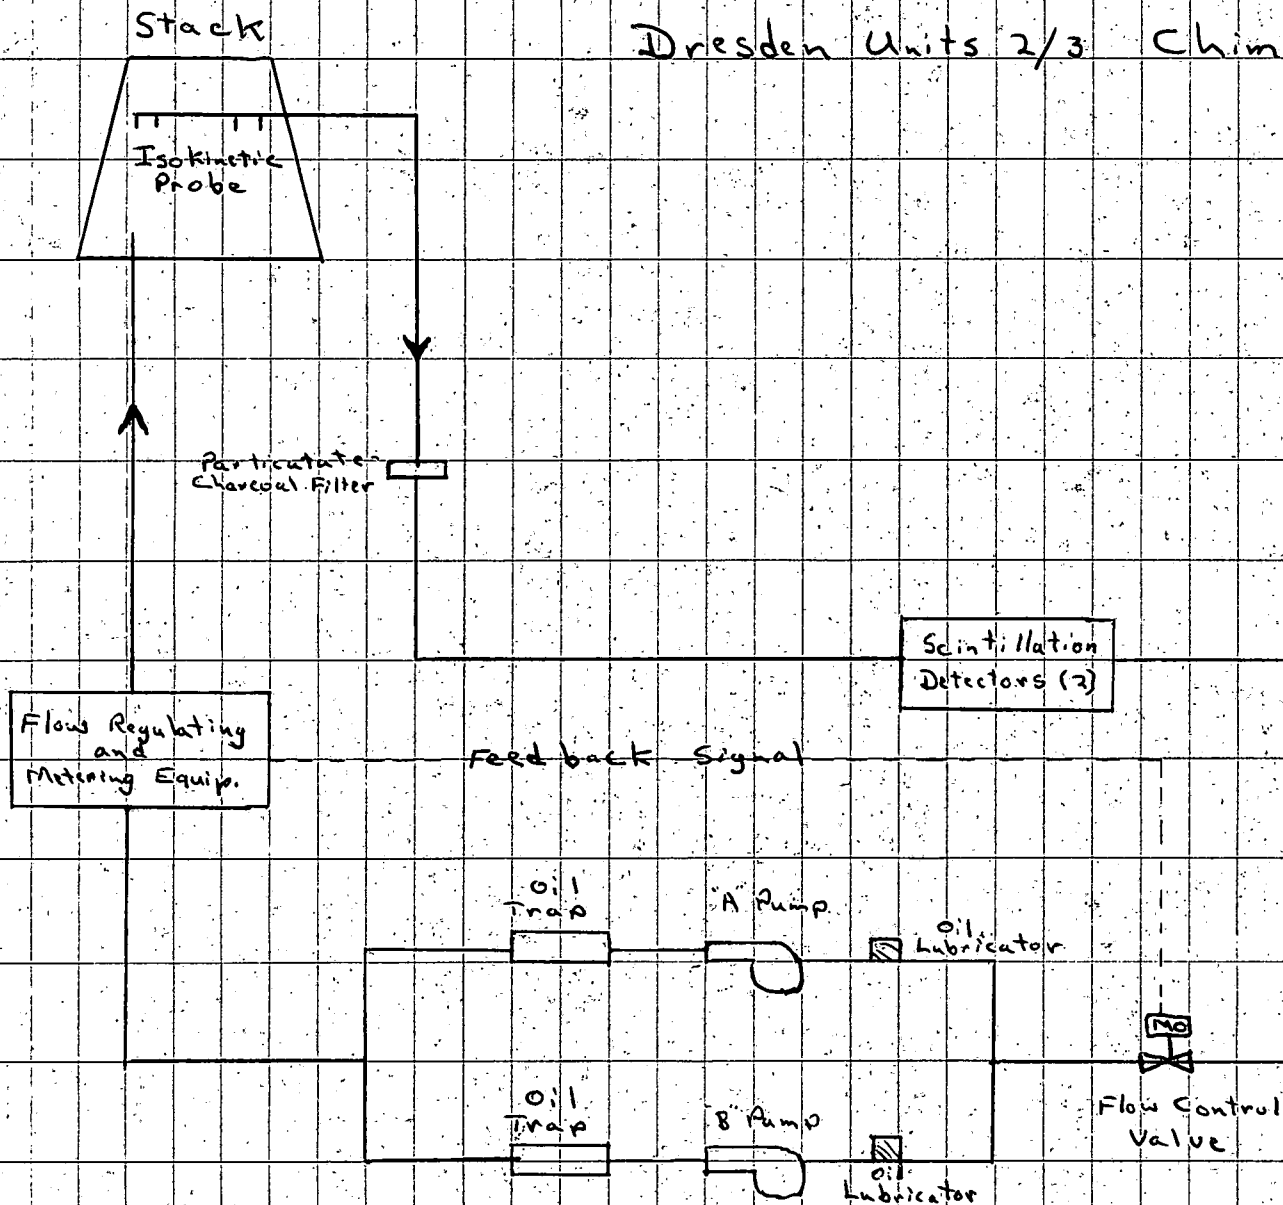
On October 5, 1972, the Units 2/3 chimney monitoring system was removed from service for 37 minutes for repairs. At 1718, "A" sample pump was removed from service to repair burnt motor leads caused by carbon deposits within the pump which were making the motor run hot. The standby sample pump could not be started, since it had been removed from service at 1604 (10/5/72) for replacement of a failed oil lubricator. By 1755, the oil lubricator had been removed from "A" pump and installed on "B" pump, and the monitoring system returned to service. The oil lubricator and motor leads on "B" pump were replaced the following day (10/6/72). See attached sketch.

The failed oil lubricator on "B" pump resulted from attack of its plastic housing by a new type of lubricant, which was placed in the pump to eliminate carboning of pump internals. By 10/18/72, both pumps had been backfitted with new metal oil lubricators not subject to attack by this lubricant. The operation of both pumps following change to the new lubricant and new type lubricator has been satisfactory to date.

This system, as installed, is already redundant with regard to the sample pumps, in that two samples, each with 100% capacity, are provided. The simultaneous failure of both pumps has not been experienced before, and is considered an isolated incident. The station, therefore, plans no further corrective action.
