PILGRIM NUCLEAR POWER STATION REGULATORY CONFERENCE

EDG A Cooling Fan Right Angle Drive Gearbox

July 13, 2017

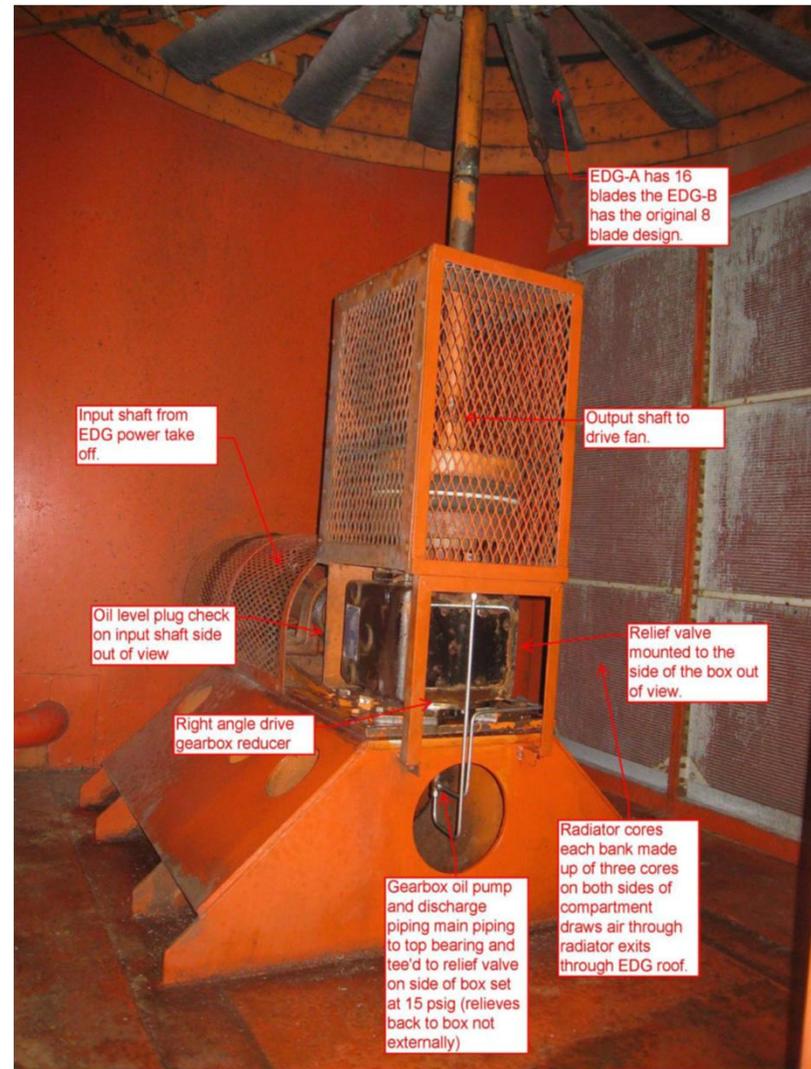
- As-found Condition
- Actual picture of EDG-A cooling fan gear box room

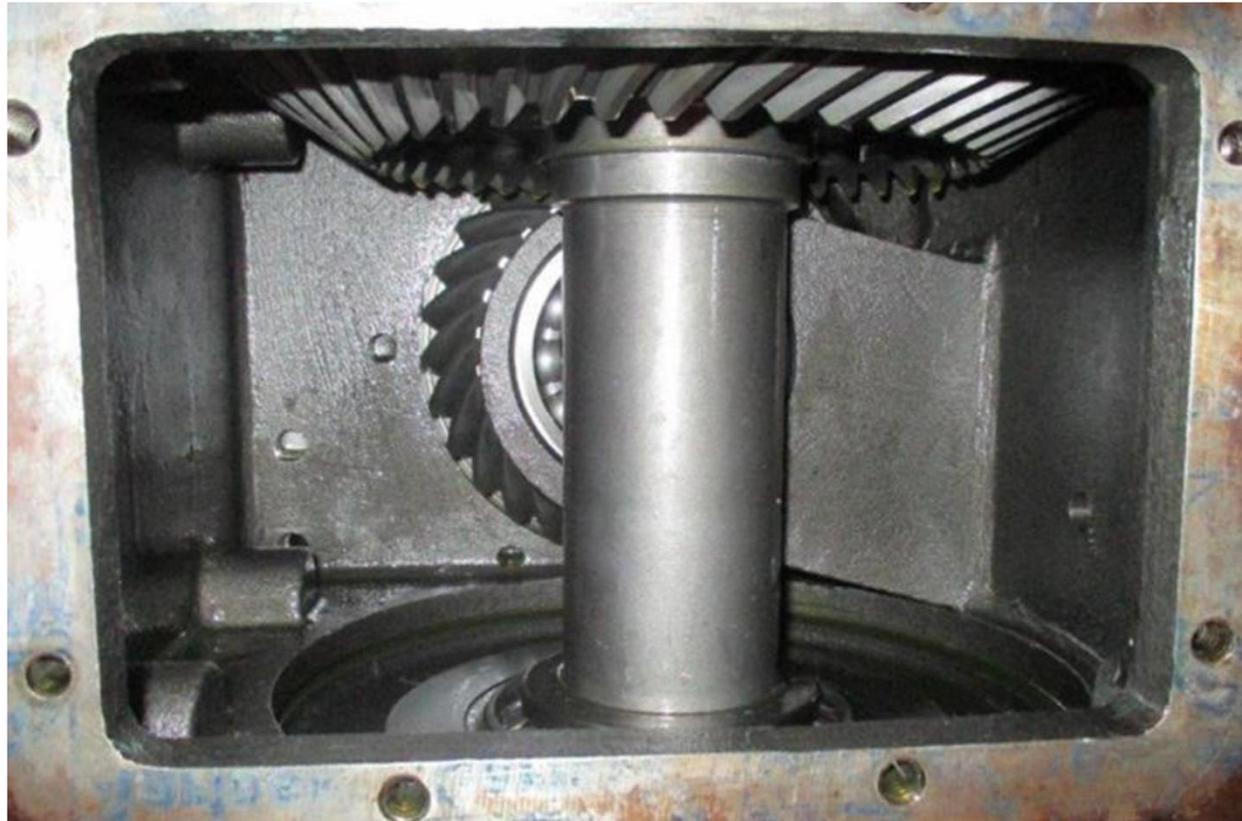
Gearbox Internals

Robust design with machined gears

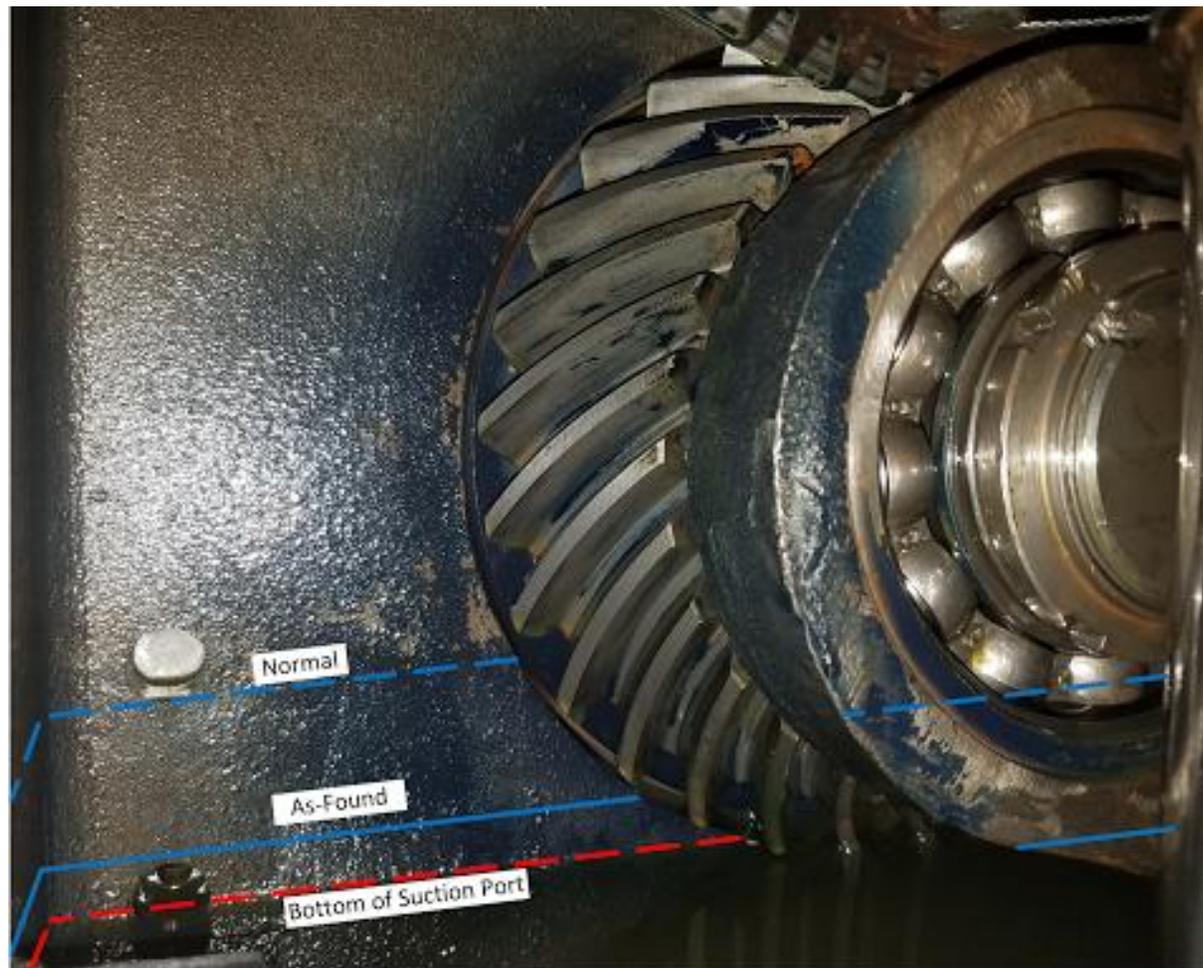
Gearbox Oil Level – Post-Endurance Test

Gear on horizontal shaft always in contact with oil

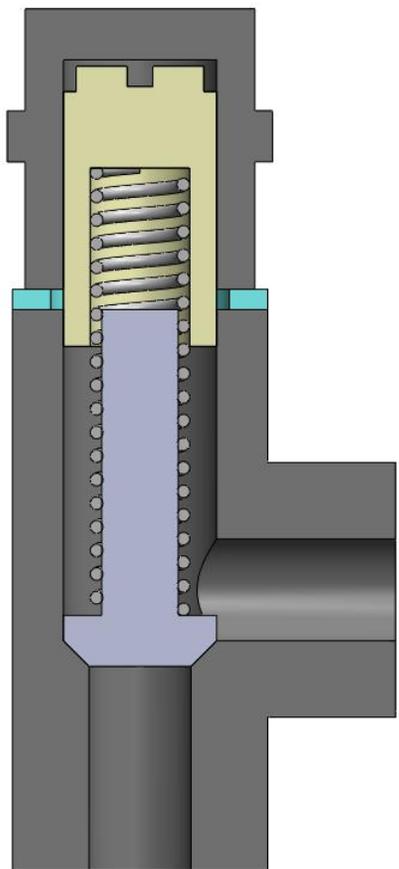
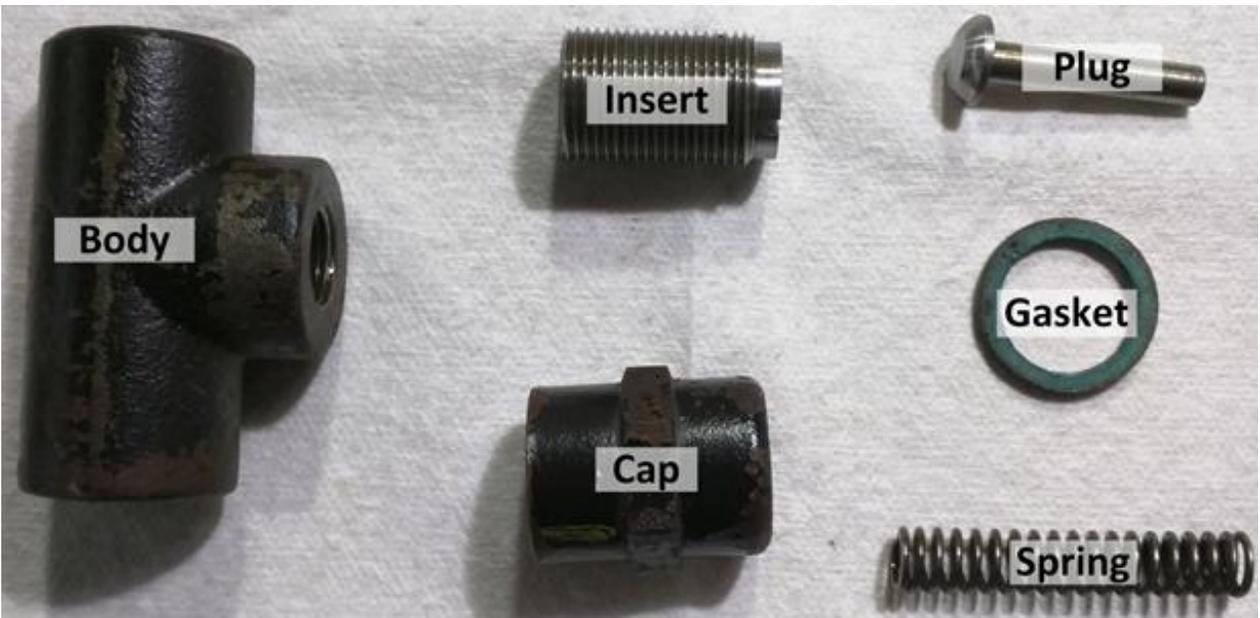
Relief Valve

Vibration incapable of loosening a properly set RV

- Analytic Approach
 - A calculation evaluated conservative vibration loading to thread pre-load.
 - Determined with the relief valve at normal set pressure, the insert will not back out due to in-plant vibrations.
- Testing Approach
 - A test monitored the movement of the valve insert and cap under vibrations.
 - Determined with the relief valve at normal set pressure, the insert will not back out due to in-plant vibrations.
 - Determined that the as-found relief valve insert and cap position did not result from in-plant vibrations.

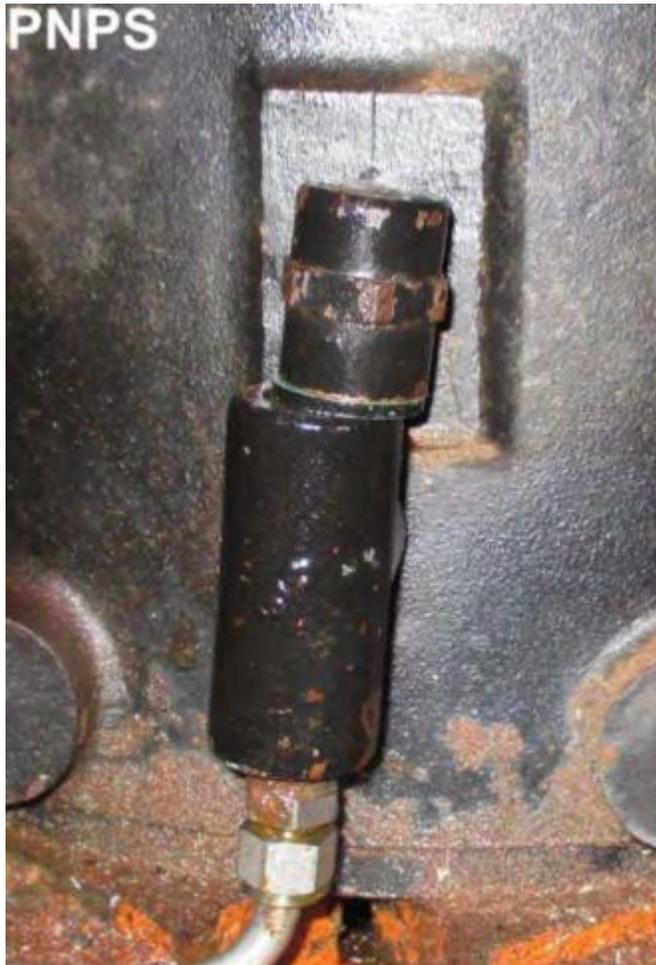
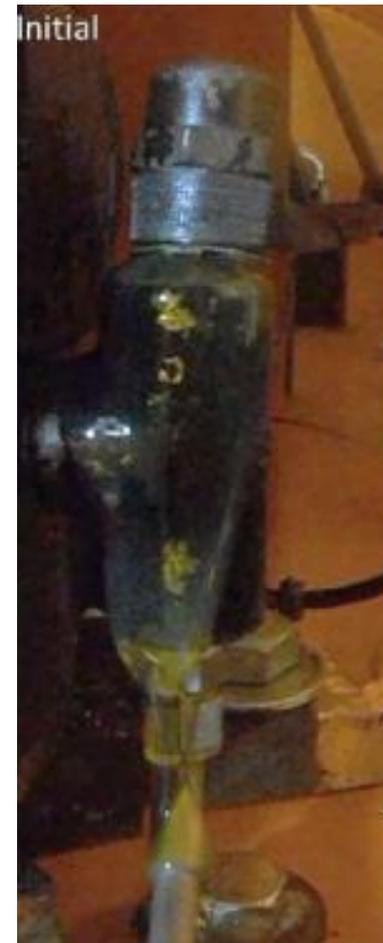
As-Found Condition of Relief Valve

Oil lost only during gear pump operation

- On September 28, 2016, after identifying the low oil condition:
 - Drained oil and internally inspected gearbox visually; with no damage identified.
 - Reassembled, bench tested and set the relief valve at 15 psig and refilled the gearbox with new oil. The monthly Surveillance Test was then successfully completed.
- Pre-start check procedure changed to provide additional guidance on how to validate the gearbox oil level.
- Non-licensed operator trained on gearbox oil level validation method.

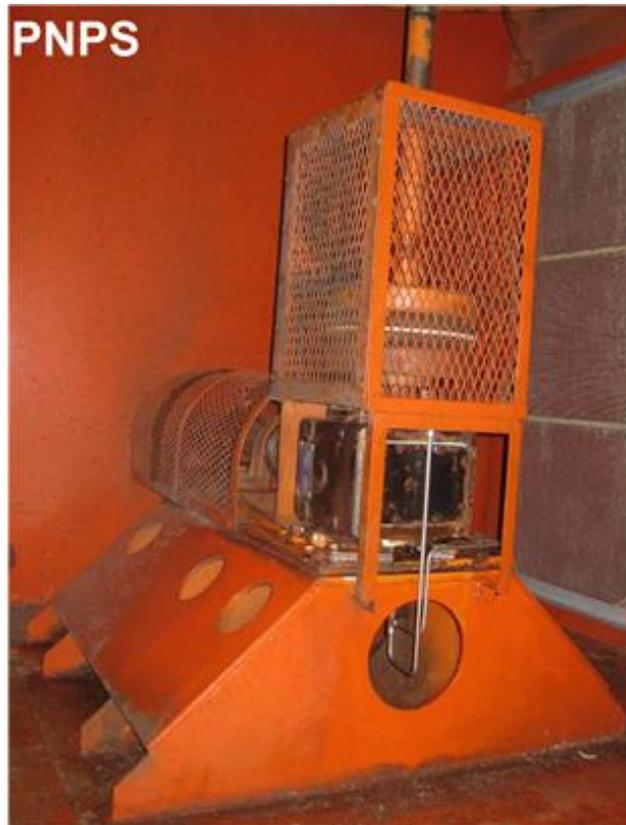
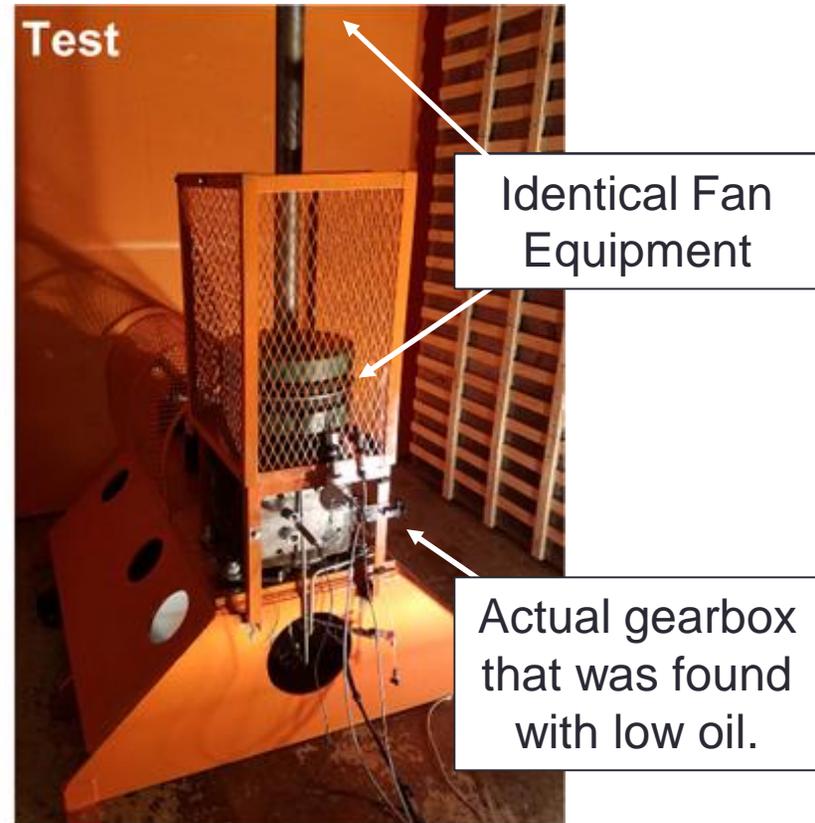
Test Setup

Test setup well represented
actual installation

- Equipment Representative of Air Side EDG-A Radiator System

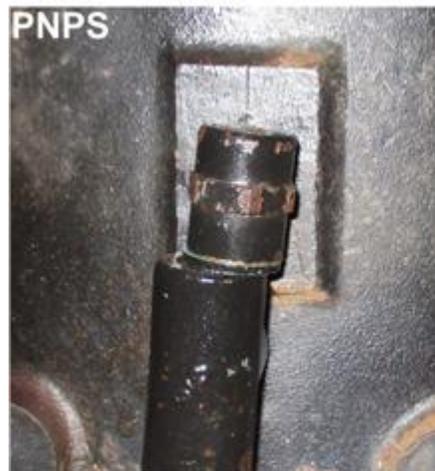
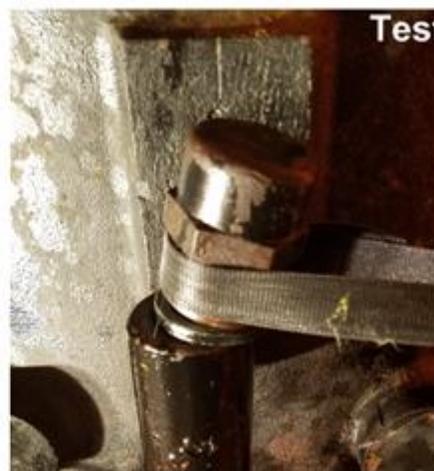
Endurance Test Conditions

- Air temperature bounded possible plant conditions. The temperature was determined for:
 - Highest ambient temperatures recorded on site between August 31 to September 28, 2016
 - Highest accident scenario (LOCA) engine loading
- Relief valve was offset in the as-reported as-found condition, and restrained to bound any condition that could occur.

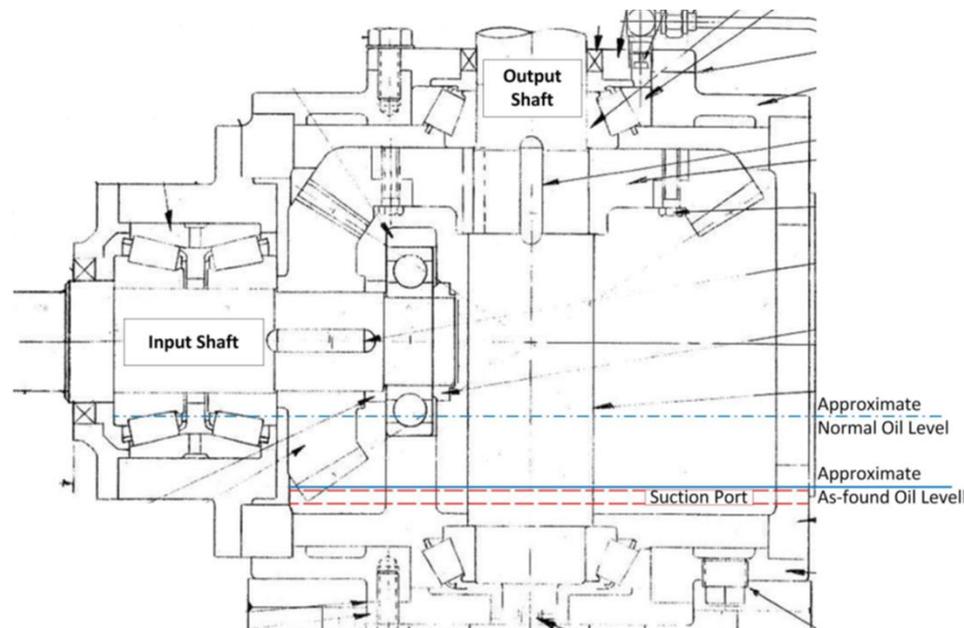
Endurance Test Conditions

- The initial oil level was at the as-found level observed by the maintenance technicians.
 - Allowed the oil to drain undisturbed for 48 hours prior to testing.
 - Level was well below input shaft bearings.

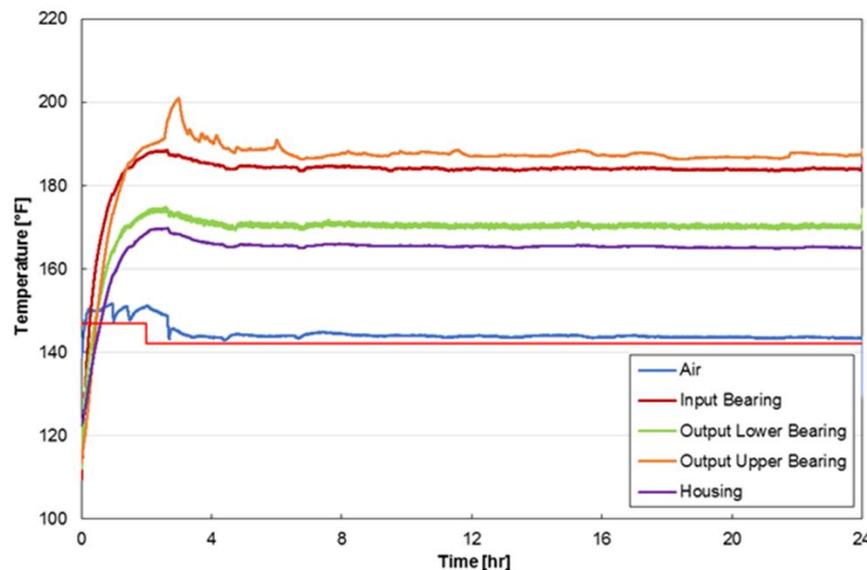
Endurance Test Temperature Results

Temperatures remained well below the 300 F limit

- The gearbox successfully performed its function of transmitting power to the fan for 24 hours with low oil.
- Gearbox temperatures reached steady-state values well below manufacturer's damage threshold limits.

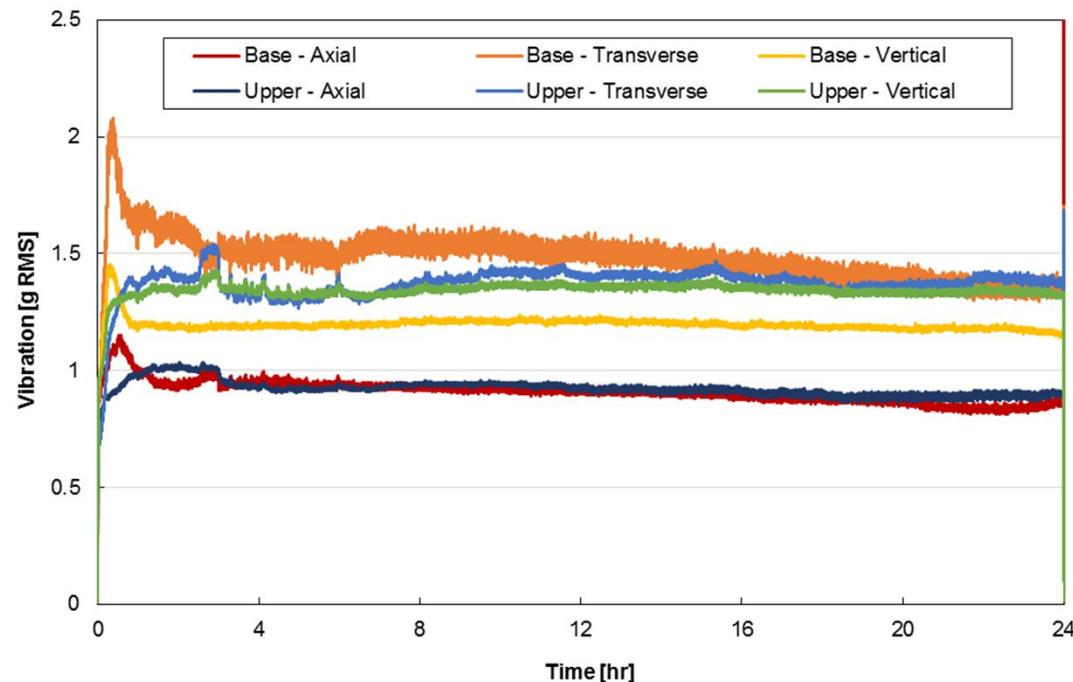
Endurance Test Vibration Results

- The gearbox vendor stated that no increase in vibration indicates no equipment degradation
- Gearbox vibrations reached steady state values during testing in acceptable range

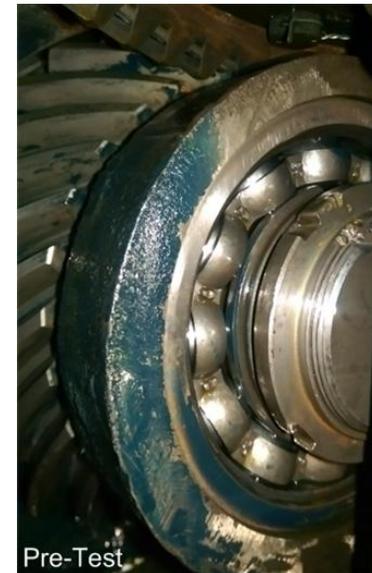
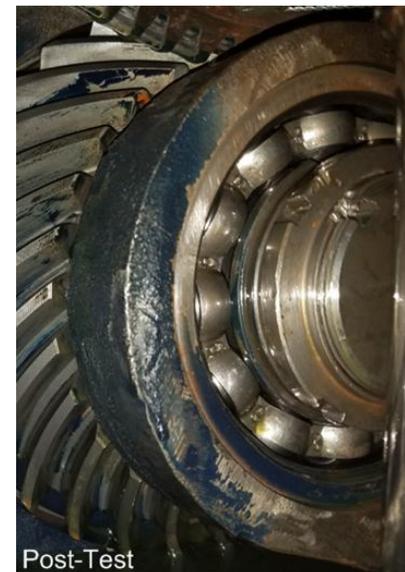
Endurance Test Results

- Demonstrated sustainable operation
- Post-test internal inspections showed no visible damage to gear teeth or the roller bearings.
- Gearbox backlash measurements essentially the same before and after testing
- Oil analysis found indicators of small wear particles
 - Less than 5 mils
 - Symptomatic of misalignment
 - The observed wear would not have impacted long term operation.
