**LICENSEE EVENT REPORT (LER)**

FACILITY NAME (1) Dresden Nuclear Power Station, Unit 3		DOCKET NUMBER (2) 05000249	PAGE (3) 1 of 5
--	--	-------------------------------	--------------------

TITLE (4)  
Unit 3 Shutdown Cooling Isolation from an invalid Low Reactor Water Level Signal due to Procedural Deficiency

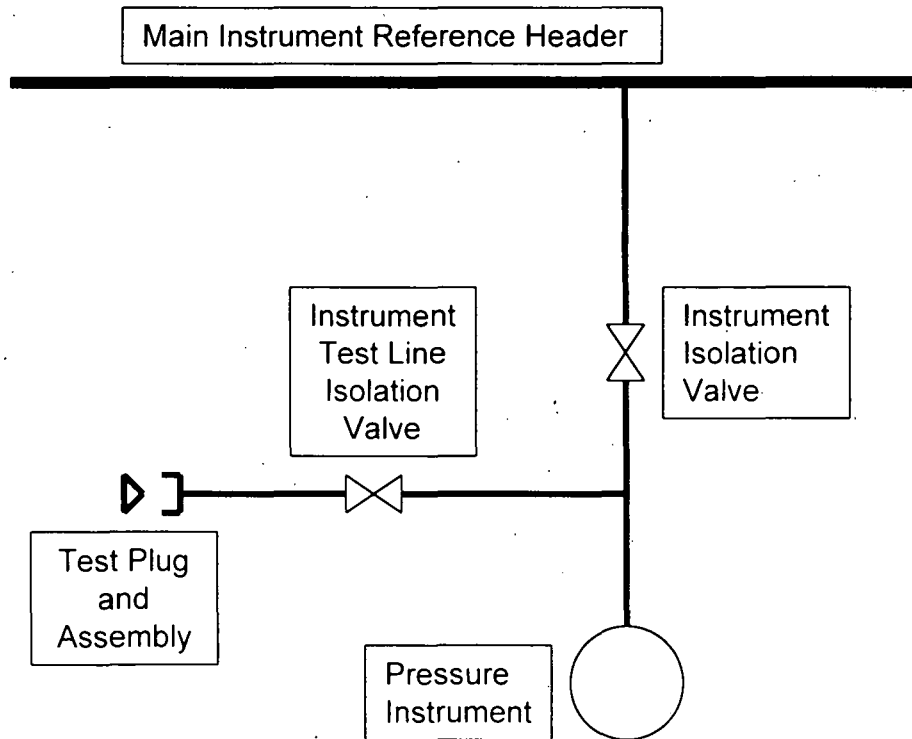
Attachment A  
Typical Pressure Switch Configuration

For each instrument to be returned to service, the Equipment Attendants replaced the instrument test line vent plug, closed the instrument vent plug isolation valve, and then unisolated the instrument reference leg isolation valve. (Attachment A - typical pressure switch configuration) For each instrument, one Equipment Attendant would perform a verification of the component alignment concurrent with a second Equipment Attendant who performed the

The reactor pressure instruments on the 2203-5 rack share a common sensing line with the reactor level instruments. Normally, with reactor pressure at zero pounds, there is a 13-pound pressure seen at each instrument due to the height of water present in the instrument reference line. When the Equipment Attendants replaced the cap on the instrument vent line, a pressure of zero existed in the pressure instrument and associated piping. As the operator proceeded to valve the reactor pressure instrument into service, a sudden pressure drop occurred as the 13-pound pressure equalized with the zero pound instrument pressure. The system saw the overall effect as a momentary pressure oscillation in the reference piping. This small pressure oscillation was determined to be sufficient to affect the sensitive level instruments, causing the instruments to see a momentary (indicated) level drop causing the reactor scram and Group Isolations to occur.
