LICENSEE EVENT REPORT (LER)

Dresden Nuclear Power Station, Unit 3

Reactor Recirculation B Loop, High Pressure Flow Element Venturi Instrument Line Steam Leakage Results in Unit 3 Shutdown Due to Fatigue Failure of Socket Welded Pipe Joint

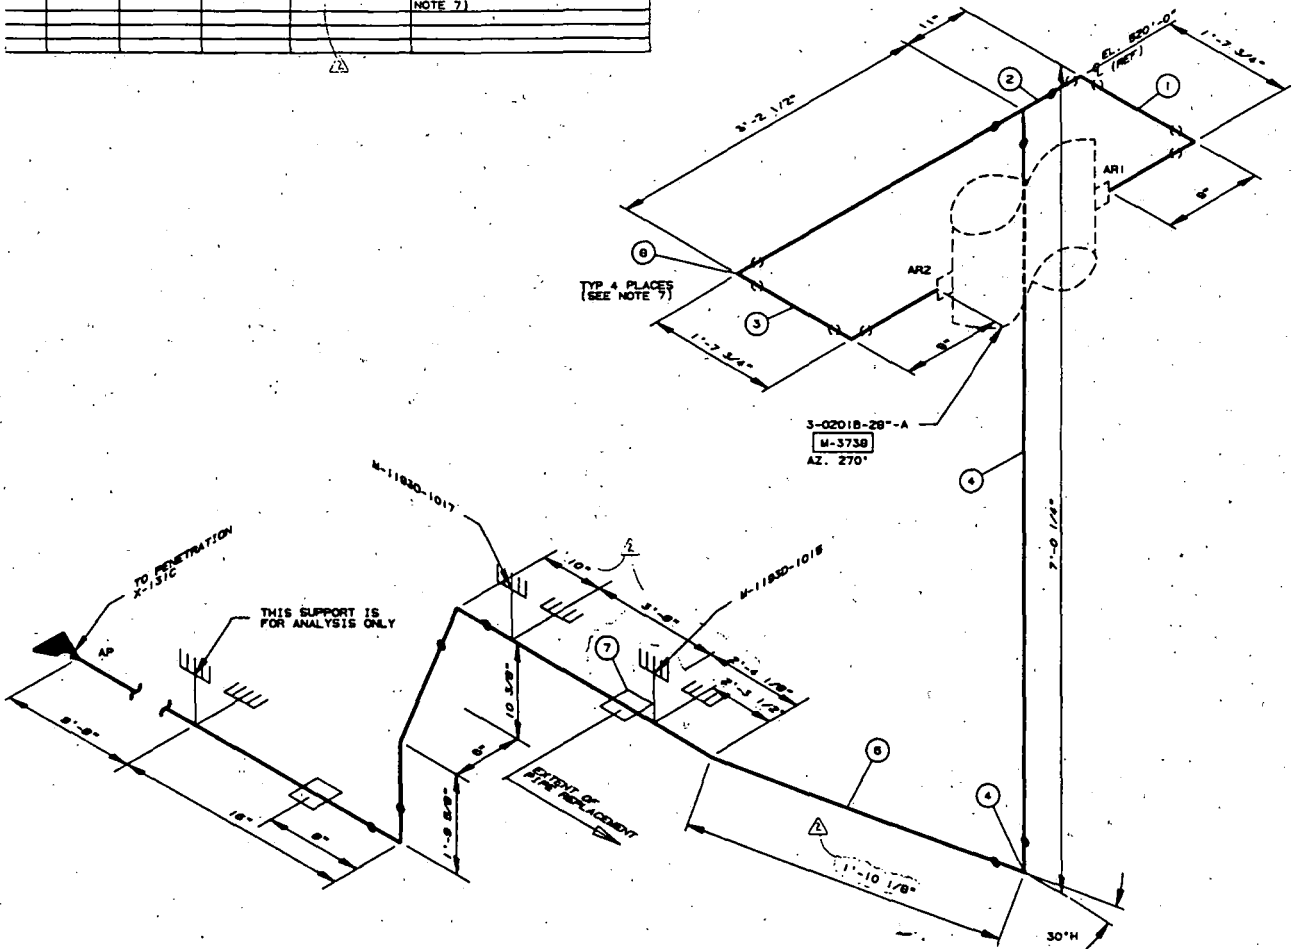
The instrument piping is stainless steel and originates at two locations on the B recirc. loop venturi, high-pressure side. Two branch pipes route around the recirc. piping and join together at the subject tee fitting. The piping is then routed through drywell penetration X-131C to flow transmitters 3-261-6C & 6D (see sketch on page 6).

There are two guide-type supports between the tee and the drywell penetration. The supports are closer to the drywell penetration than to the recirc. loop piping. Those two supports are U-bolts, with gaps, intended to act as two-way restraints.

The steam leak was located in the top portion of the pipe-to-tee socket weld connection. A Management decision was made to replace the piping, two elbows, and the tee with new material. Stronger welds

The tee with the failed weld, the two adjacent elbows (to the left and right sides of the run element of the tee), the pipe between the elbows, and approximately 5 inches of the pipe welded to the branch side of the tee were replaced with type 304 stainless steel. The original material was type 316L stainless steel, which has a lower stress allowable. (complete)

EPRI report TR-107455 states, "Most significantly, increasing the axial weld leg dimension with respect to ASME Code minimums can substantially increase the fatigue strength of the joint and can even counteract the potentially damage effect of weld root defects." In keeping with this recommendation, the old welds were replaced with a stronger weld (the weld leg length along the pipe is twice the socket height). The leg length of the old weld was equal to the socket height. The existing pipes that are welded to the new elbows were polished and non-destructive surface examined by penetrant testing (PT) before welding. (complete)
