LICENSEE EVENT REPORT (LER)

Dresden Nuclear Power Station, Unit 3

Supplement to Reactor Recirculation B Loop, High Pressure Flow Element Venturi Instrument Line Steam Leakage Results in Unit 3 Shutdown Due to Fatigue Failure of Socket Welded Pipe Joint

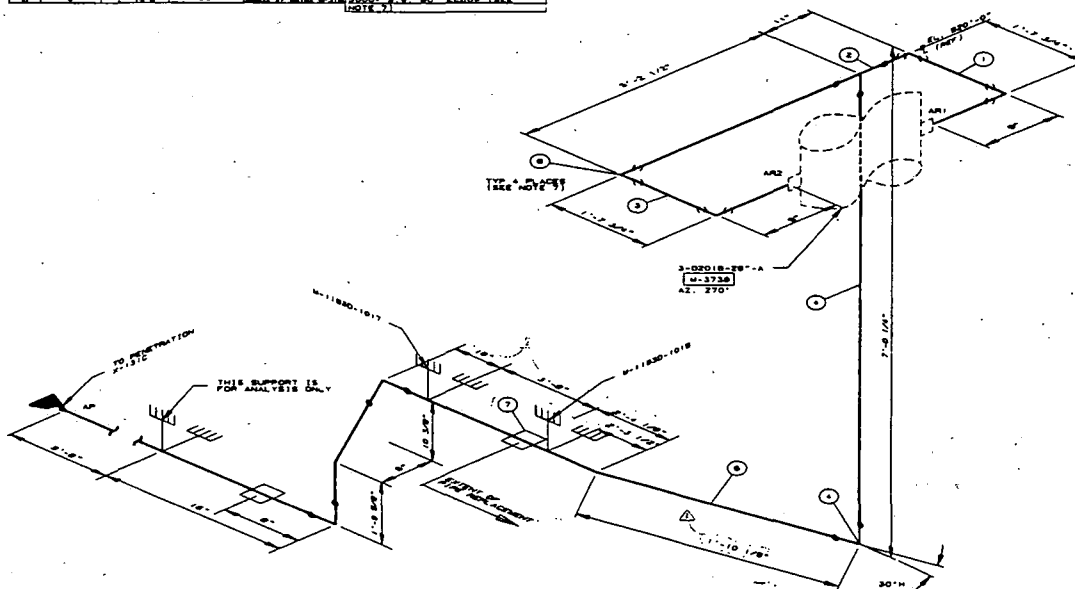
The instrument piping is stainless steel and originates at two locations on the B recirculation loop venturi, high-pressure side. Two branch pipes route around the recirculation piping and join together at the subject tee fitting. The piping is then routed through drywell penetration X-131C to flow transmitters 3-261-6C & 6D (see sketch on page 6).

The steam leak was located in the top portion of the pipe-to-tee socket weld connection. A Management decision was made to replace the piping, two elbows, and the tee with new material. The new socket welds

A detailed analysis for the failed tee weld indicated the root cause of the weld failure was attributed to fatigue crack propagation resulting from low amplitude, high cycle vibration which was accelerated by the presence of a lack of fusion root weld defect. This conclusion is supported by industry research. EPRI Technical Report (TR) 107455 (Vibration Fatigue of Small Bore Socket-Welded Pipe Joint) and INPO Operations and Maintenance Reminder (O&MR) 01-98 (Small Bore Piping Connection Failures – Operation and Maintenance Reminder 424) cite examples where this type of failure is attributed to fatigue due to vibration in conjunction with a pre-existing flaw. The vibration in the line works on a flaw in the root weld. When sufficient cycles are reached, the weld fails with crack initiation on the inside of the weld.

The tee with the failed weld, the two adjacent elbows (to the left and right sides of the run element of the tee), the pipe between the elbows, and approximately 5 inches of the pipe welded to the branch side of the tee were replaced with type 304 stainless steel. The original material was type 316L stainless steel, which has a lower stress allowable. (Complete)

EPRI report TR-107455 states, "Most significantly, increasing the axial weld leg dimension with respect to ASME Code minimums can substantially increase the fatigue strength of the joint and can even counteract the potentially damage effect of weld root defects." In keeping with this recommendation, the old welds were replaced with a weld more resistant to a vibration induced fatigue failure (the weld leg length along the pipe is twice the socket height). The leg length of the old weld was equal to the socket height. The existing pipes that are welded to the new elbows were polished and non-destructive surface examined by penetrant testing (PT) before welding. (Complete)
