**LICENSEE EVENT REPORT (LER)**

FACILITY NAME (1) <b>Dresden Nuclear Power Station, Unit 3</b>	DOCKET NUMBER (2) <b>05000249</b>	PAGE (3) <b>1 of 6</b>
---	--------------------------------------	---------------------------

TITLE (4)  
**Supplement to Reactor Recirculation B Loop, High Pressure Flow Element Venturi Instrument Line Steam Leakage Results in Unit 3 Shutdown Due to Fatigue Failure of Socket Welded Pipe Joint**

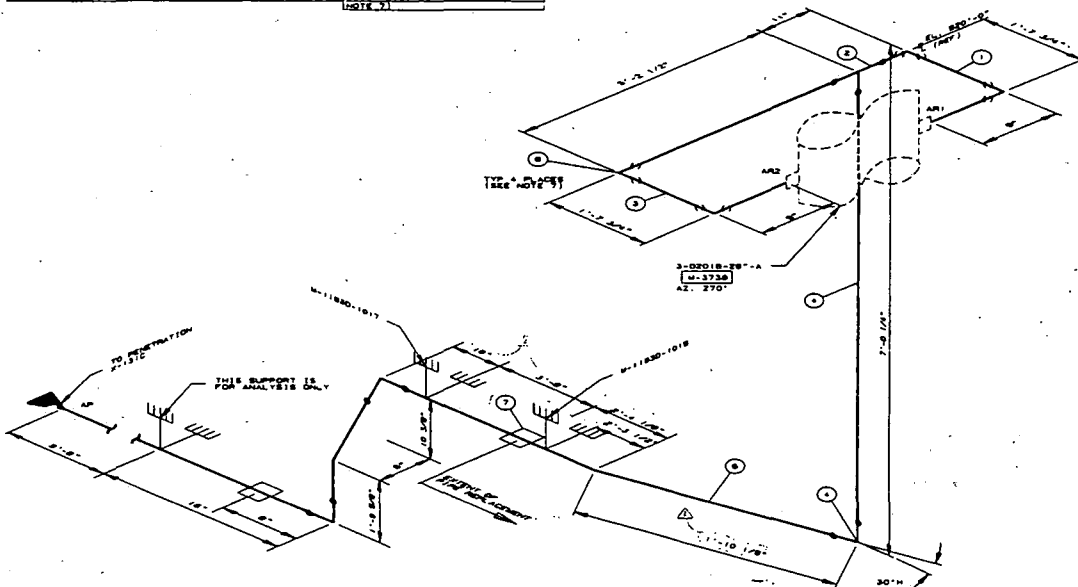
The instrument piping is stainless steel and originates at two locations on the B recirculation loop venturi, high-pressure side. Two branch pipes route around the recirculation piping and join together at the subject tee fitting. The piping is then routed through drywell penetration X-131C to flow transmitters 3-261-6C & 6D (see sketch on page 6).

There are two guide-type supports between the tee and the drywell penetration. The supports are closer to the drywell penetration than to the recirculation loop piping. Those two supports are U-bolts, with gaps, intended to act as two-way restraints.

The steam leak was located in the top portion of the pipe-to-tee socket weld connection. A Management decision was made to replace the piping, two elbows, and the tee with new material. The new socket welds

The tee with the failed weld, the two adjacent elbows (to the left and right sides of the run element of the tee), the pipe between the elbows, and approximately 5 inches of the pipe welded to the branch side of the tee were replaced with type 304 stainless steel. The original material was type 316L stainless steel, which has a lower stress allowable. (Complete)

EPRI report TR-107455 states, "Most significantly, increasing the axial weld leg dimension with respect to ASME Code minimums can substantially increase the fatigue strength of the joint and can even counteract the potentially damage effect of weld root defects." In keeping with this recommendation, the old welds were replaced with a weld more resistant to a vibration induced fatigue failure (the weld leg length along the pipe is twice the socket height). The leg length of the old weld was equal to the socket height. The existing pipes that are welded to the new elbows were polished and non-destructive surface examined by penetrant testing (PT) before welding. (Complete)
