February 25, 1980

Subject: Dresden Station Unit 3
Feedwater Nozzle/Sparger and
CRD Return Line Nozzle
Inspection Programs
NRC Docket No. 50-249

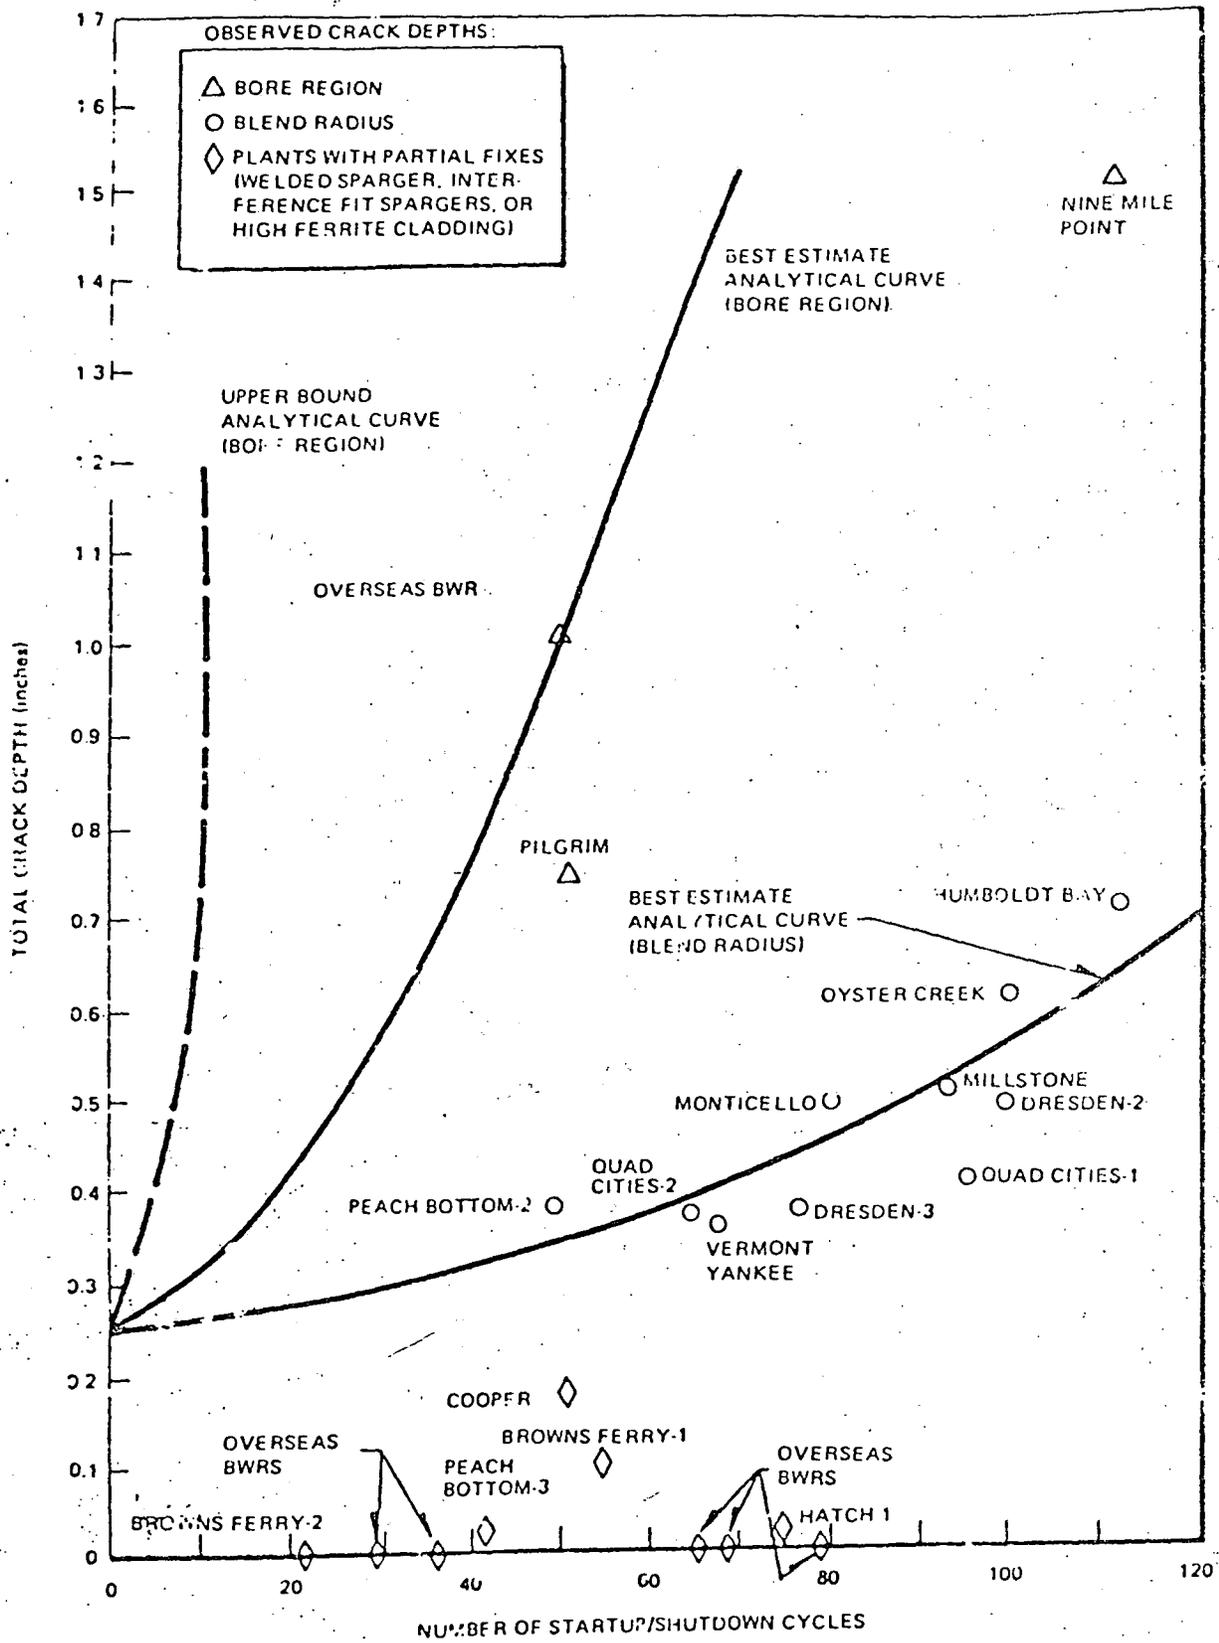
Experience accumulated with the new interference fit sparger, however, has pointed out the conservatism even in the CECo. crack growth curves. Figure 1 contains data accumulated by General Electric on crack depth for up to 75 SU/SD cycles with the interference sparger in use. A curve established using the G.E. generic SU/SD cycle is compared to this actual interference fit data. It can be seen that the worst case of the 10 units with the interference fit sparger has a maximum crack depth of 0.2", with only one other unit having a maximum crack depth of 0.1". The remaining eight units, however, had maximum crack depths that were much smaller or nonexistent. The above data points out the effectiveness of the interference fit sparger in eliminating the leakage flow which is the mechanism initiating the cracking in the feedwater nozzles.
