**Commonwealth Edison**  
One First National Plaza, Chicago, Illinois  
Address Reply to: Post Office Box 767  
Chicago, Illinois 60690

Subject: Status Report on SSRT  
Open Issues  
NRC Docket No. 50-237

This letter satisfies the commitment in reference (b) to  
provide a status report for the open SSRT review items for  
Dresden Unit 2.

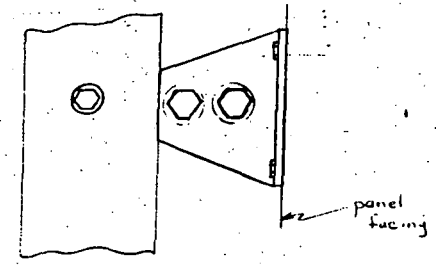
SEC. B-B

Vertical boards 902-15 and 902-17 had a vertical brace added as shown in the attachment except the top was directly bolted to the top of the cabinet by two bolts instead of bolting to a piece of P-1000 unistrut. The vertical brace was fastened to the panel by lateral elements of the type shown in section B-B

of the attachment. There are five of these lateral elements evenly spaced from top to bottom.

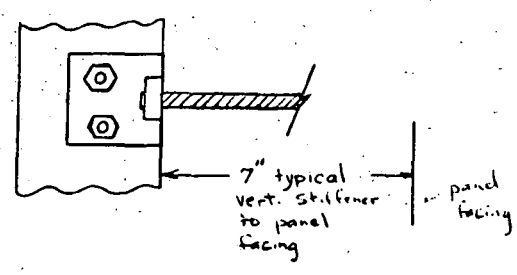
SEC. A-A

Instrument racks and vertical boards 902-32, 902-33, 902-39, 902-46, and 902-47 had bracing added as illustrated on attachment A. The vertical brace was fastened to the panel by lateral elements of the type shown in section A-A of the attachment. The 1/4" threaded rod used for the lateral elements were not always evenly spaced but were always attached to the panel sections containing HFA relays.

Hoffman enclosures 902-40, 902-41, 2202-15A, and 2202-15B had bracing added to the inside of the enclosures. This added bracing has a vertical brace like the one shown in the attachment and is attached to the top and bottom of the enclosures by the same method shown attaching the vertical brace to the floor in the attachment. There are three evenly spaced vertical braces each having three evenly spaced lateral elements as shown in section A-A attached to the back of the enclosure.
