Dresden Nuclear Power Station
 R. R. #1
 Morris, Illinois 60450
 December 12, 1973

SUBJECT: LICENSE DPR-19, DRESDEN NUCLEAR POWER STATION, UNIT #2, REPORT OF ABNORMAL OCCURRENCES PER SECTION 6.6.B.1.a OF THE TECHNICAL SPECIFICATIONS, HPCI DRAIN LINE LEAK AND TORUS HIGH LEVEL RESULTING FROM VALVE LINEUP SUBSEQUENT TO REPAIRS.

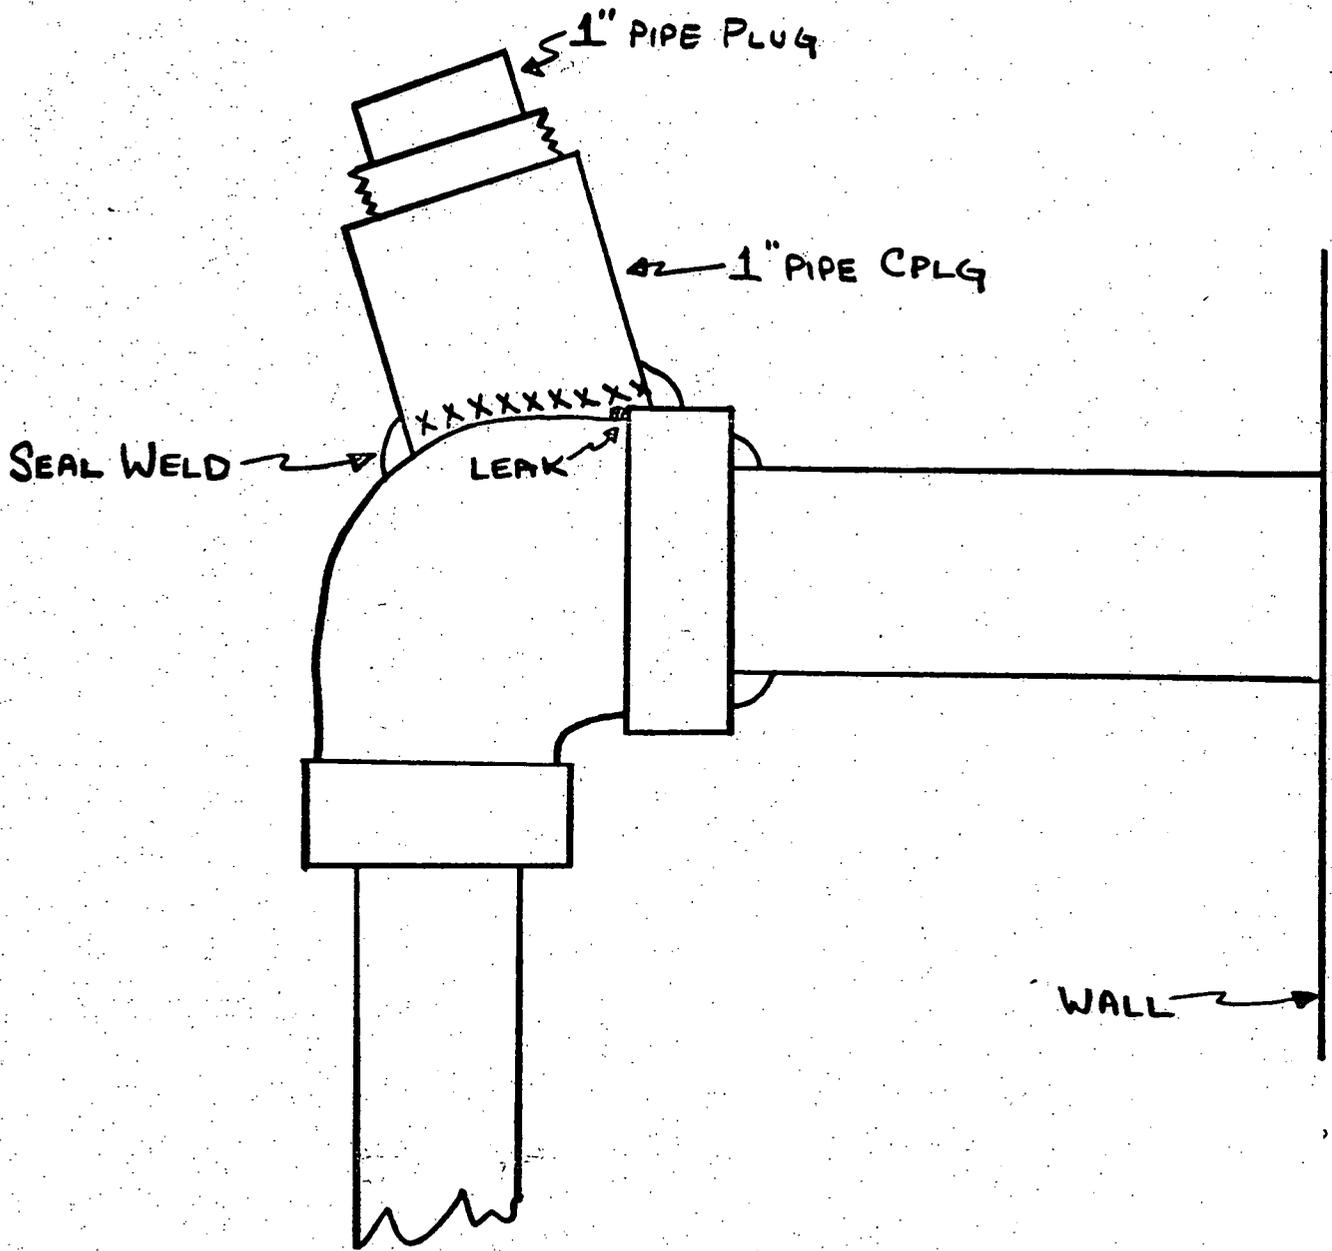
FIG. 1

The unit was operating at 735 MWe with steady state conditions. At 0900 hours on December 3 it was noted in the Unit #2 turbine building walkway that the HPCI drain pot drain line 2-2323-1"-LX was leaking steam at a 90° elbow where the line penetrates a shield wall to enter the condenser. Because of the manner in which the line is situated, it is tied directly to the condenser from the HPCI drain pot with isolation valves upstream of the leak which prevents condenser vacuum from being isolated from the affected area of the line. At 1315 hours, the valve lineup was changed such that drainage was directed to the torus instead of the condenser and the segment of line isolated so that the elbow was under a vacuum. Close inspection

Investigation of the leaking elbow showed steam was blowing through the line under pressure. The trap in the drain pot discharge line should eliminate any steam blowing down this line. The trap has a one inch bypass valve which if it was leaking could also cause this steam. Either inadequate trap performance or bypass valve leakage could be the main reason for this erosion problem.

Because the line is tied directly to the condenser from the drain pot, this segment of line can't be isolated and will always be under a vacuum from the condenser. The line was temporarily repaired by 2200 hours December 3. This temporary fix only lasted approximately 2.5 days, however, and the line was taken out of service at 0800 hours on December 6 to make another repair. This time repairs consisted of seal welding a one inch pipe coupling around the leak and sealing with a pipe plug (Fig.1). These repairs were completed by 1407 hours on December 7, 1973. During the next extended unit outage, this segment of carbon steel line and elbows will be replaced with stainless steel pipe. At the same time, as many fittings as possible will be removed to decrease the opportunities for erosion. The drain pot trap and trap bypass valve will be inspected for proper operation.
