Dresden Nuclear Power Station  
 R. R. #1  
 Morris, Illinois 60450  
 December 12, 1973

**SUBJECT: LICENSE DPR-19, DRESDEN NUCLEAR POWER STATION, UNIT #2, REPORT OF ABNORMAL OCCURRENCES PER SECTION 6.6.B.1.a OF THE TECHNICAL SPECIFICATIONS, HPCI DRAIN LINE LEAK AND TORUS HIGH LEVEL RESULTING FROM VALVE LINEUP SUBSEQUENT TO REPAIRS.**

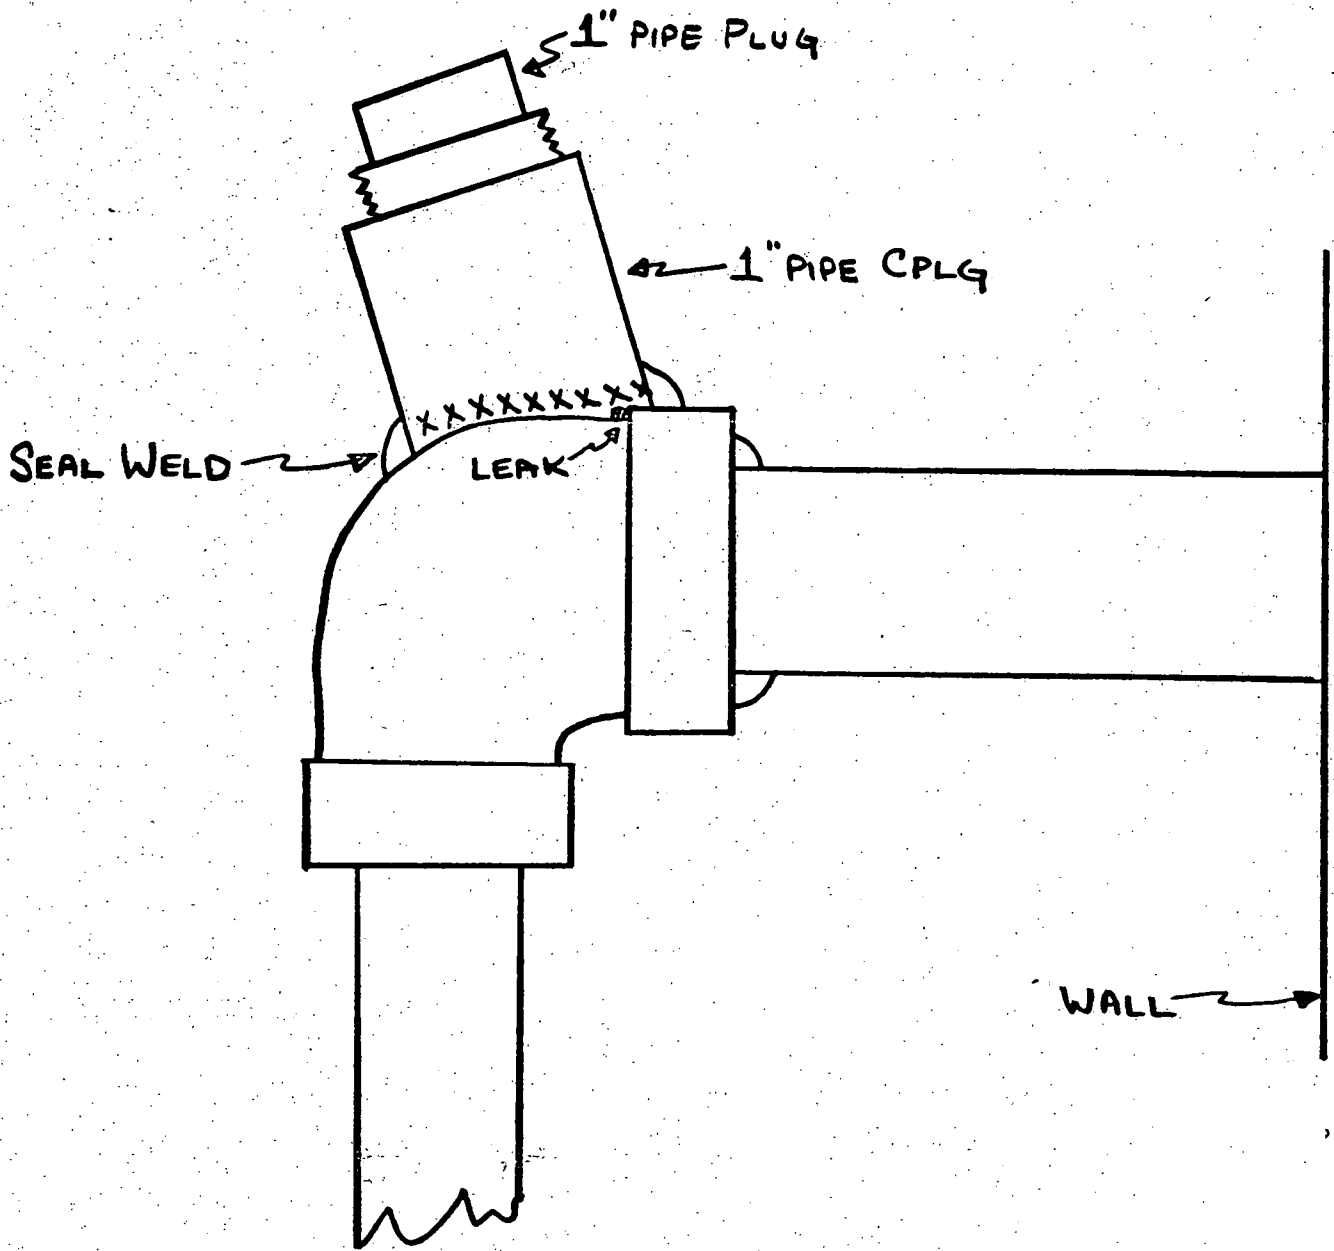
FIG. 1

The unit was operating at 735 MWe with steady state conditions. At 0900 hours on December 3 it was noted in the Unit #2 turbine building walkway that the HPCI drain pot drain line 2-2323-1"-LX was leaking steam at a 90° elbow where the line penetrates a shield wall to enter the condenser. Because of the manner in which the line is situated, it is tied directly to the condenser from the HPCI drain pot with isolation valves upstream of the leak which prevents condenser vacuum from being isolated from the affected area of the line. At 1315 hours, the valve lineup was changed such that drainage was directed to the torus instead of the condenser and the segment of line isolated so that the elbow was under a vacuum. Close inspection

Investigation of the leaking elbow showed steam was blowing through the line under pressure. The trap in the drain pot discharge line should eliminate any steam blowing down this line. The trap has a one inch bypass valve which if it was leaking could also cause this steam. Either inadequate trap performance or bypass valve leakage could be the main reason for this erosion problem.

Because the line is tied directly to the condenser from the drain pot, this segment of line can't be isolated and will always be under a vacuum from the condenser. The line was temporarily repaired by 2200 hours December 3. This temporary fix only lasted approximately 2.5 days, however, and the line was taken out of service at 0800 hours on December 6 to make another repair. This time repairs consisted of seal welding a one inch pipe coupling around the leak and sealing with a pipe plug (Fig.1). These repairs were completed by 1407 hours on December 7, 1973. During the next extended unit outage, this segment of carbon steel line and elbows will be replaced with stainless steel pipe. At the same time, as many fittings as possible will be removed to decrease the opportunities for erosion. The drain pot trap and trap bypass valve will be inspected for proper operation.
