CENSEE EVENT REPORT

ATTACHMENT TO LICENSEE EVENT REPORT 78-004/01T-0
COMMONWEALTH EDISON COMPANY (CWE)
DRESDEN UNIT 2 (ILDRS-2)
DOCKET # 050-237

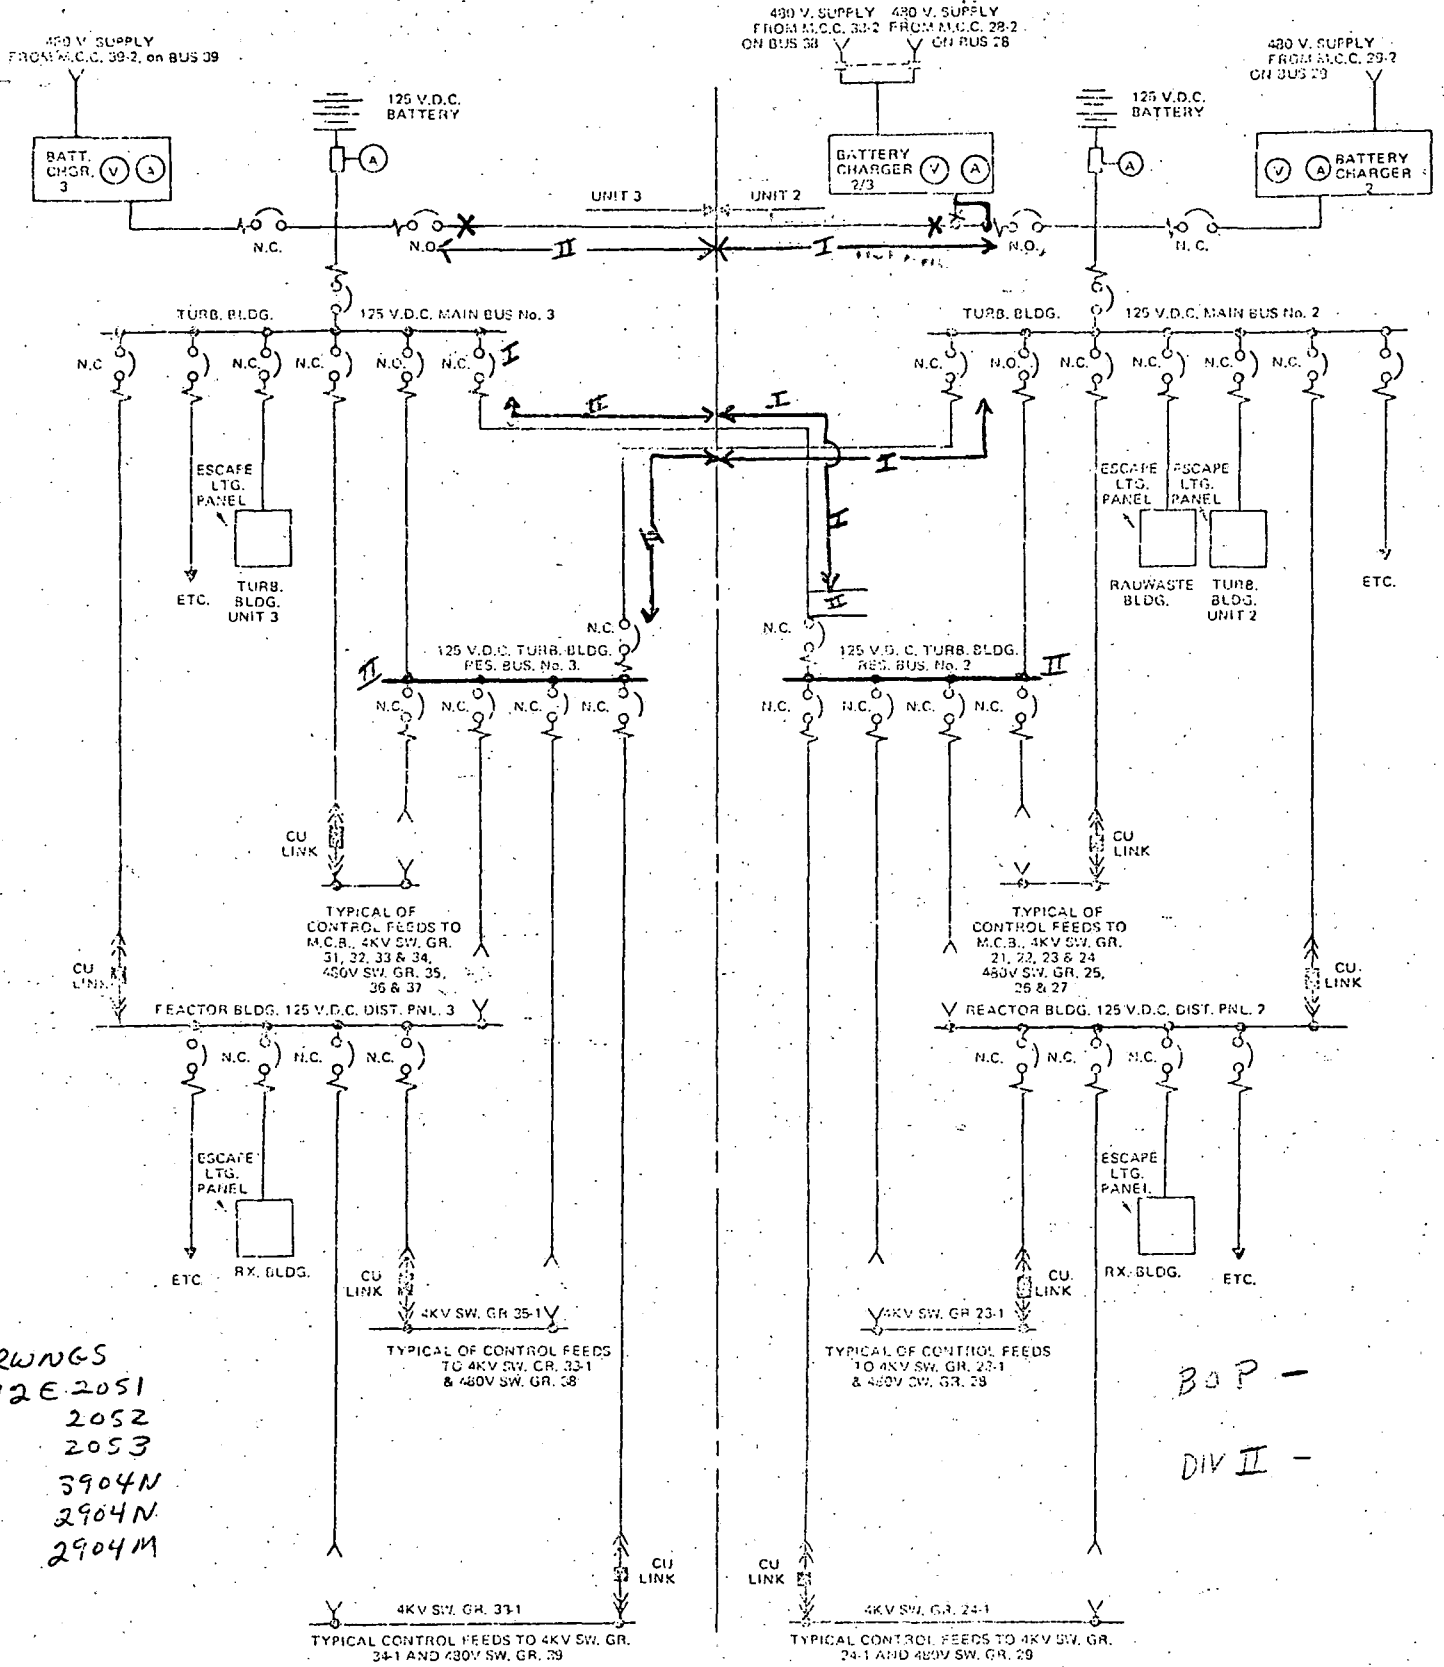
FIGURE 10-9. 125 Vdc STATION BATTERY SYSTEM

During normal plant operation, an inspection was made in response to NRC questions regarding fire protection. The NRC requested that the licensee verify routing and separation of the U-2 and U-3 125V DC cables. It was determined that two cables were not routed conservatively from a separation standpoint. These cables were the cables connecting the U-2/3 125V DC battery charger with the U3 125V DC batteries and the cable connecting the U-3 turbine building 125V DC Main Bus No. 3 with the U-2 turbine building 125V DC Reserve Bus No. 2. Even though non-conservatively routed, the effect on safe plant operation is minimized since in the unlikely event of a fire in these cable trays multiple circuit breaker failures would have to occur to jeopardize the 125V batteries. The currently envisioned modifications are as follows.

The cable which connects the U 2/3 125V DC battery charger (which is located in the U-2 battery room) to the U-3 125V DC battery will be disconnected and the existing U 2/3 battery charger will become a redundant charger dedicated to U-2. A new charger is planned for installation as a redundant charger for the Unit 3 battery. The cable which is routed from the U-3 turbine building 125V DC Main Bus No. 3 (Division 1) is in a conduit attached to the bottom of U-3 Division 2 trays up to the wall to the U-2 turbine building 125V DC Reserve Bus No. 2 (Division 2) is routed in U-2 Division 1 trays. This connection will be rerouted so that the cable from the U-3 turbine building 125V DC Main Bus No. 3 to the wall between Units 2 and 3 is in U3 Division 1. The connection from the Units 2 and 3 wall to the U-2 turbine building 125V DC Reserve Bus No. 2 will be rerouted in U-2 Division 2.
