SUBJECT: Supplemental Report to Abnormal Occurrence Report No. 50-237/1975-11, Entitled "Core Spray Injection Line Through-Wall Cracks"

REPORT NUMBER: 50-237/1975-11A

FACILITY: Dresden Nuclear Power Station, Morris, Illinois

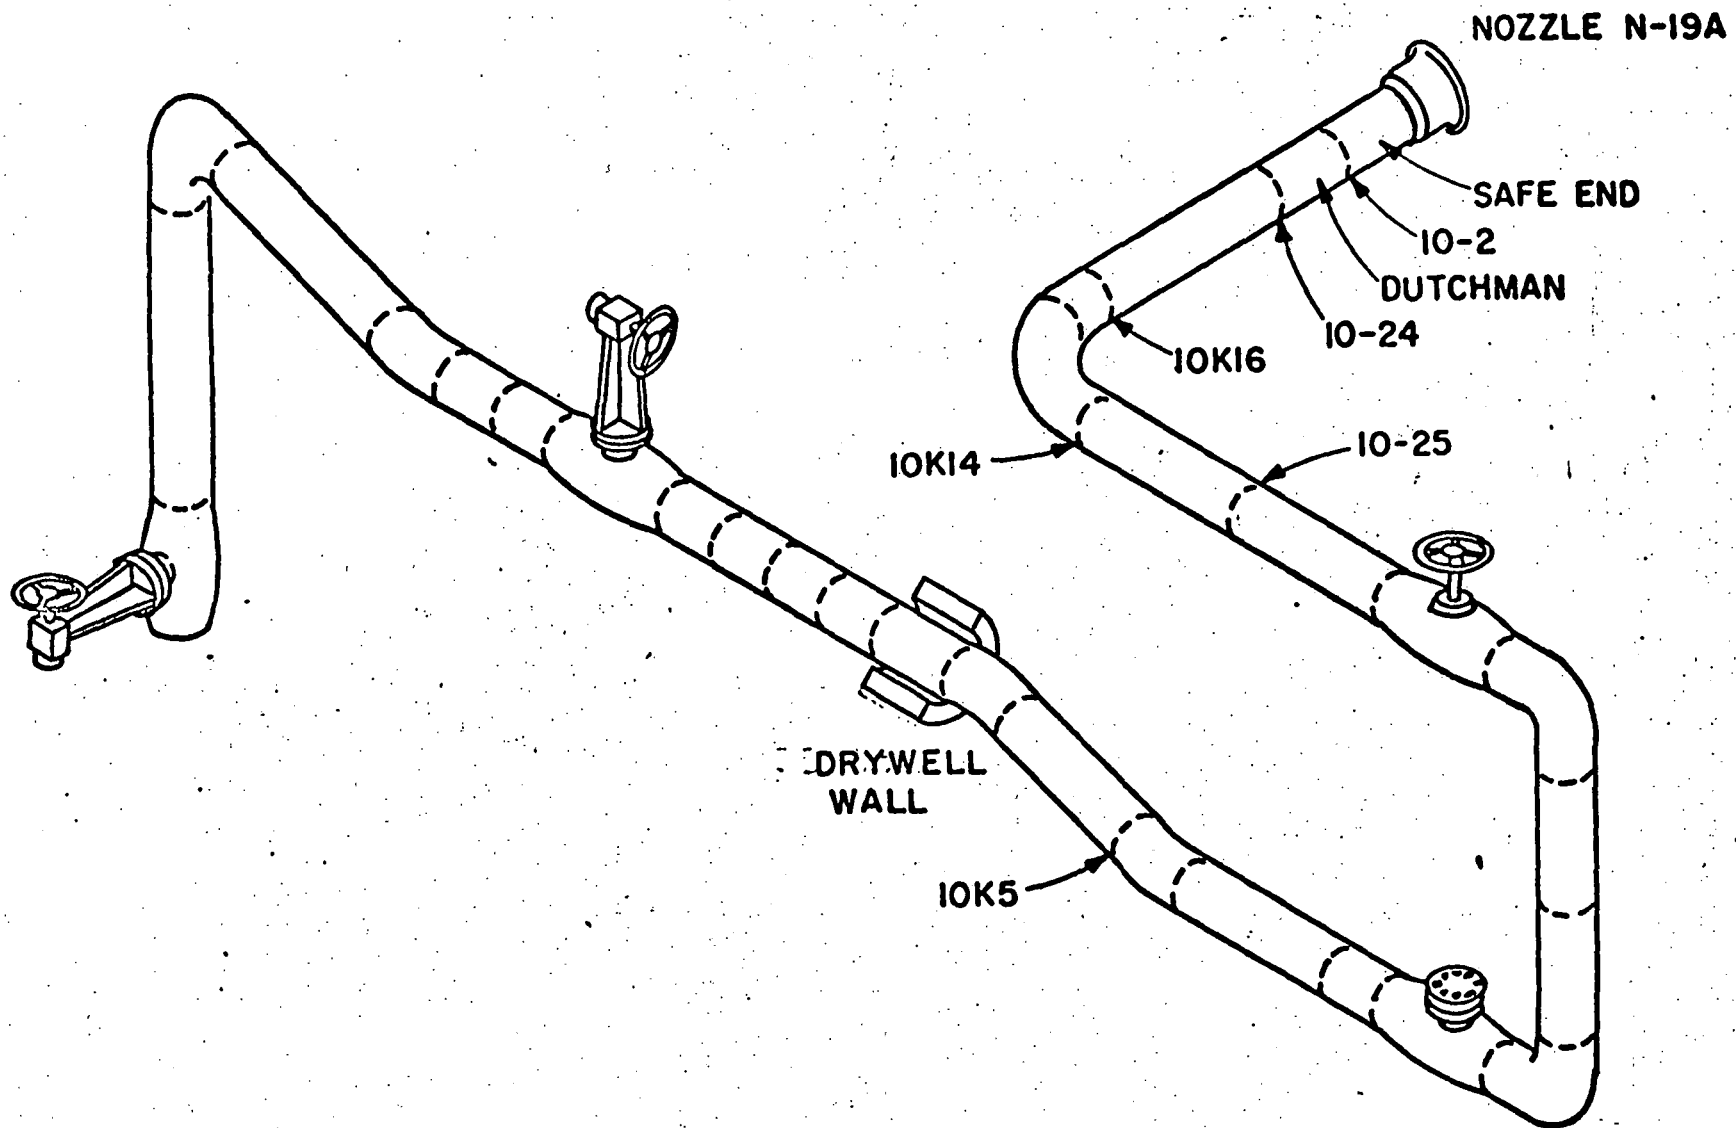
- a) The cracks were generally circumferential and were located in the heat-affected zone near the welds

- b) The mode of failure was strictly intergranular stress corrosion, initiating at the I.D. surface and propagating toward the O.D.
- c) Fatigue striations were not observed on the cracked surfaces by scanning electron microscopy
- d) None of the cracks propagated through welds, but were limited to a penetration of about 0.2 inches
- e) The cracks were similar to those found in 4-inch recirculation bypass lines, even in the relative composition of corrosion products.

Fig. 1. Loop A Emergency Core-spray Piping of Dresden-2 BWR. The weldments are indicated by dashed circumferential lines. Crack areas are denoted by arrows and weld identification numbers.

Corrective action taken to prevent recurrence was to replace the stainless steel portion of the core spray piping from the vessel nozzle to the second isolation valve with SA-333 Grade 6 carbon steel, and to replace the reactor vessel core spray safe-ends with SA-182 type 316L stainless steel with I.D. cladding of 308L weld material.

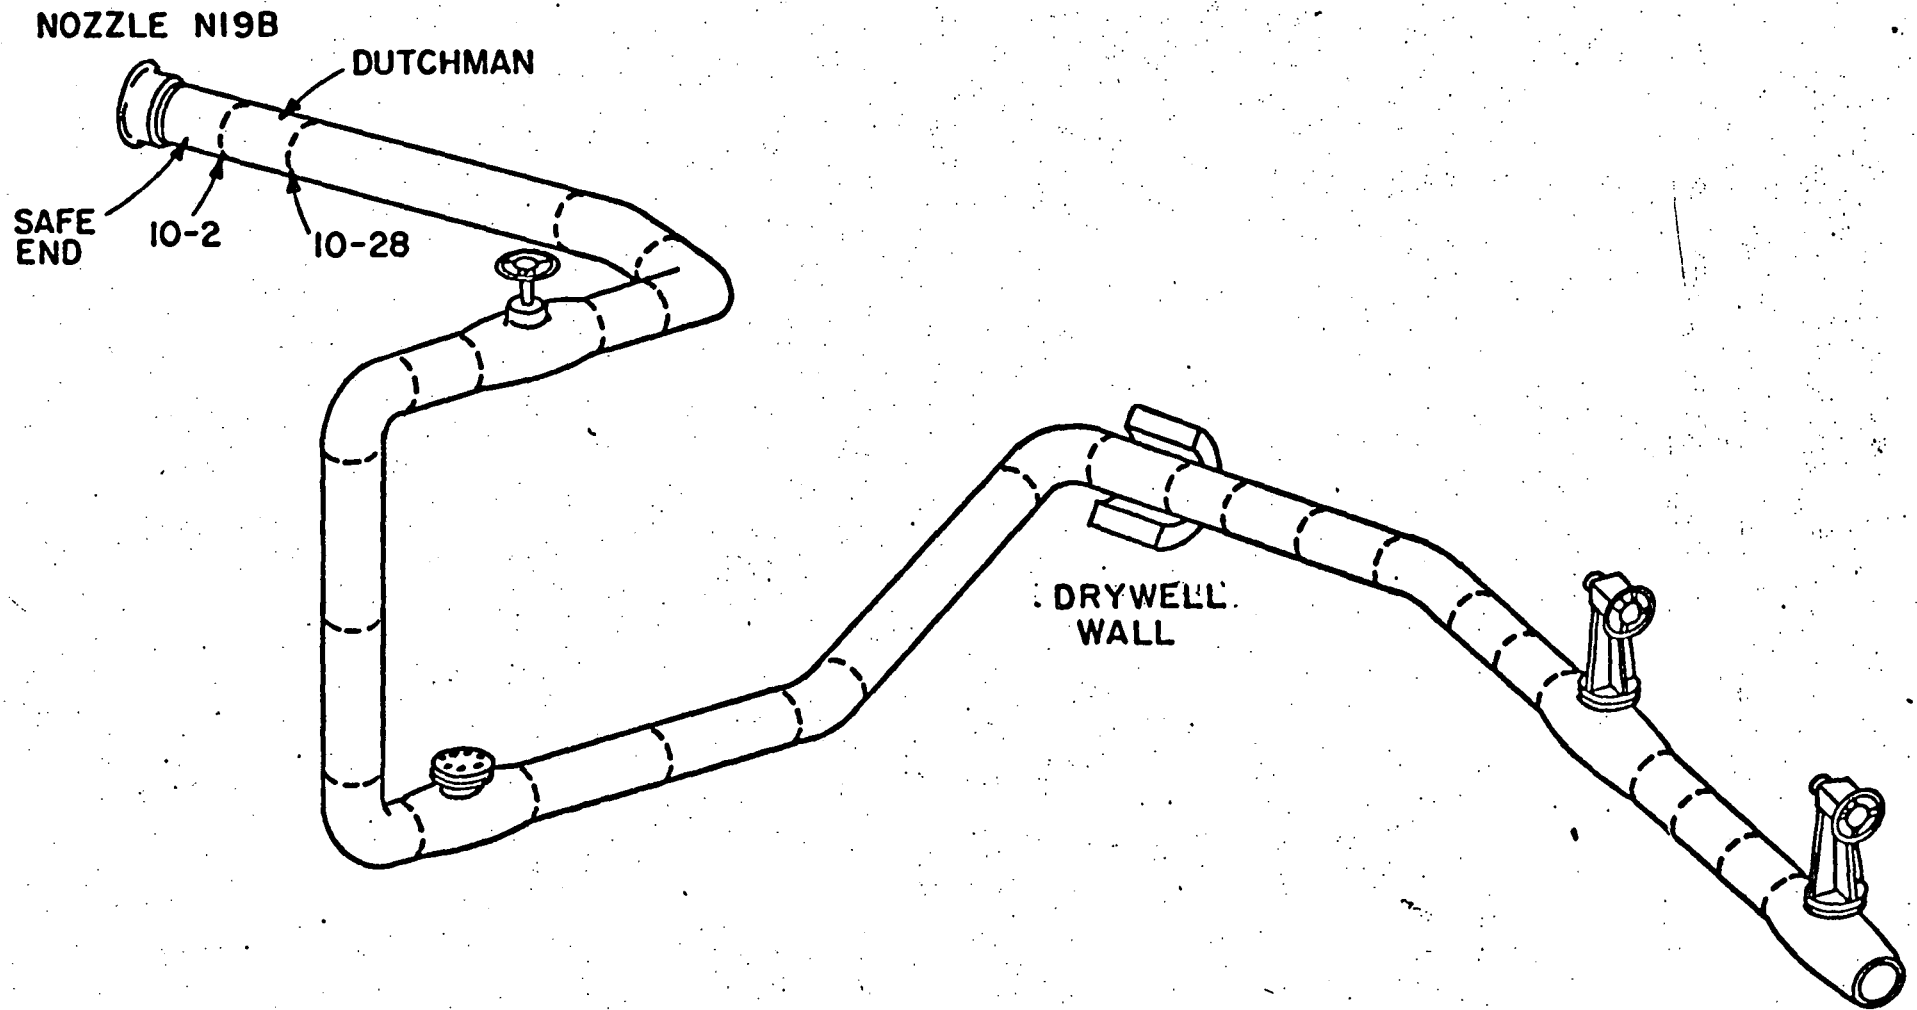
Fig. 2. Loop B Emergency Core-spray Piping of Dresden-2 BWR. The weldments are indicated by dashed circumferential lines. Crack areas are denoted by arrows and weld identification numbers.
