# Commonwealth Edison Company

Dresden Nuclear Power Station

Subject: License DPR-19, Dresden Nuclear Power Station  
Unit #2 Section 6.6.B.2 of the Technical Specifications

This is to report a condition relating to the operation of the station in which on July 24, 1972, the Unit 2 diesel generator failed to operate. Operability of the diesel generator is required by Section 3.9.B.2 of the Technical Specifications.

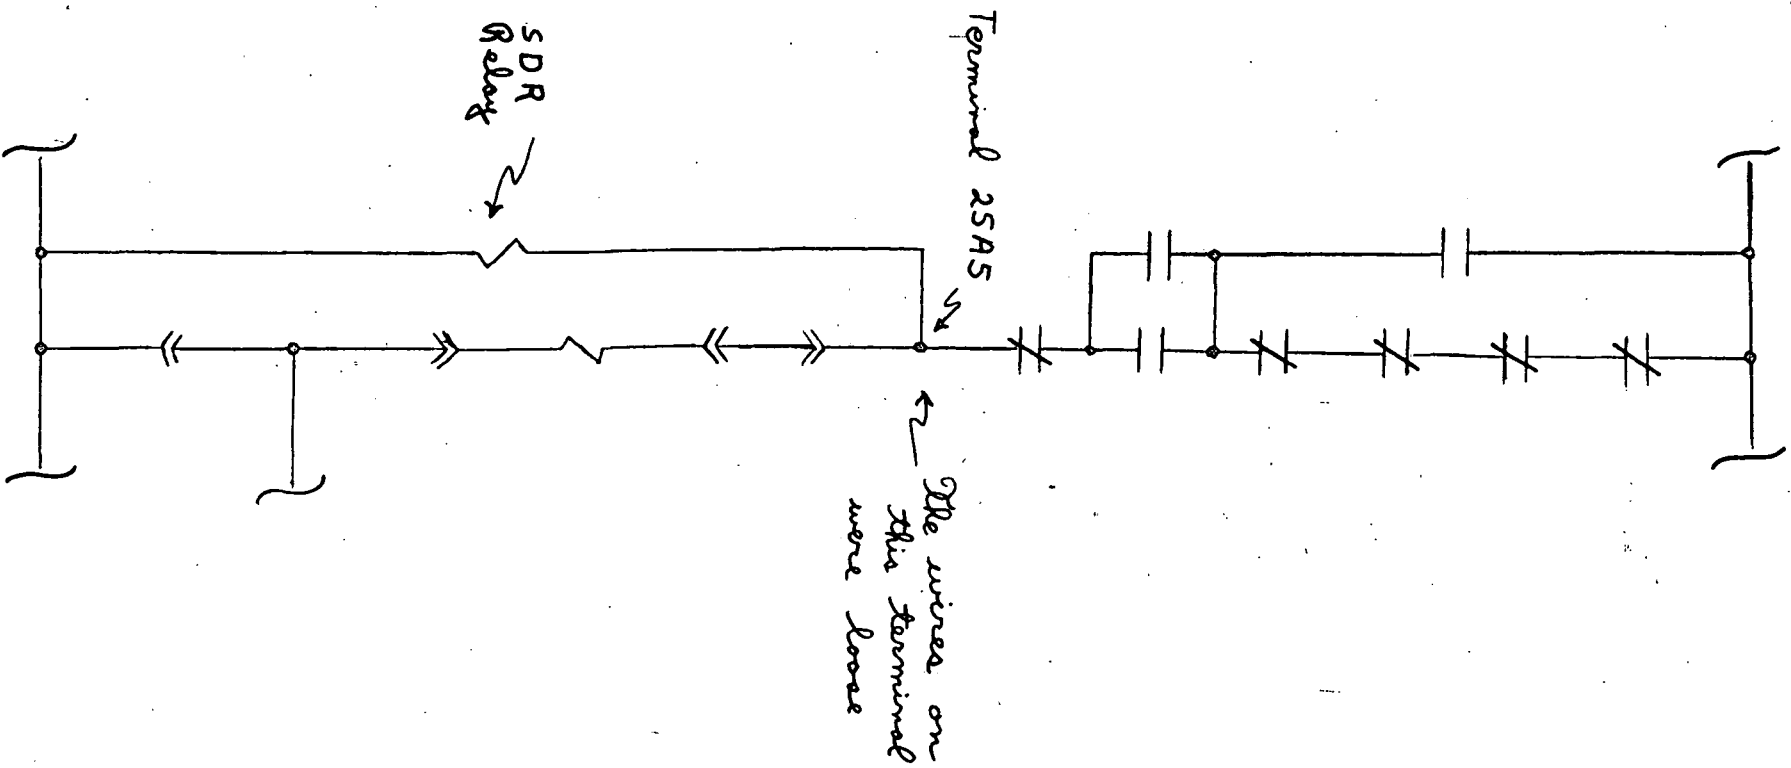
Fig. 1

Investigation revealed a loose connector lug at terminal 25A5 (See Figure 1). Because this lug was not properly connected, the SDR relay de-energized when diesel engine vibration caused the circuit to open intermittently. The SDR relay must be energized in order to have the diesel cooling water pump running. The SDR relay also energizes the VSR relay (generator excitation start relay). De-energizing the VSR relay would cause the voltage regulator to shut down.
