SUBJECT: LICENSE DPR-25, DRESDEN NUCLEAR POWER STATION, UNIT #3, SECTION 6.6.C.1 OF THE TECHNICAL SPECIFICATIONS, AND LICENSE DPR-19, DRESDEN NUCLEAR POWER STATION, UNIT #2, SECTION 6.6.C.1 OF THE TECHNICAL SPECIFICATIONS.

PROBLEM AND INVESTIGATION

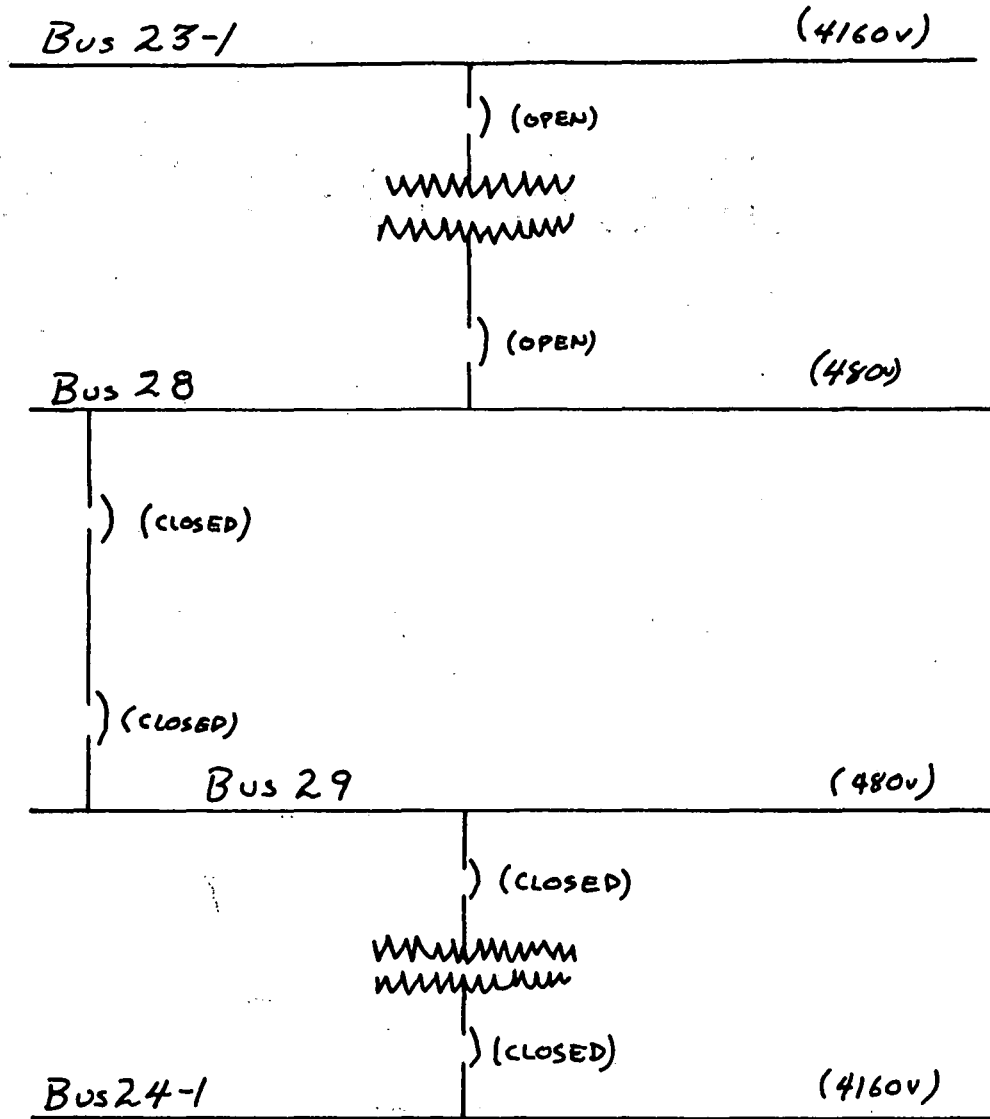
At 1130 hours on March 29, 1972, Unit #3 was at 800 MWe with the mode switch in "Run" and Unit #2 was in "Refuel" with all rods in and no fuel moves in progress. An electrical maintenance crew was overhauling the Transformer 28 high-side breaker at bus 23-1. Bus 28 was being supplied from bus 29 via the 28-29 bus tie breaker. (See figure 1)

The breaker auxiliary contacts in the breaker cubicle were exercised as part of the overhaul job. When these contacts were moved to a position corresponding to that of a closed breaker, an interlock circuit was satisfied that automatically tripped the 28-29 bus tie breaker at bus 29. This interlock circuit is designed to prevent tying bus 28 and 29 together when they are being fed from their parent 4160V buses.

When the bus tie breaker opened, power was lost to the motor control centers supplying "A" standby gas treatment system, "2A" standby liquid pump, and the "2A" core spray system valves, which rendered these systems inoperable.

The "B" standby gas treatment system was started immediately by the operator and verified to be operable. Normal electrical feed to bus 28 and its components was restored by 1330 hours the same day.

Maintenance procedural changes have been made to preclude a recurrence of this type of incident. In addition, caution signs have been placed in the Transformer 28 and 29 high-side breaker cubicles and in the corresponding breaker cubicles on Unit 3.
