Commonwealth Edison Company

Dresden Nuclear Power Station
R. R. #1
Morris, Illinois 60450
June 21, 1971

Subject: License DPR-19, Dresden Nuclear Power Station Unit #2
Sections 6.6.A.1 and 6.6.C.1 of the Technical Specifications

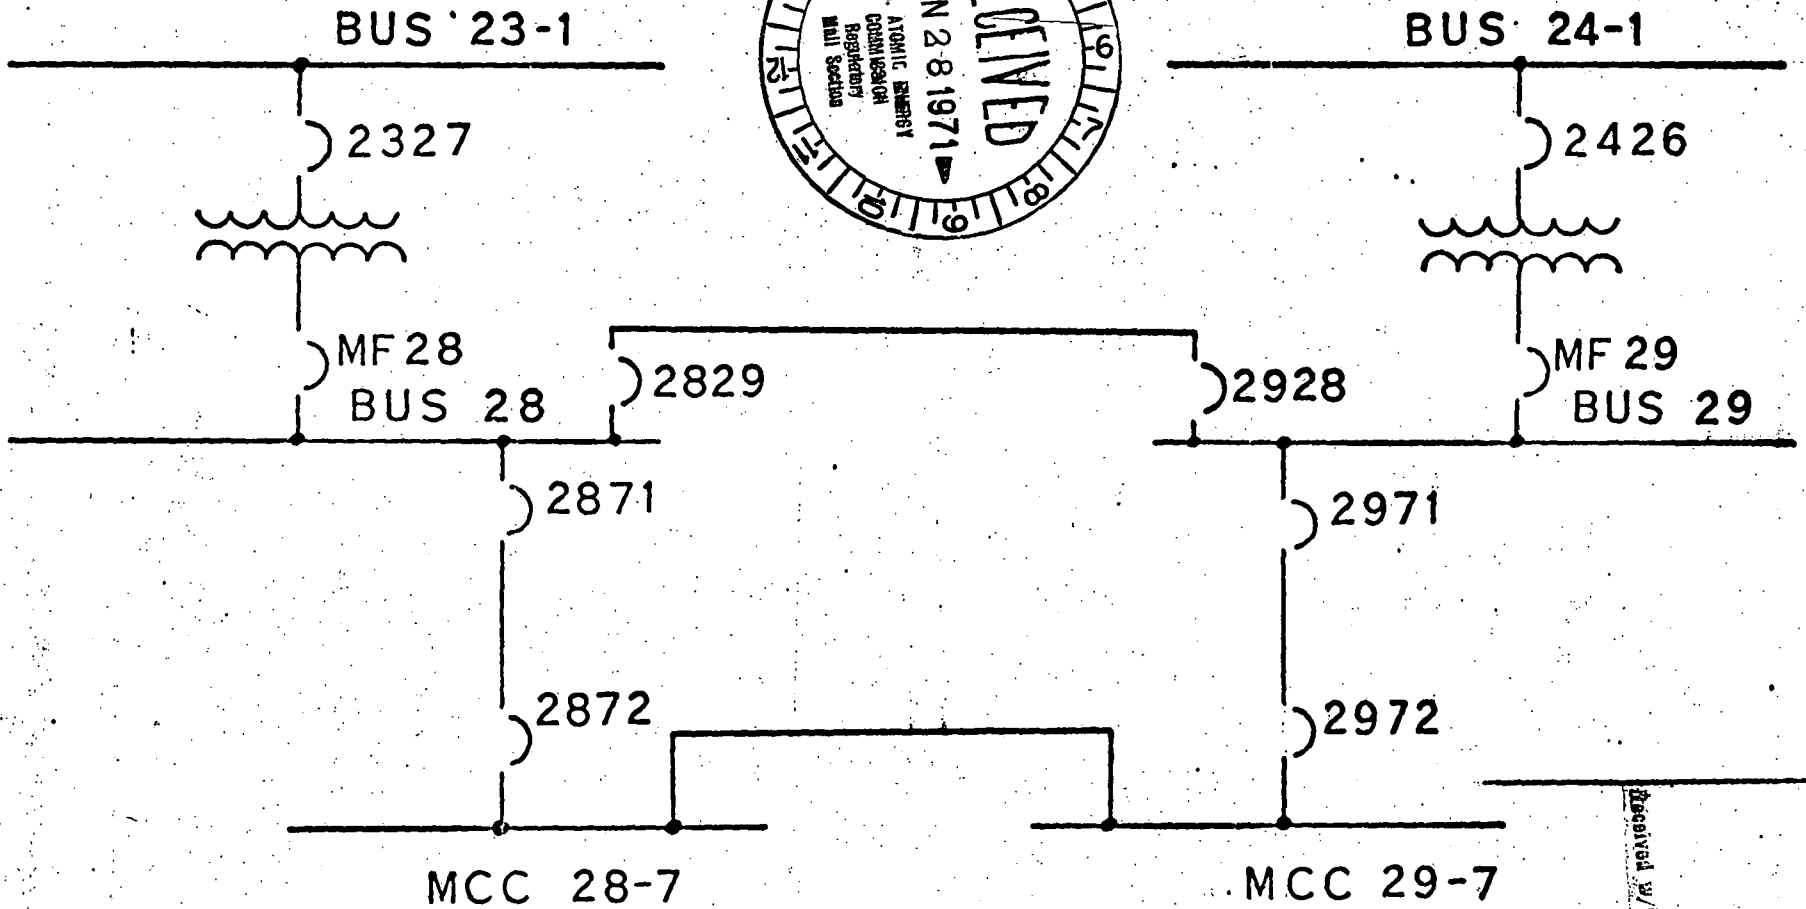
FIGURE 1

On May 21, 1971, bus undervoltage device functional tests were being conducted in accordance with DPR-19 Technical Specifications Section 4.2.1 as the result of a scheduled refueling outage. An undervoltage signal was supplied to Bus 29, causing the normal feed breakers (2971 and 2972) to trip satisfactorily. (See Figure One) It was then observed that the backup feed breakers 2871 and 2872 had no position indication. Immediate investigation revealed that MCC 28-7 and 29-7 were not energized, breaker 2871 was closed and breaker 2872 was open. Further investigation revealed that the rear control power fuse for breaker 2872 was blown. This fuse was replaced and an unsuccessful attempt was made to close the breaker automatically. A manual close signal was then given to the breaker which caused the front control power fuse to blow and the closing coil to burn out.

It is believed that the blown control power fuses were caused by an overcurrent condition in the breaker closing coil which eventually burned out the coil.

Following an inspection of breaker 2872, the closing coil was replaced, the MCC phase rotation was checked, and successful manual and automatic transfer tests were performed. No specific cause of the anomaly could be found nor could the malfunction be duplicated.
