# Commonwealth Edison Company

Dresden Nuclear Power Station  
R.R. #1  
Morris, Illinois 60450  
April 21, 1971

SUBJECT: LICENSE DPR-19, DRESDEN NUCLEAR POWER STATION UNIT #2, SECTIONS 6.6.A.1 AND 6.6.B.2 OF THE TECHNICAL SPECIFICATIONS.

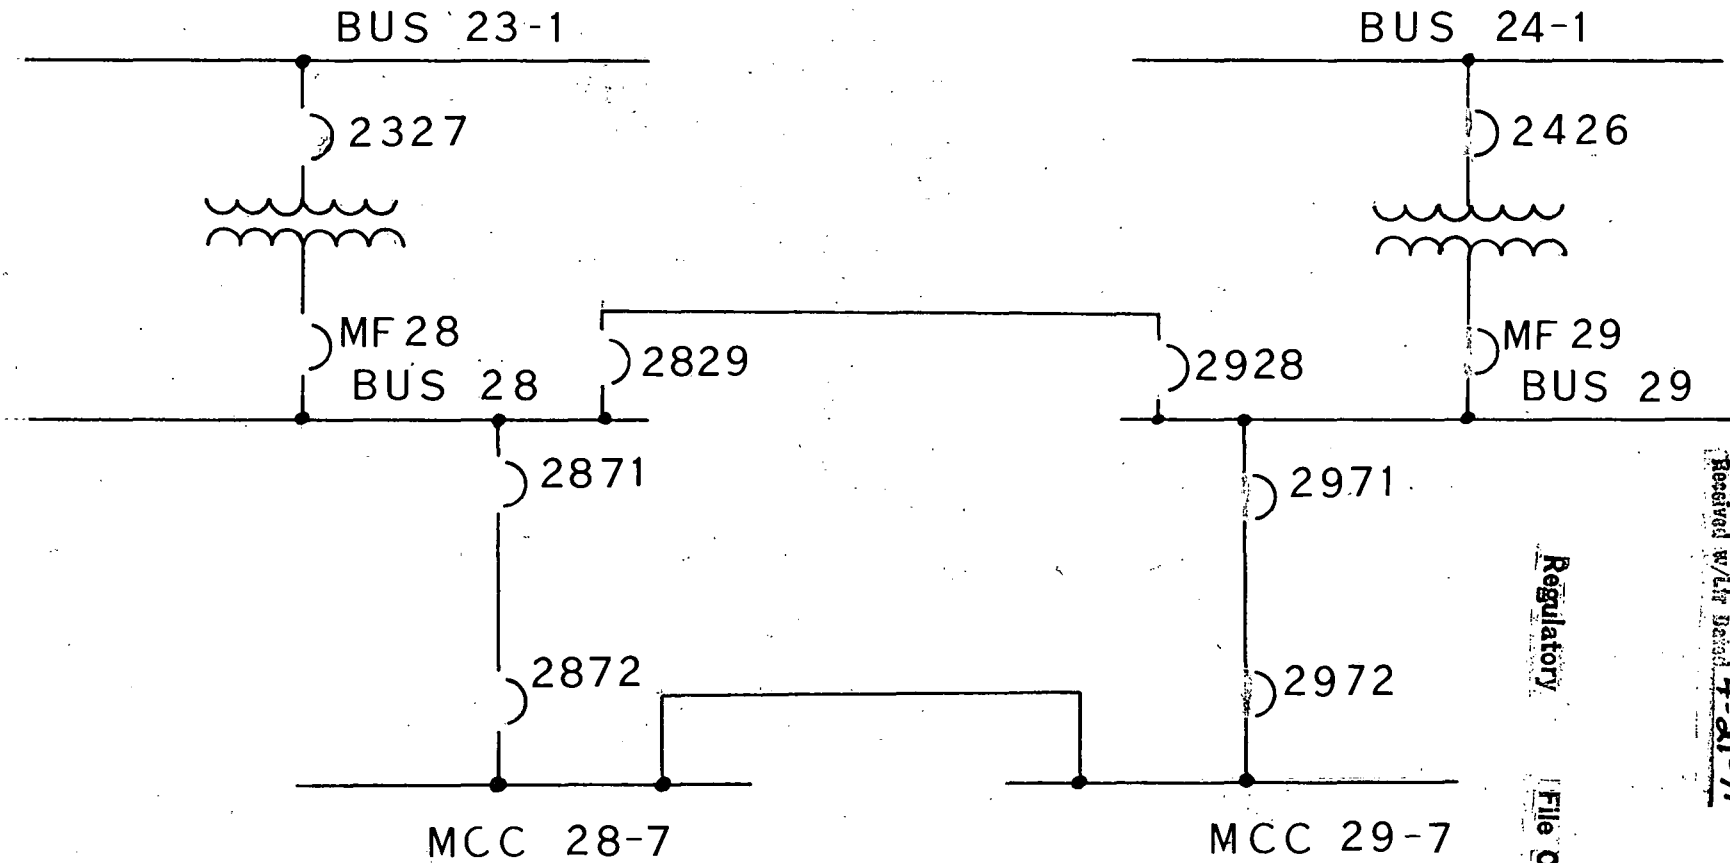
FIGURE 1

On April 4, 1971 a reactor recirculation system valve was returned to service following repacking of the valve shaft gland. The valve was exercised and was observed to travel opposite to the direction selected in the Control Room. Further testing revealed similar responses from other valves in that system. These valves are supplied from Motor Control Centers (MCC) 28-7 and 29-7 which were being supplied from their bus 28 feed (See attached Figure #1). These motor control centers also supply the LPCI reactor injection valve motors.

1. A phase rotation difference existed between bus 28 and MCC 28-7 and 29-7.
2. When MCC 28-7 and 29-7 were supplied from Bus 29 the phase rotations were proper.
3. The phase rotation difference was at the MCC 28-7 supply breaker 2872.

A search of the operating records revealed that the supply breaker 2872 had been replaced by construction personnel on February 26, 1970. This was the only work requiring disconnection of the power supply wiring performed on that breaker since the original construction. Proper phase rotation was verified during the construction tests, but apparently was not checked after the breaker replacement.

It is felt that the phase reversal on the MCC 28-7 and 29-7 backup power supply occurred at this time.

The phase rotation difference was corrected immediately and tested satisfactorily.

Procedures now in effect require that all construction changes be reviewed and adequately tested. The phase reversal would have been discovered and corrected immediately had these procedures been in effect at the time the breaker was replaced.

A review is currently in progress to ensure that construction changes completed prior to this time have been adequately tested.
