Subject: Dresden Station, Unit 2
 LP Turbine Wheel Ultrasonic Inspection
 Report of Findings
NRC Docket No. 50-237

TABLE #1

KEYWAY ULTRASONIC INDICATION SUMMARY

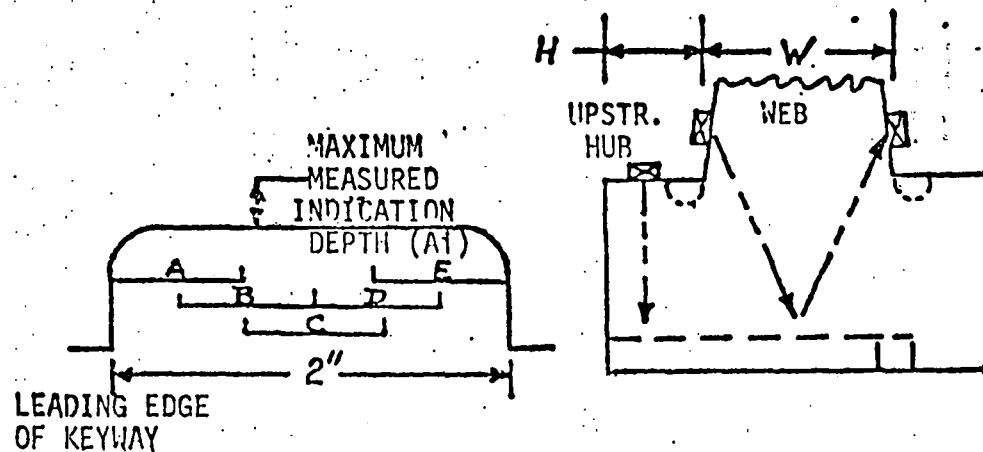
The keyway indications varied from less than 0.03 inches to a maximum of 0.29 inches. The attached Table 1 gives a complete description of the depths and locations of the keyway indications found.

Wh1	H (In)	W (In)	Hub Test (HT)		Web Test (WT)		Comments
			Location Zone (A-E)	A ₁ (In)	Location Zone (A-E)	A ₁ (In)	
5-TA	2.23	5.5	B	.21	---	---	Indication appears deepest near web
6-TA	2.73	6.5	E	<.03	---	---	Indication appears deepest near web
5-TB	2.23	5.5	B	.22	---	---	Indication appears deepest near hub face
			D,E	.24	---	---	Indication appears deepest near web
5-GB	2.23	5.5	A	.29	---	---	Indication appears deepest near web
			E	.26	E	.23	Indication under hub appears deepest near web
8-TB	3.48	11.5	---	---	E	<.03	
4-TC	2.73	4.0	C	<.03	---	---	
5-TC	2.23	5.5	A	.23	---	---	Indication appears deepest near web
			E	.24	D	<.03	Indication under hub appears deepest near web
5-GC	2.23	5.5	B	.27	---	---	Indication appears deepest near web
			E	.24	D	<.03	Indication under hub appears deepest near web
6-TC	2.73	6.5	A	<.03	---	---
