Commonwealth Edison
 Dresden Nuclear Power Station
 R.R. #1
 Morris, Illinois 60450
 Telephone 815/942-2920

SUBJECT: Results of an Investigation into the Unit 3 and Unit 2/3 Diesel Generators at Dresden Nuclear Power Station on October 23, 1981, and November 19, 1981

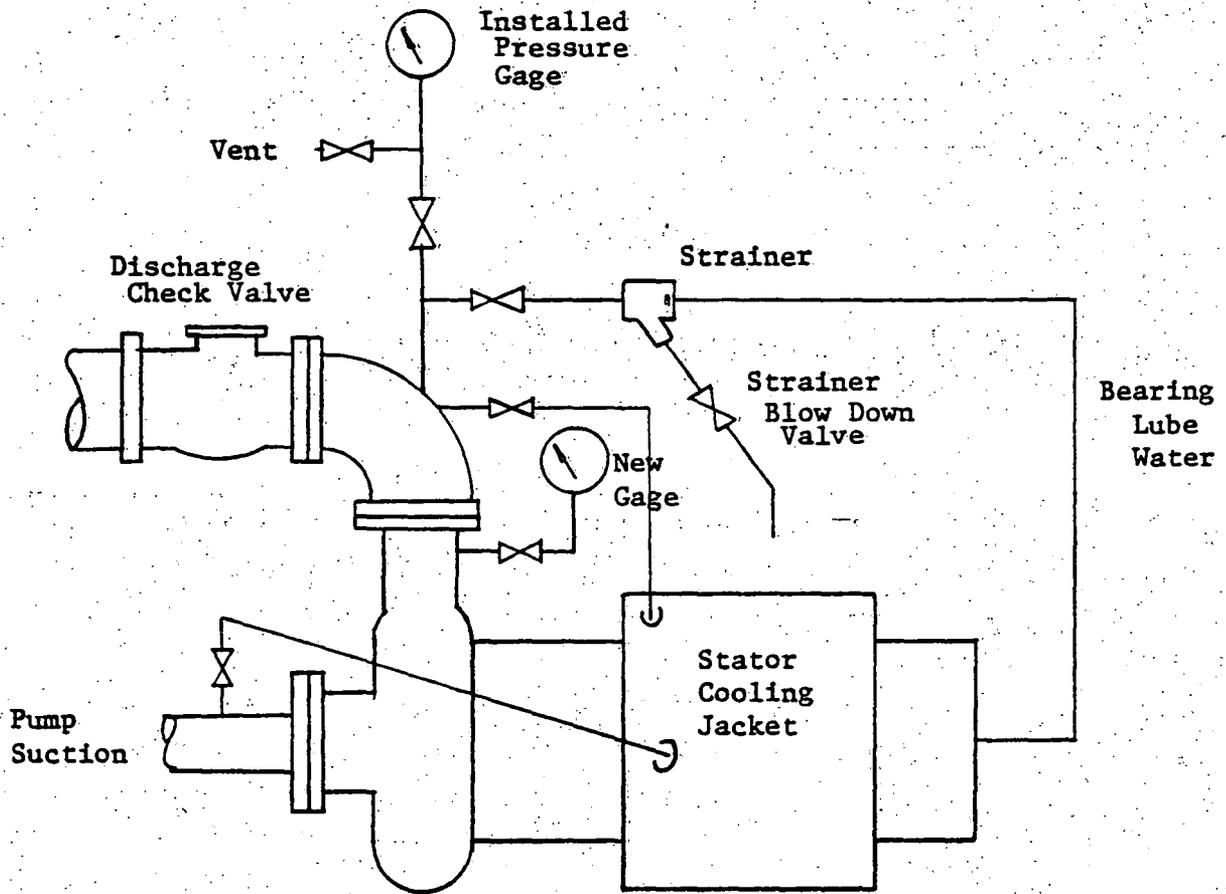
We have also determined that the present pump discharge gage piping and arrangement can result in unreliable readings, or readings not indicative of the actual pump discharge conditions. Because these are canned rotor pumps, there are no local indications other than pump discharge pressure that the pumps are actually operating. The cooling water pump discharge pressure gage is installed on the line supplying lubricating water to the pump motor bearings. (See Sketch on page 6).

The above test was then repeated on the Unit 3 diesel generator cooling water pumps. The discharge pressure gage reading decreased 25 psig (50 psig to 25 psig) when the strainer blowdown valve was opened. Thus, opening the vent and blowdown valves dramatically lowers the "indicated" pump discharge pressure, and can mislead an operator about the actual (higher) pump discharge pressure. We believe this phenomena resulted in the "apparent" low pump discharge pressures reported by the operators during the October events. We have added an additional discharge pressure gage directly off the discharge volute of all the diesel generator cooling water pumps to provide an accurate indication of pump discharge pressure. (See sketch)
