Part 21 (PAR)

Event # 48797

PART 21 - WEDGE PIN FAILURE IN ANCHOR DARLING MOTOR OPERATED DOUBLE DISC GATE VALVES WITH THREADED STEM TO UPPER WEDGE CONNECTIONS

Subject: Stem-Wedge Separation of an Anchor/Darling Double Disc Gate Valve at Exelon, LaSalle County Station, Unit 2, February 2017.

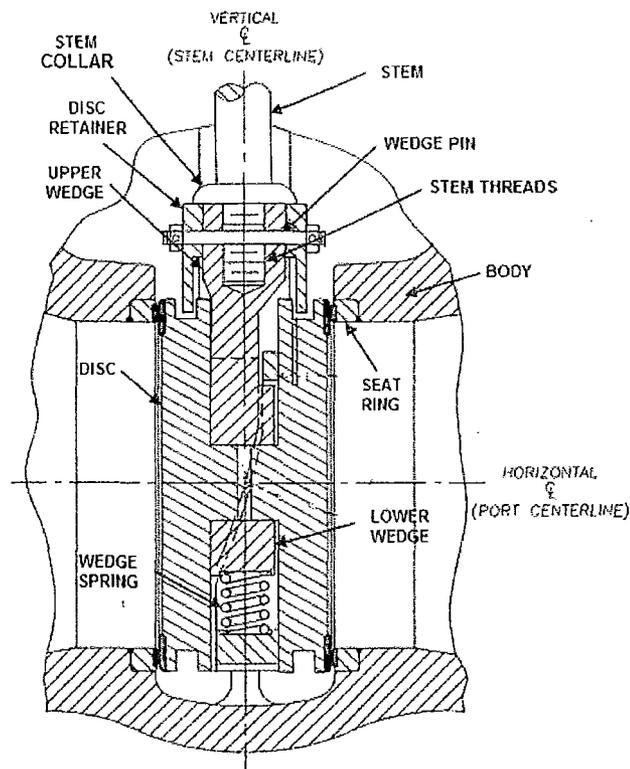
Figure 1
Typical Double-Disc Gate Valve Trim

Flowserve has been working with Exelon and nuclear industry groups to investigate and evaluate the stem-wedge separation in a size 12 class 900 Anchor/Darling motor-operated double disc (DD) gate valve. The valve stem was completely separated from the upper wedge, the wedge pin was sheared, the wedge threads stripped away and the pressed-on stem collar was pushed up leaving the valve inoperable. The valve operating thrust and torque is transmitted through the stem-wedge assembly, therefore separation of the stem and wedge will prevent the valve from opening and can adversely affect closing. See Figure 1 for a sketch of the stem-wedge joint.

Review of the LaSalle incident concluded repeated valve cycles at high actuator loads eventually wore the wedge threads to the point of failure in shear during a valve closing cycle and subsequent separation of the stem from the wedge. Before thread failure the wedge pin sheared which allowed stem to wedge movement with accompanying wedge thread wear and degradation. In addition the pressed-on collar was pushed up out of position, which would reduce or eliminate any existing preload in the joint. Wedge pin failure is attributed to both limited preload on the stem threaded section and exposure to actuator torques higher than the limit of the pin material. Since stem-wedge preload can be reduced or removed by a stem thrust which exceeds the stem-wedge joint capability, high thrust can be a precursor for wedge pin shear for applications with wedge pins that cannot independently withstand the actuator stem torque. The capability to maintain the preload is much less for stems with pressed-on collars than for stems with integral collars.

A loose connection is the result of inadequate stem thread preload whether not applied initially during assembly or not maintained during operation. The initial stem preload can be reduced if the stem closing thrust in service is high enough to cause local yielding of the joint. Stems with integral collars typically have allowable thrusts which do not govern the thrust limit of the valve however a stem with a pressed-on collar, supplied with many of the originally supplied valves, has a thrust limit which is less than the typical maximum allowed thrust values previously determined by weak-link or maximum thrust analyses.

- Torque the stem into the wedge to the maximum joint capacity.
- Replacement stems should have integral collars in lieu of press-on.
- Replacement wedge pins are manufactured from high strength material.
- Verify the actuator stem thrust is less than the maximum allowed to maintain the stem preload.
